SCHWEIZER SERVICE BULLETIN

B-247
30 Oct 1992

SUBJECT: TAIL ROTOR PEDAL BULKHEAD (FLOOR BEAM) GUSSET

MODELS AFFECTED: All Model 269A, TH55A, 269A-1, 269B and 269C Helicopters

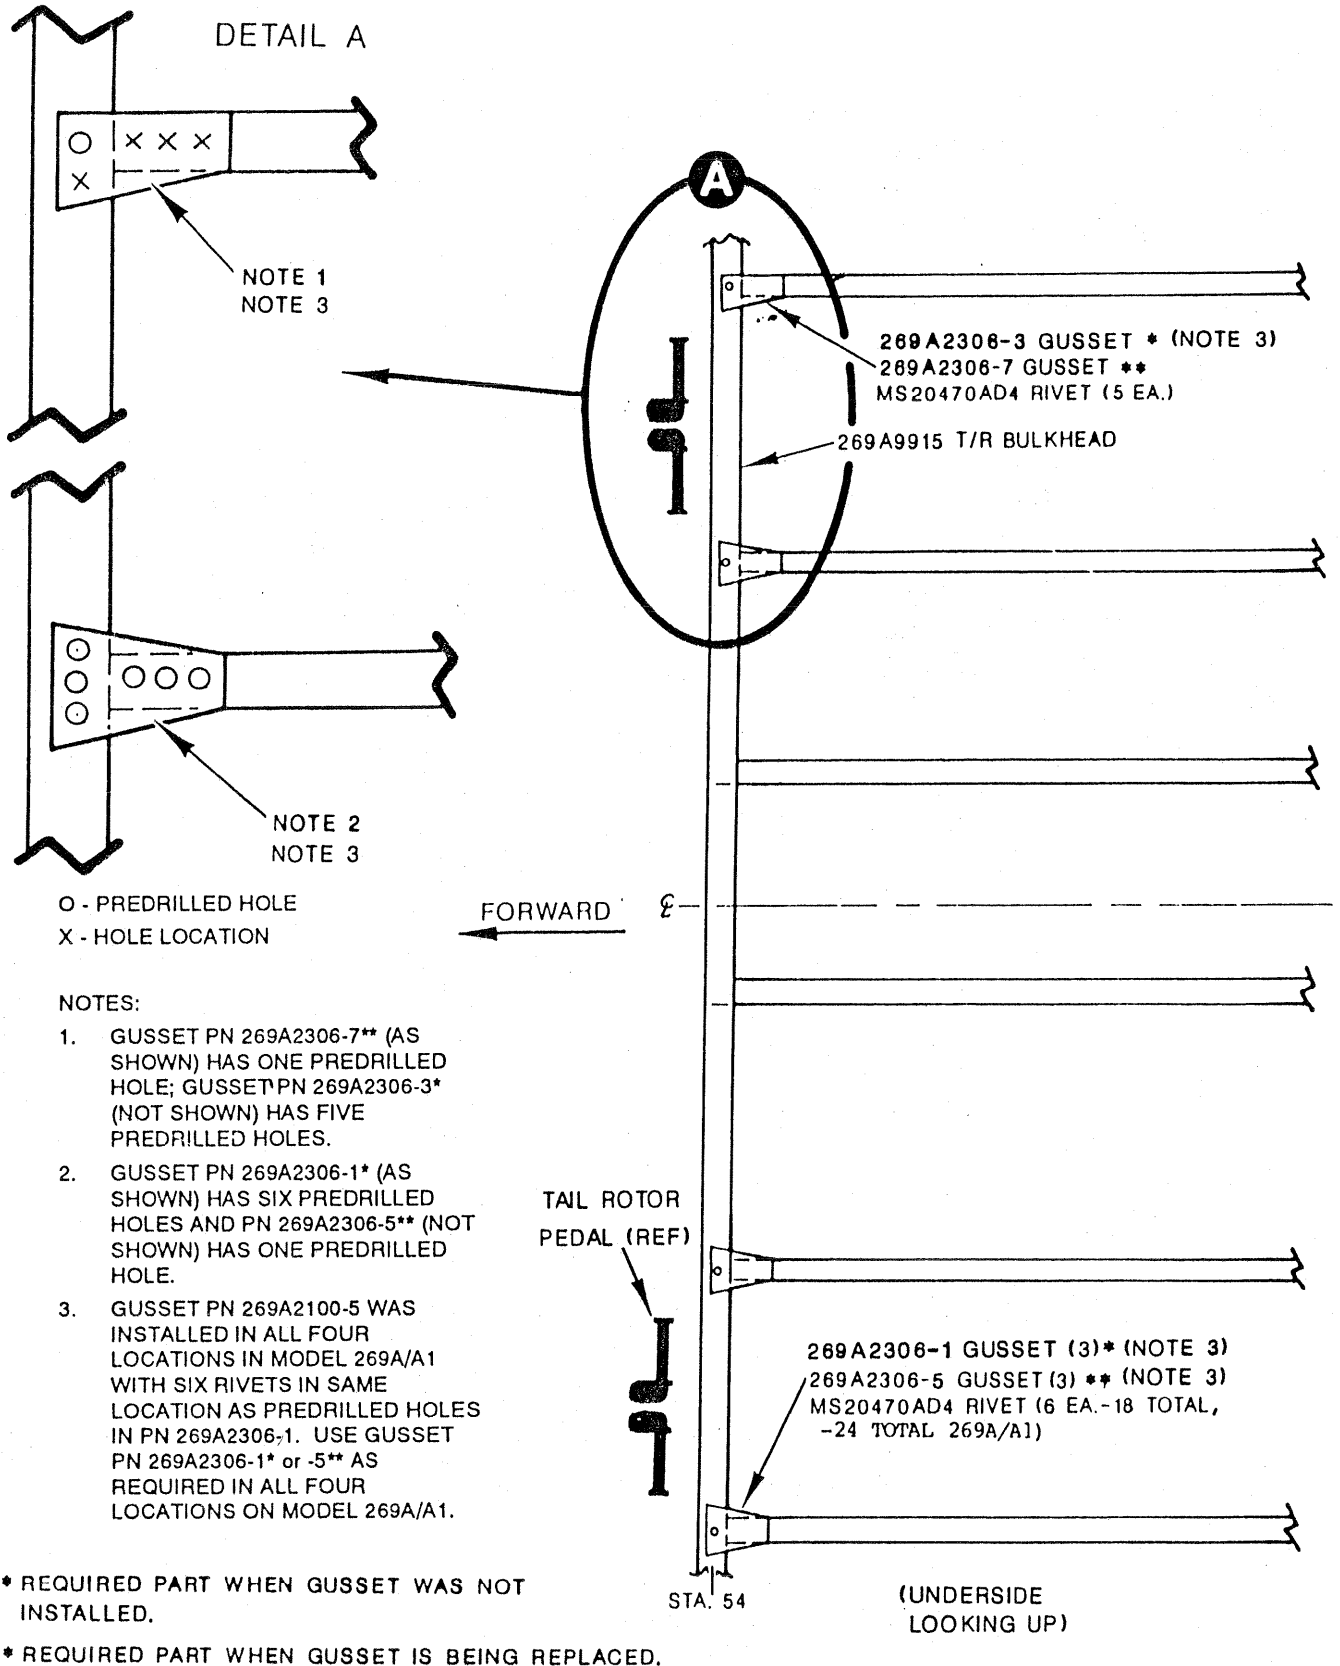
Figure B-247-1. Floor Construction

PREFACE: ● A field report indicates that tail rotor pedal gussets were not installed in a Model 269A aircraft. In other aircraft, gussets were found with cracks, elongated rivet holes, and loose or missing rivets.

- a. Remove forward fairing assembly.
- b. Locate fuselage Sta 54.0 beam (tail rotor pedal bulkhead) (Figure B-247-1).
- c. Inspect for missing or cracked gussets, elongated rivet holes, and loose or missing rivets. If repair is required, refer to Part II and/or Part III, as applicable.
- d. If no discrepancies are found reinstall forward fairing assembly and record compliance with this Service Bulletin in the aircraft records.

Refer to Figure B-247-1 for location and installation of gussets and location of rivets.

- b. Drill #30 hole through gusset and beam and install clecos. Remove clamp(s) and drill remaining holes.
- c. Deburr rivet holes. Remove all metal particles and loose paint.
- d. Clean area with Methyl-Ethyl-Ketone (MEK).
- e. Apply zinc chromate primer to gusset and beam assembly.
- f. Install MS20470AD4 rivets using wet zinc chromate primer.
- g. Paint in accordance with Basic HMI Section 2.
- h. Reinstall forward fairing assembly.
- i. Record compliance with Part II of this Service Bulletin in the aircraft records.

- a. Carefully remove rivets from gusset (Figure B-247-1).
- b. Cleco new gusset through existing hole to beam assembly.
- c. Clamp gusset to beam assembly.

- d. Using a #30 hole finder, locate and drill remaining holes in gusset. Remove clamp(s) and cleco.
- e. Deburr rivet holes and remove all metal particles and loose paint.
- f. Clean area with Methyl-Ethyl-Ketone (MEK).
- g. Apply zinc chromate primer to gusset and beam assembly.
- h. Using wet zinc chromate primer, install MS20470AD4 rivets.
- i. Paint in accordance with Basic HMI Section 2.
- j. Reinstall fairing assembly.
- k. Record compliance with Part III of this Service Bulletin in the aircraft records.
