SCHWEIZER SERVICE BULLETIN

B-249
20 Mar 1992

SUBJECT: ONE-TIME INSPECTION OF THROTTLE OVERRIDE BELLCRANK ASSEMBLY

MODELS AFFECTED: Model 269C Helicopters S/N 1166 through 1543

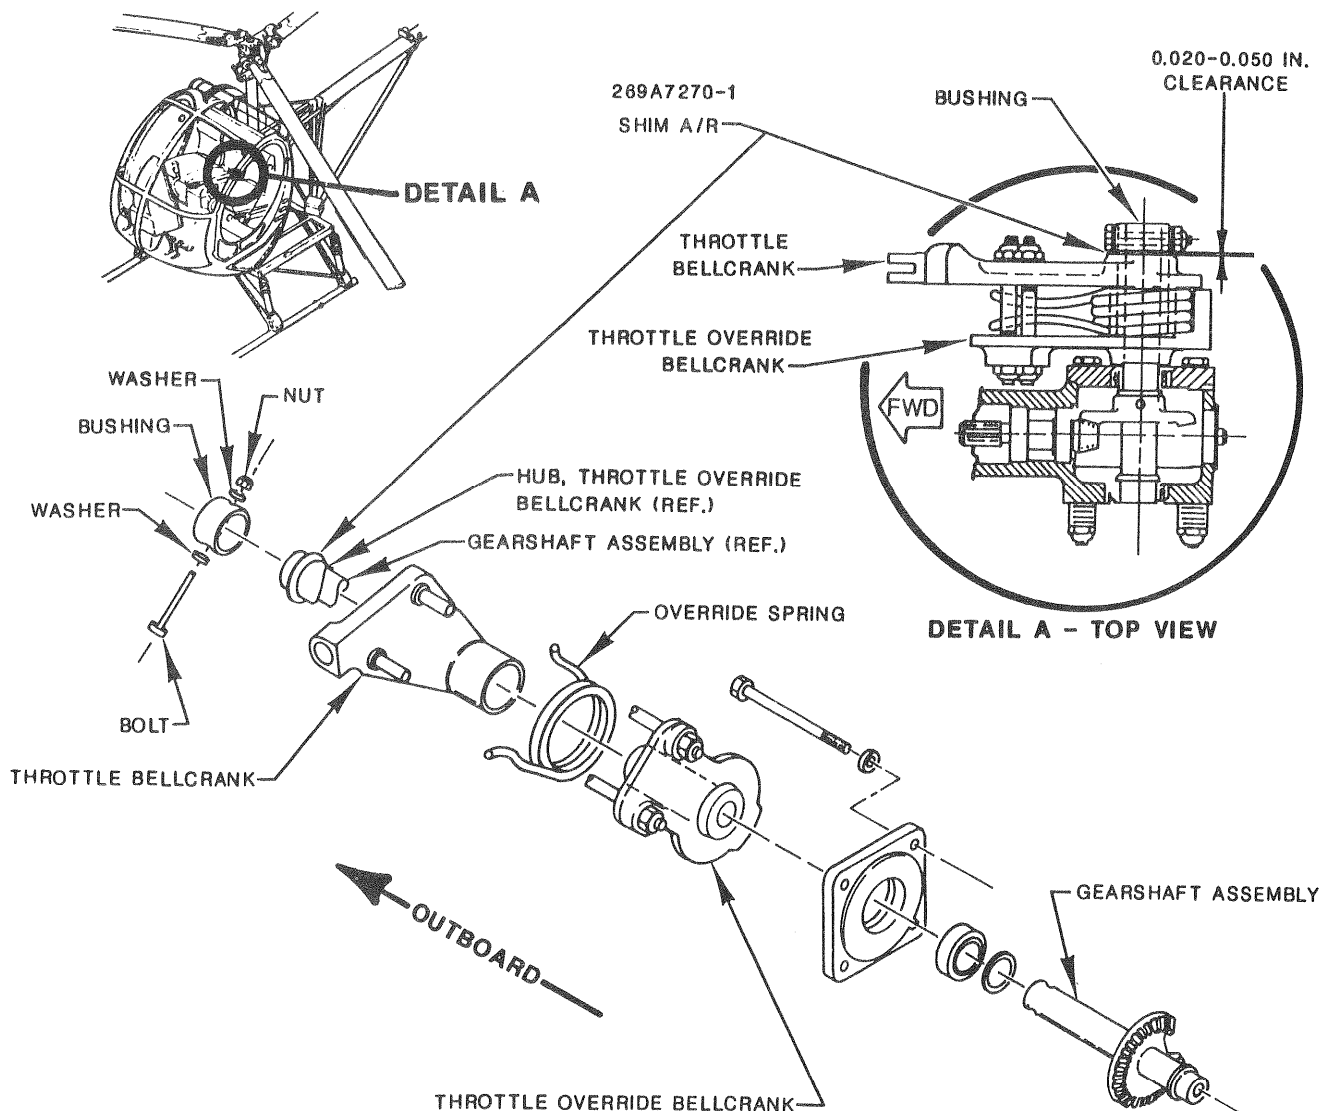
Figure B-249-1. Throttle Override Bellcrank Assembly.

PREFACE: There is a possibility that the throttle bellcrank may have excessive lateral movement on the hub of the throttle override bellcrank. This Service Bulletin provides a one-time inspection to check for this condition, and subsequent corrective action if required.

Excessive lateral movement may allow the override spring (located between the bellcranks) to slip past the bellcrank pins, resulting in loss of throttle control. This condition could lead to a loss of control of the helicopter and subsequent serious injury, death and/or property damage.

- a. Gain access to throttle bellcrank area.
- b. Push inboard on throttle bellcrank (Figure B-249-1) and verify that it is in solid contact with throttle override bellcrank. Using a feeler gage or similar tool, inspect for 0.020 to 0.050 inch clearance between throttle bellcrank and bushing, as shown on Figure B-249-1, Detail A.

- d. If clearance (step b.) is greater than 0.050 inch, install shim(s) at outboard end of throttle bellcrank, in accordance with the following:
 - (1) Calculate the number of .020 inch shims (P/N 269A7270-1) necessary to reduce the clearance to 0.020 to 0.050 inch.

- (4) Using the data from step (1), install 269A7270-1 shim(s) at outboard end of throttle bellcrank, as shown on Figure B-249-1.
