# SCHWEIZER SERVICE BULLETIN

B-277  
25 Jan 2002

SUBJECT: ONE-TIME INSPECTION OF CERTAIN 269A2234-3 (LH) AND 269A2235-3 (RH) AFT CLUSTER FITTINGS

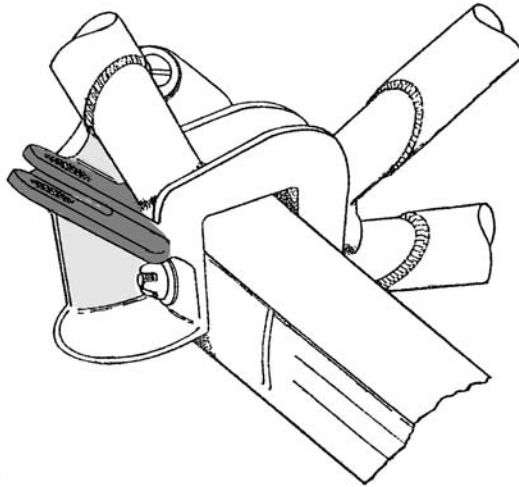
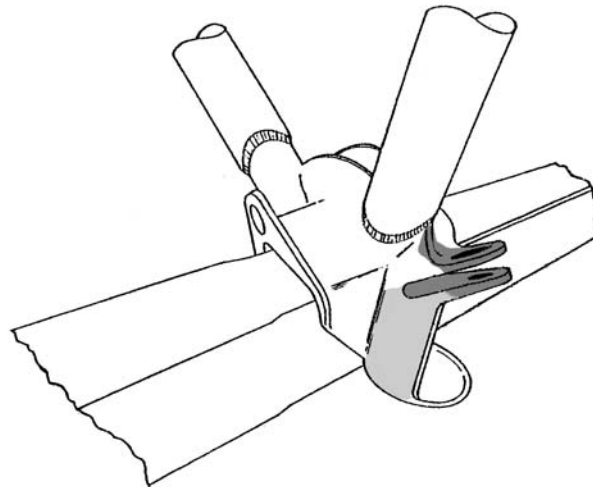
Figure B-277-1. Inspection of Cluster Fittings

- PREFACE:
- Field reports indicate a possibility of cracking of the attachment lug (for tailboom struts) on subject cluster fittings. This cracking may be caused by surface defects (nicks, scratches, and gouges) on the lugs and/or incorrect web radii. This Service Bulletin requires a one-time special inspection to check for cracks and surface defects; and also provides appropriate corrective action. Any cluster fitting that is cracked or has surface defects beyond rework limits must be replaced.
  - Failure to comply with this Service Bulletin may lead to loss of control of the helicopter and subsequent injury, death and/or property damage.

- c. If no cracks are found, perform at least a 5X visual inspection on attachment lugs (Figure B-277-1). Inspect lugs and vertical webs above and below lugs for nicks, scratches, gouges, and other surface defects.

INSPECTION AREA	TYPE OF INSPECTION	MAXIMUM SERVICEABLE LIMITS	MAXIMUM REPAIRABLE LIMITS

VISUAL W/10X MAGNIFYING GLASS	NO IMPERFECTIONS ALLOWED	REFER TO FIGURE B-277-2

DYE PENETRANT AND VISUAL	NO IMPERFECTIONS ALLOWED	LUG MUST BE MIN. OF 0.115 INCH THICK AFTER REWORK

- b. Perform dye penetrant inspection on cluster fitting tailboom strut attachment lugs using applicable steps of Basic HMI, Paragraph 13-43. If any indication of cracks are found, replace cluster fitting (Paragraph 13-44).

- d. If surface defects are found on lugs, use progressively finer grades of abrasive material to remove defects up to the maximum repairable limits specified in Figure B-277-1. Remove material only as necessary to remove defects. Polish lugs smooth with 320 grade (or finer) abrasive paper.

- e. Measure thickness of lugs; it must be a minimum of 0.115 inch after rework. If lug thickness is less than 0.115 inch, replace cluster fitting (Paragraph 13-44).

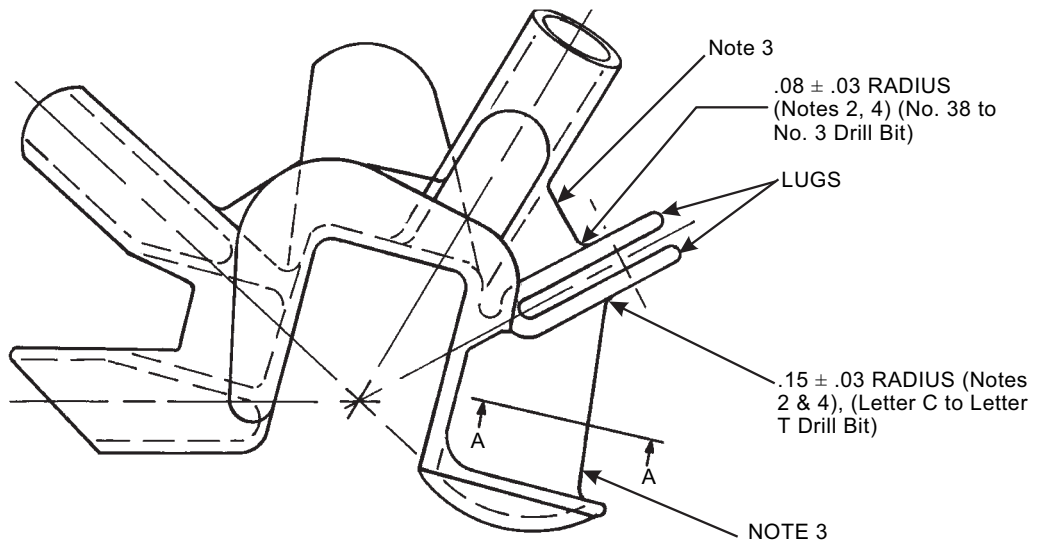
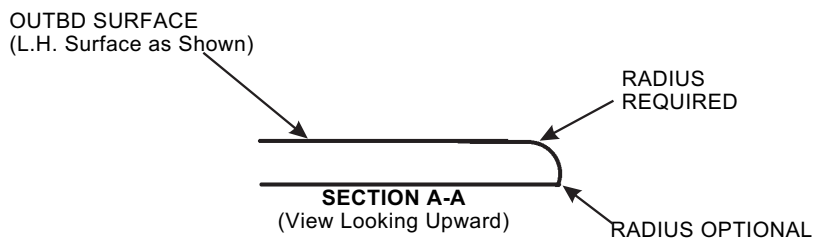
Figure B-277-2. Radius Limitations

- f. Using a radius gage or suitable drill size, check for correct fillet radii in web between attachment lugs (as shown in Figure B-277-2).
- g. If radii is not correct, use appropriate size round file and progressively finer grades of abrasive paper to feather radii into web (as shown in Figure B-277-3). Remove no more material than necessary; polish smooth with 320 grade (or finer) abrasive paper. Do not feather radii into lug. (Undercuts are not permitted.)

1. ALL DIMENSIONS IN INCHES.
2. NO UNDERCUTS PERMITTED. SMOOTHLY TRANSITION RADII INTO WEB AND BLEND TO MATCH CONTOUR (see Figure B-277-3). USE RADIUS GAGE OR SUITABLE DRILL BIT SIZE TO MEASURE RADIUS.
3. RADIUS REQUIRED ALONG ENTIRE OUTBOARD EDGE OF WEBS.
4. IF REWORK OF RADIUS IS PERFORMED, DO NOT UNDERCUT INTO LUGS.

- h. Visually inspect vertical webs above and below lugs for a radius at outer edge of webs (Section A-A). If necessary, use grade 220 (or finer) abrasive paper to obtain a smooth rounded edge.
