SCHWEIZER SERVICE BULLETIN

B-283.1*
04 Mar 2005

SUBJECT: INSPECTION AND MODIFICATION OF 269A7316-13 LATERAL CONTROL TRIM ASSEMBLY

MODELS AFFECTED: Model 269C S/N S1865 thru S/N S1874

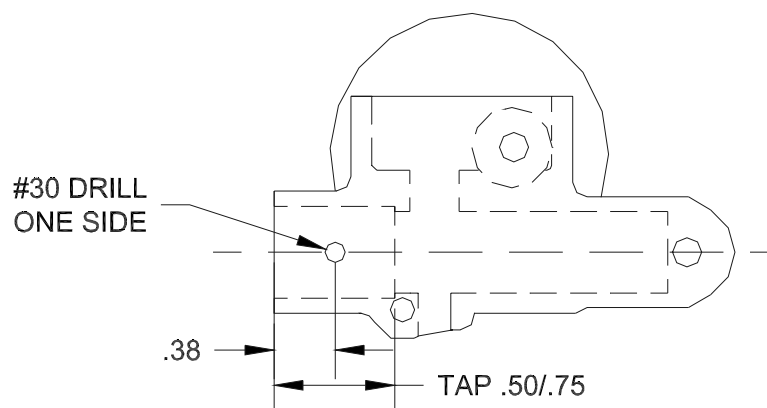
Figure B-283.1 - Trim Control

PREFACE: • Field reports indicate there is a possibility of separation of the spring tube from the trim assembly housing after extraneous external sideward load application. To preclude the possibility of separation, this bulletin provides instructions for an interim preflight inspection and scheduled modification of the subject 269A7316-13 lateral trim actuator assemblies.

- a. Turn on battery power and move the cyclic trim actuator to full left cyclic position.
- b. Examine assembly for evidence of a side load application to actuator in the form of scuffmarks, indentation, or outer spring guide tube deformation. Inspect tube security in socket of housing by aggressively rotating and pulling on the inner spring tube. Examine the resin bead around the base of the inner spring tube and housing socket. Resin should be translucent dark pink in color to indicate a good bond.

- c. If scuffmarks, indentation, or outer spring tube deformation exists, tube is loose or has motion, or bond shows evidence of separation, before further flight, remove actuator assembly and modify according to **Part II**.

Actuator assemblies containing a #30 drilled hole in housing through the wall of the inner spring tube socket as shown in Figure B-283.1 are in compliance with this Service Bulletin and no further action is required.

- e. Drill a No. 30 hole in the housing through the socket wall as shown in Figure B-283.1; deburr hole paying particular attention to burrs on the inside diameter of the housing tube socket.

- f. Cut spiral grooves inside the housing tube socket to depth of 0.50 to 0.75 inch using a 5/8"-11 standard tap as shown in Figure B-283.1 and remove all loose debris. Clean with MEK and dry with clean cloth.

- g. Mix Hysol EA9309 adhesive in accordance with manufacturers instructions and apply to faying surfaces of tube, and socket in housing. Insert tube using a clockwise rotation until tube is full seated in housing socket. Remove excess adhesive from interior and exterior with clean cloth saturated with MEK, paying particular attention to inside of tube and housing. Allow adhesive resin to cure undisturbed for a minimum of 8 hours at 70° F room temperature before reassembly of the actuator.
