# SCHWEIZER SERVICE BULLETIN

C1B-031  
24 Aug 2010

**SUBJECT:** INCORRECT BUSHING USED IN 269C-1 FLIGHT CONTROLS

**MODELS AFFECTED:** • All 269C-1 Model Helicopters

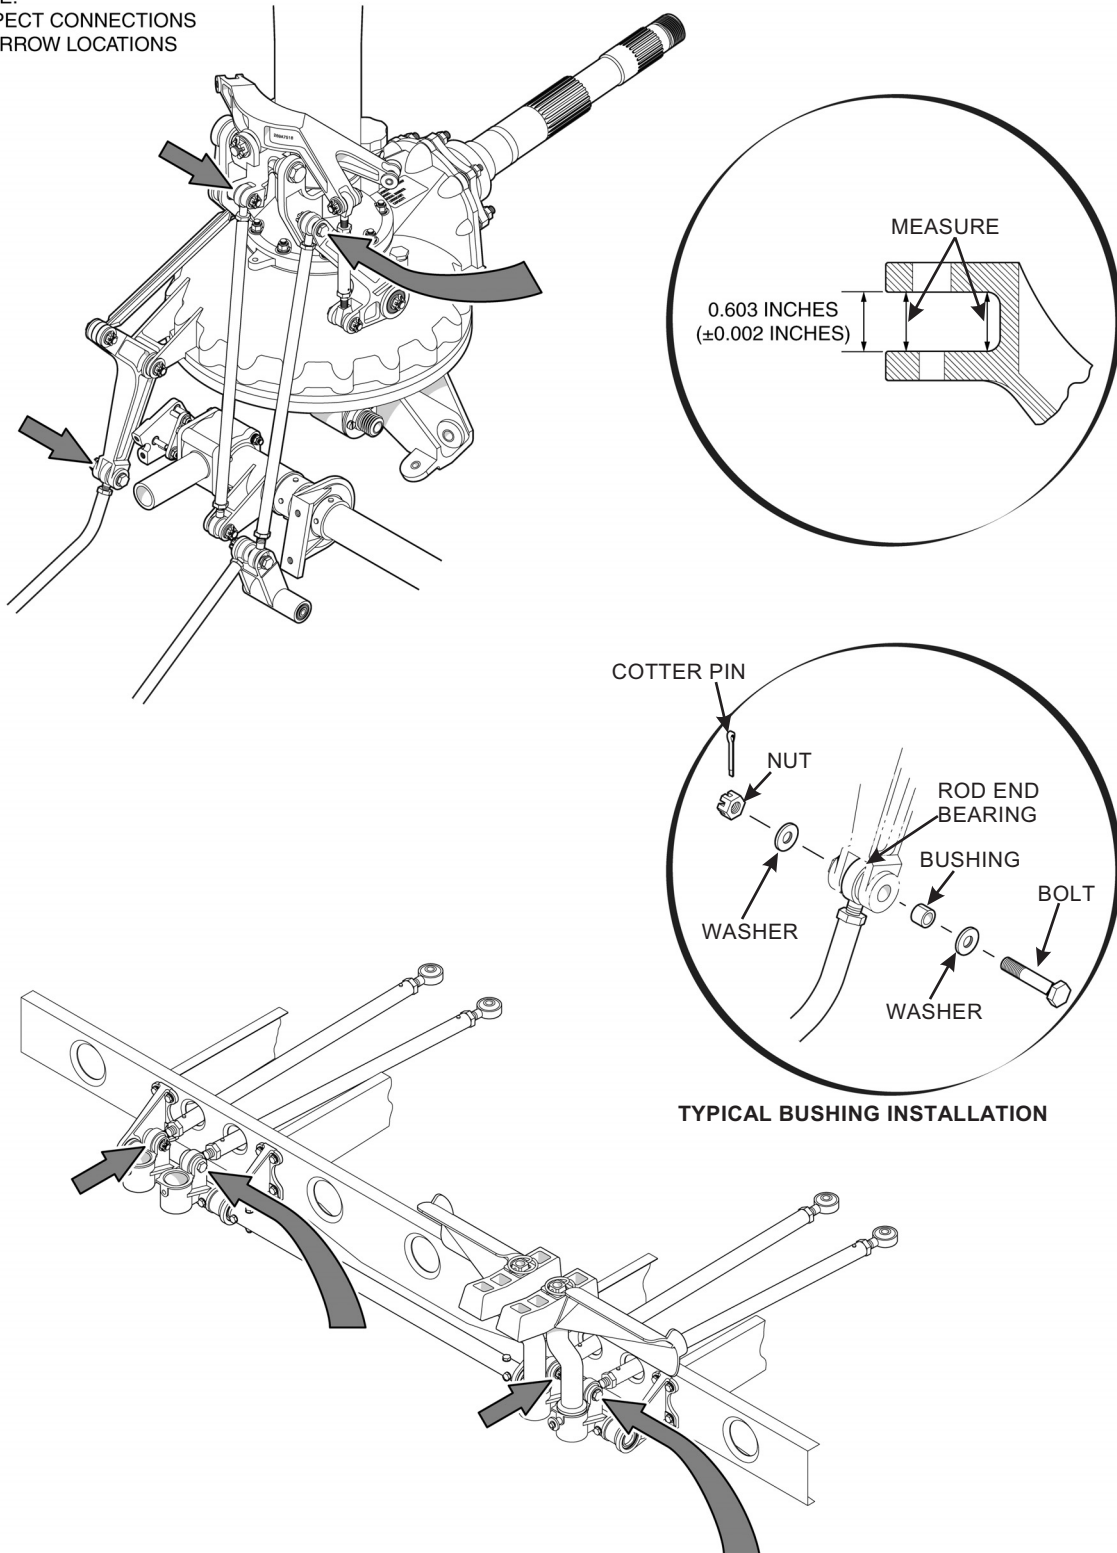
Figure C1B-031-1. Flight Control Inspection Points

**PREFACE:** • Schweizer Aircraft has received a report that a helicopter was delivered with the incorrect slotted bushing installed in the attachment of the top end of the collective control rod to the collective pitch mixer bellcrank. Investigation of the condition revealed that the stocks of SHS626-4-313 slotted bushings located on the assembly line had inadvertently been contaminated with SHS626-4-250 slotted bushings. This Service Bulletin is being issued for a one time inspection to assure the correct length bushings have been installed in the flight control system. Warehouse inventories of the subject bushing have not been contaminated and this Bulletin does not effect spares sales.

At installation, the SHS626-4-313 bushings are designed to be longer than the thickness of the bellcrank lug. When torqued, the bushing should contact the bearing rod end and extend above the bellcrank outside surface, keeping the washer from touching the bellcrank. If the washers on both sides of the fork are in contact with the fork, the incorrect bushing is installed.

**If the incorrect bushing has been installed when the hardware is torqued, the legs of the forks will be drawn to the inner race of the rod end bearing. This can cause permanent distortion of the fork legs that can lead to cracks at the root end of the legs.**

NOTE:  
INSPECT CONNECTIONS  
AT ARROW LOCATIONS

- a. Review Figure C1B-031-1 and note locations of all SHS626-4-313 bushing installations.

- b. Gain access to all flight control rod connections containing SHS626-4-313 bushings and using a bright light and as required a mirror, inspect assemblies for installation of correct length slotted bushing.

- c. If incorrect bushing is installed, remove bellcrank. Using Vernier calipers, check that the inside surfaces of the fork legs in two locations measure  $.603 \pm .002$  (Figure C1B-031-1) and are parallel to each other. If surfaces are parallel, perform a dye penetrant inspection in accordance with Basic HMI Section 2. Remove from service and destroy any bellcrank found to have distorted or cracked legs.

- d. If a dye penetrant inspection has been performed and the bellcrank is found to be acceptable within the design specifications specified in drawing number 269A7508, restore paint finish in accordance with HMI Appendix D, Corrosion Control Manual.
