SCHWEIZER SERVICE BULLETIN

DB-012
08 Feb 2005

SUBJECT: INSPECTION AND MODIFICATION OF 269A7316-13 LATERAL CONTROL TRIM ASSEMBLY

MODELS EFFECTED: Model 269D Configuration "A" S/N 0044A thru S/N 0050A

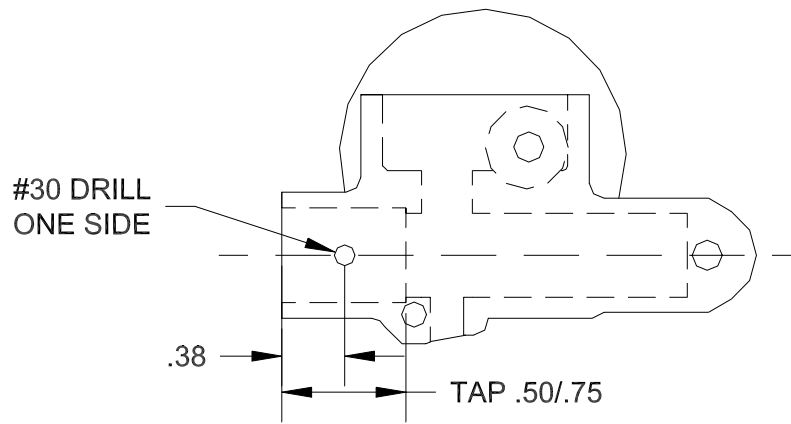
FIGURE DB-012 - Trim Control

- PREFACE:
- Field reports indicate there is a possibility of separation of the spring tube from the trim assembly housing after extraneous external sideward load application. To preclude the possibility of separation, this bulletin provides instructions for a modification of the subject 269A7316-13 lateral trim actuator assemblies.
 - Failure to comply with this bulletin may lead to loss of trim control and increased local resistance to cyclic stick movement, which could be interpreted as restrictive flight control. This interpretation could result in a forced landing, and potentially actions that could cause the loss of the aircraft with subsequent injury, death, and/or property damage.

Actuator assemblies containing a #30 drilled hole in housing through the wall of the inner spring tube socket as shown in Figure DB-012 are in compliance with this service bulletin and no further action is required.

- e. Drill a No. 30 hole in the housing through the socket wall as shown in Figure DB-012; deburr hole paying particular attention to burrs on the inside diameter of the housing tube socket.

- f. Cut spiral grooves inside the housing tube socket to depth of 0.50 to 0.75 inch using a 5/8"-11 standard tap as shown in Figure DB-012 and remove all loose debris. Clean with MEK and dry with clean cloth.

- g. Mix Hysol EA9309 adhesive in accordance with manufacturers instructions and apply to faying surfaces of tube, and socket in housing. Insert tube using a clockwise rotation until tube is full seated in housing socket. Remove excess adhesive from interior and exterior with clean cloth saturated with MEK, paying particular attention to inside of tube and housing. Allow adhesive resin to cure undisturbed for a minimum of 8 hours at 70° F room temperature before reassembly of the actuator.
