# SCHWEIZER SERVICE BULLETIN

DB-034  
9 May 2011

**SUBJECT: 269D1120 Main Rotor Blade Paint Separation**

**MODELS AFFECTED: Model 269D Configuration "A" Helicopter (S-333)**

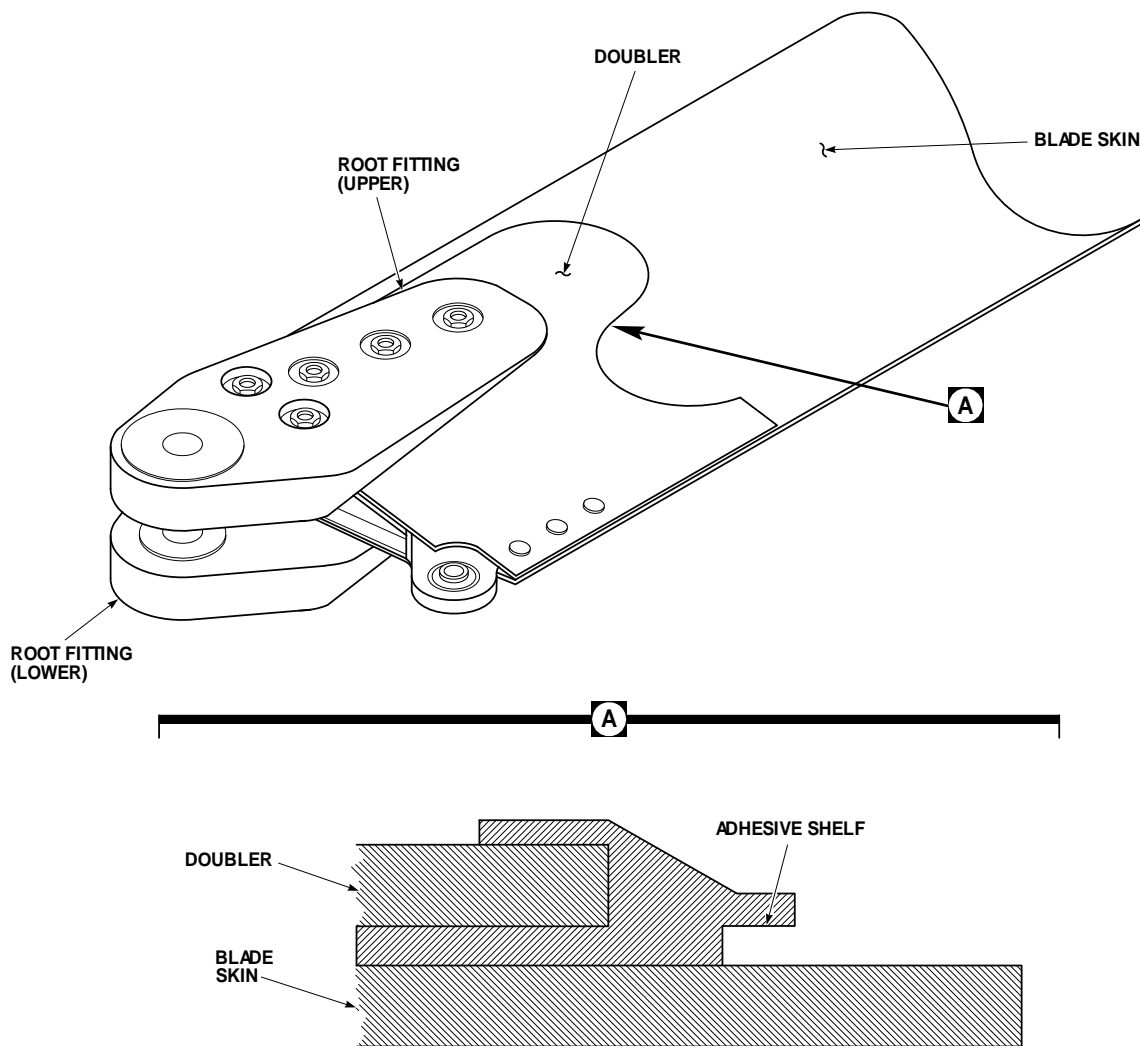
During main rotor blade manufacturing, the doubler is bonded to the blade skin. The bonding process may leave a small ridge or "shelf" of dried adhesive along the interface of the doubler and skin (see Figure 1). When the blade is painted this adhesive shelf may give a false appearance of the paint having separated from the blade.

Figure 1. Adhesive Shelf at Interface of Doubler and Blade Skin

1. Wash area in accordance with HMI. Remove all sand, dust, dirt and debris.
2. Lightly sand area with 200 grit abrasive paper (HMI, Section 2, Table 2-2, Item 28) to roughen surface.

5. Apply a small bead of EA934 sealant (HMI, Section 2, Table 2-2, Item 134) or EA960 bonding resin (HMI, Section 2, Table 2-2, Item 74) along entire doubler OML. Follow manufacturer's instructions for application and curing.

6. Lightly sand dried sealant or bonding resin to smooth out fillet between doubler and blade skin.
7. Wipe area with clean cloth dampened with dry cleaning (Stoddard) solvent (HMI, Section 2, Table 2-2, Item 42) to remove all debris.
