Subject: SERVICE BULLETIN No. DB-037.1 - Inspection of Main Rotor Drive Thrust Bearing Journal Radius

269D

DB-037.1

SUBJECT: Inspection of Main Rotor Drive Thrust Bearing Journal Radius

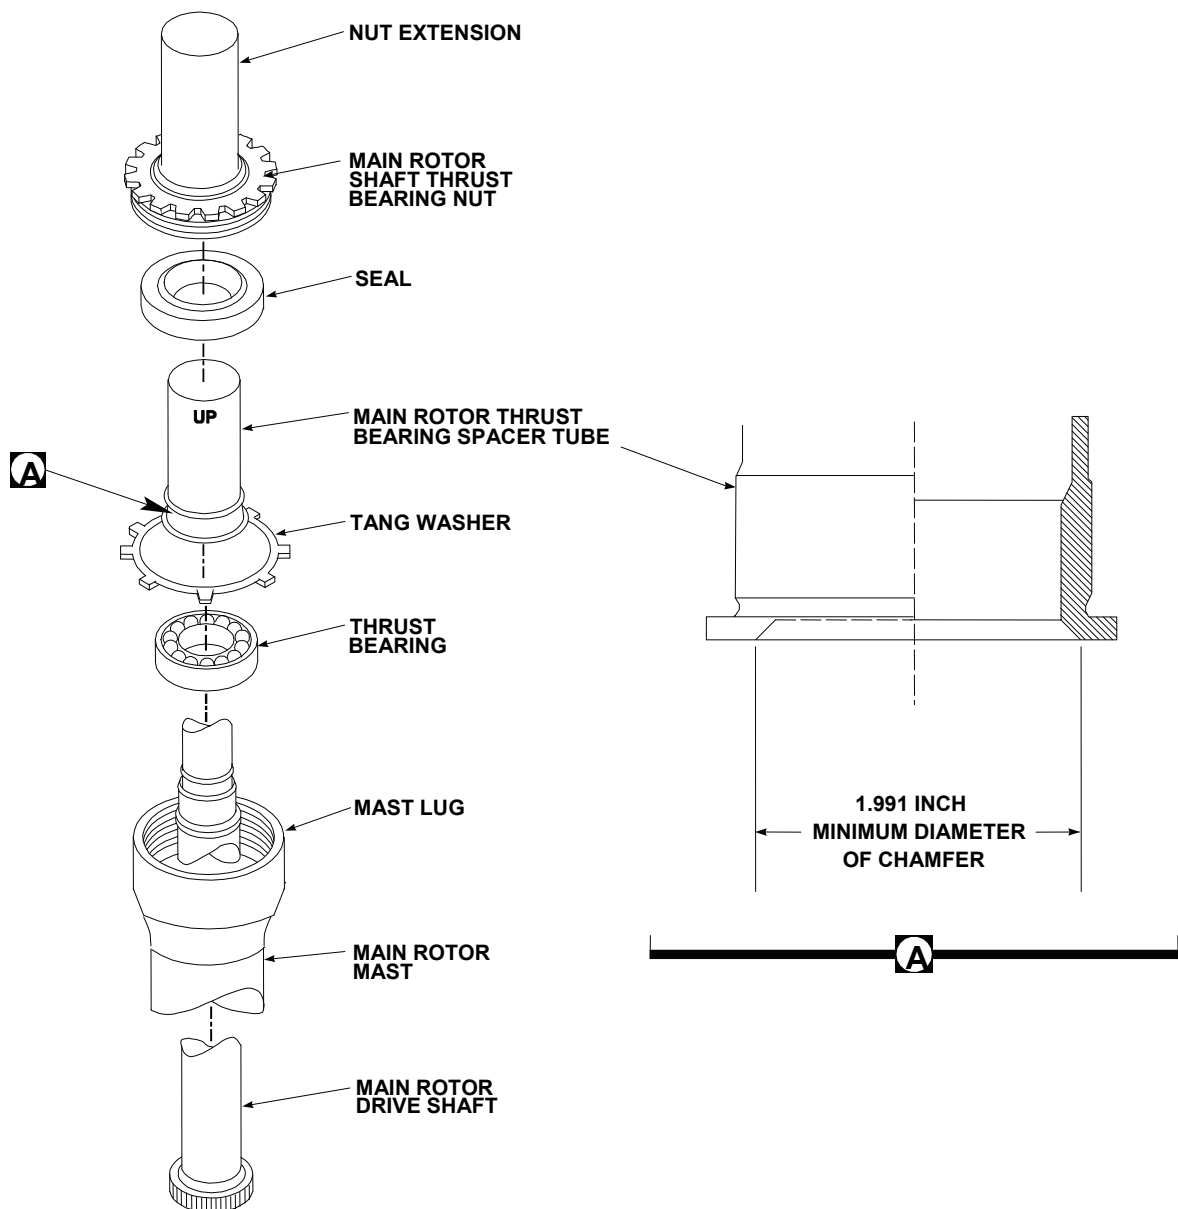
Figure 1. Main Rotor Thrust Bearing Spacer Tube Inspection

- (b) If no groove is found, continue to next step.
 - (4) Measure chamfer in the bottom of main rotor thrust bearing spacer tube for minimum diameter of 1.991-inches (Figure 1).

- (a) If diameter is less than 1.991-inches, remove main rotor thrust bearing tube, and contact a Sikorsky Light Helicopter Service Center to obtain an RSA number. Fill out the RSA as applicable and mail the form and the main rotor thrust bearing spacer tube to the address shown on the form.
