269D™ HELICOPTER

ALERT SERVICE

ASB DB-044
BASIC ISSUE ▪ July 25/13

SUBJECT: One-Time Engine Alignment Check and Inspection of the KAflex® Drive Shaft, KAflex Coupling Assembly, and Engine Mount Assembly Absorbers

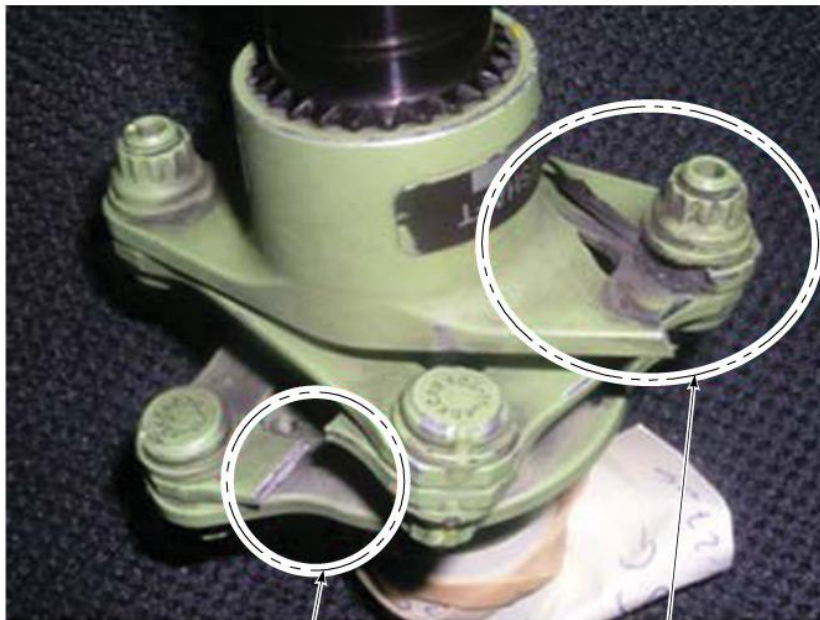
Figure 1. Example of Fractured KAflex Assembly

- (1) Remove KAflex Drive Shaft, and Coupling Assembly. Refer to Table 1 for applicable publication and helicopter model.
- (2) Refer to Figure 1 for example of fractured KAflex Assembly.

AREA OF INSPECTION FOR
ENGINE COUPLING FLEX FRAME
(SKCP2537-11)

AREA OF INSPECTION FOR
ENGINE ADAPTER LUG
(SKCP2985-11)

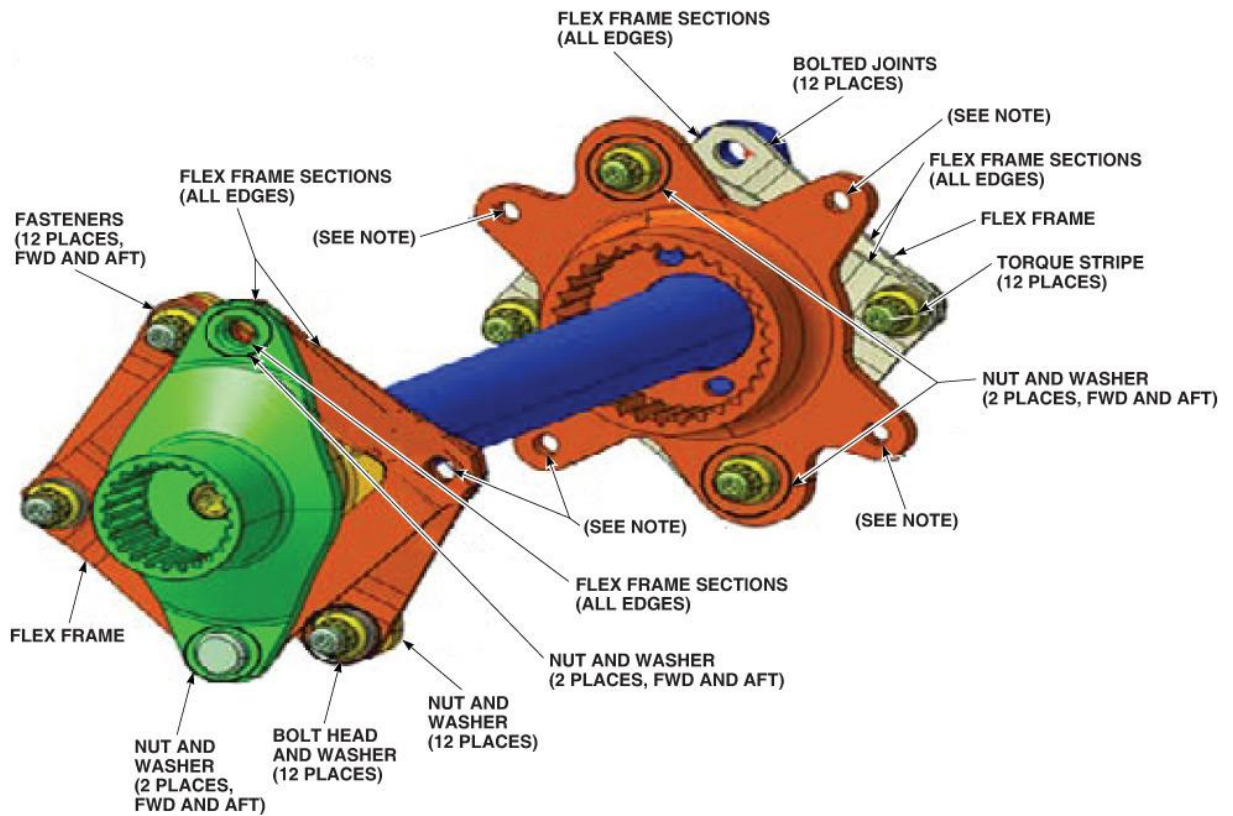
Figure 2. KAflex Assembly Inspection Locations
(Image representative of P/N SKCP2738-5/-7, but not identical.)

- (3) Check for working fastener condition at joints by hand (12 places, both sides) – black residue under head or tail. Metal wear will appear as powder (fretting debris) and appear black or red in color. If powder is found, remove the drive shaft from service. Refer to Figure 2 for location of inspection. Record findings in the ASB Work Sheet (Section E).
 - (a) If drive shaft is removed from service, proceed to step (11).
 - (b) If rejected condition is not found, proceed to step (4).
- (4) Visually inspect for cracks emanating from under head and/or tail of fasteners (12 places, both sides). Refer to Figure 2 for location of inspection. Record findings in the ASB Work Sheet (Section E).
 - (a) If drive shaft is removed from service, proceed to step (11).
 - (b) If rejected condition is not found, proceed to step (5).

NOTE: Torque stripes may have been painted over with corrosion resistant primer after assembly. This is a normal condition.
- (5) Inspect flex frame and mount bolt torque stripes for evidence of movement. If any evidence of movement is found, or torque stripes are no longer visible, remove drive shaft from service. Refer to Figure 2. Record findings in the ASB Work Sheet (Section E).

- (6) Using a 10X magnifying glass or equivalent, visually inspect flex frame bolted joints for evidence of wear. If evidence of wear is found, remove drive shaft from service. Refer to Figure 2. Record findings in the ASB Work Sheet (Section E).

- (a) If drive shaft is removed from service, proceed to step (11).
 - (b) If rejected condition is not found, proceed to step (7).
- (7) Using a 10X magnifying glass or equivalent, visually inspect flex frame for evidence of cracks over the full circumference (360 degrees) around the bolt head and washer side and over the full circumference (360 degrees) around the nut and washer side. If any evidence of cracking is found, remove drive shaft from service. Refer to Figure 2. Record findings in the ASB Work Sheet (Section E).

- (a) If drive shaft is removed from service, proceed to step (11).
 - (b) If rejected condition is not found, proceed to step (8).
- (8) Using a 10X magnifying glass or equivalent, visually inspect four inside and outside corner radii and radii edges for evidence of cracks on each flex frame. Inspect the corner radii edges on both sides of the flex frame. If any evidence of cracking is found, remove drive shaft from service. Refer to Figure 2. Record findings in the ASB Work Sheet (Section E).

- (a) If drive shaft is removed from service, proceed to step (11).
 - (b) If rejected condition is not found, proceed to step (9).
- (9) Using a 10X magnifying glass or equivalent, visually inspect each shaft end-fitting flange for evidence of cracks over the full circumference (360 degrees) around the nut and washer side. If any evidence of cracking is found, remove drive shaft from service. Refer to Figure 2. Record findings in the ASB Work Sheet (Section E).

- (a) If drive shaft is removed from service, proceed to step (11).
 - (b) If rejected condition is not found, proceed to step (5).
 - (c) If torque stripes have faded, repaint using torque seal or equivalent (Table 2-2, Item 153, HMI CSP-D-2; Table 2-2, item 139, HMI CSP-D-9) in the same location and orientation as previously applied. Refer to Figure 2.
