**HUGHES
SERVICE INFORMATION
NOTICE**

NOTICE NO. N-100

SUBJECT: REPAIR OF TAIL ROTOR BLADES, P/N 269A6035 SERIES

MODELS AFFECTED: All 269 Series Helicopters Equipped With Low Tip Speed Tail Rotor Assembly

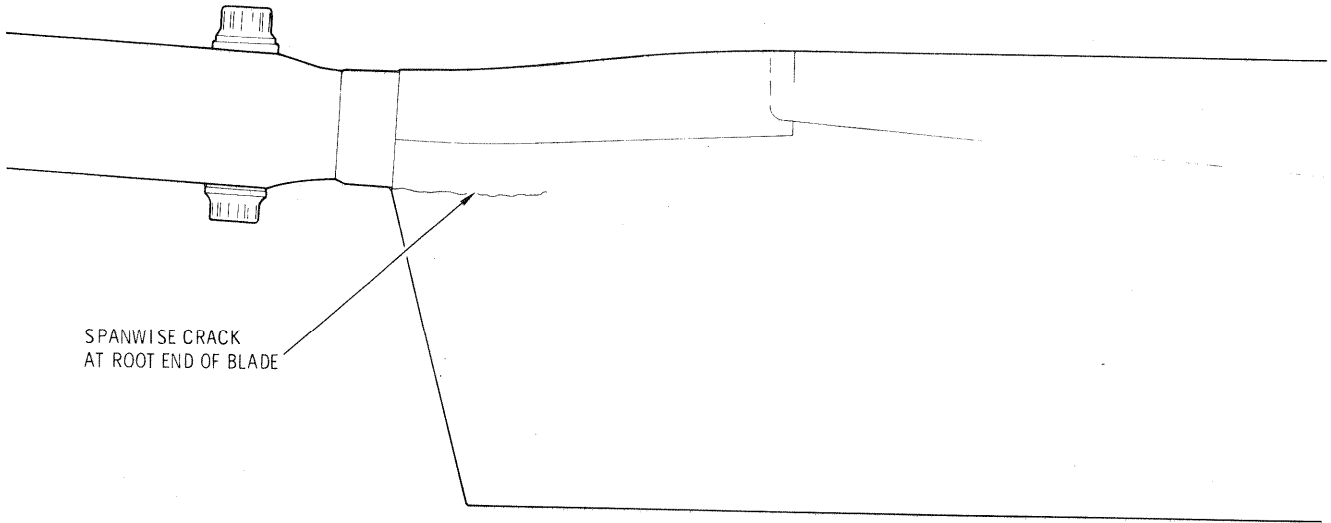
FIGURE 1

PREFACE: The information given in this Service Information Notice lists a procedure for field repair of tail rotor blades, when inspection reveals spanwise cracking at the root end of the blade close to the joint of the spar and the root end cap. (See Figure 1.)

BLADE CONDITION AT TIME OF MANUFACTURE

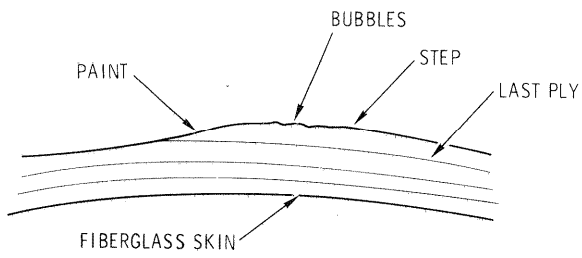
FIGURE 2

Repair is limited to cracks less than one and one-half inches in length, and not more than two plies of fiberglass skin in depth. The above described cracks can be repaired without impairing the integrity of the blade structure.

BLADE CONDITION DURING SERVICE

1. If the length of the crack is less than one and one-half inches and the depth of the crack is not more than two (2) plies of the fiberglass skin, the crack can be repaired in the field using the procedure described below. (See Figures 1 thru 3.)
2. If the crack is longer than specified above and/or extends through the entire thickness of the skin indicating complete fracture of the fiberglass, the blade shall not be repaired in the field and the Tail Rotor Assembly shall be declared unserviceable.
