SCHWEIZER SERVICE NOTICE

NOTICE NO. N-120

SUBJECT: WIRING MODIFICATION - INTEGRATED DUAL COMMUNICATION
CONSOLE (ATI)

MODELS AFFECTED: Model 269C Helicopter Serial No. 0190 and Subsequent
equipped with both Searchlight Kit and Integrated
Communications Kit (Policepac)

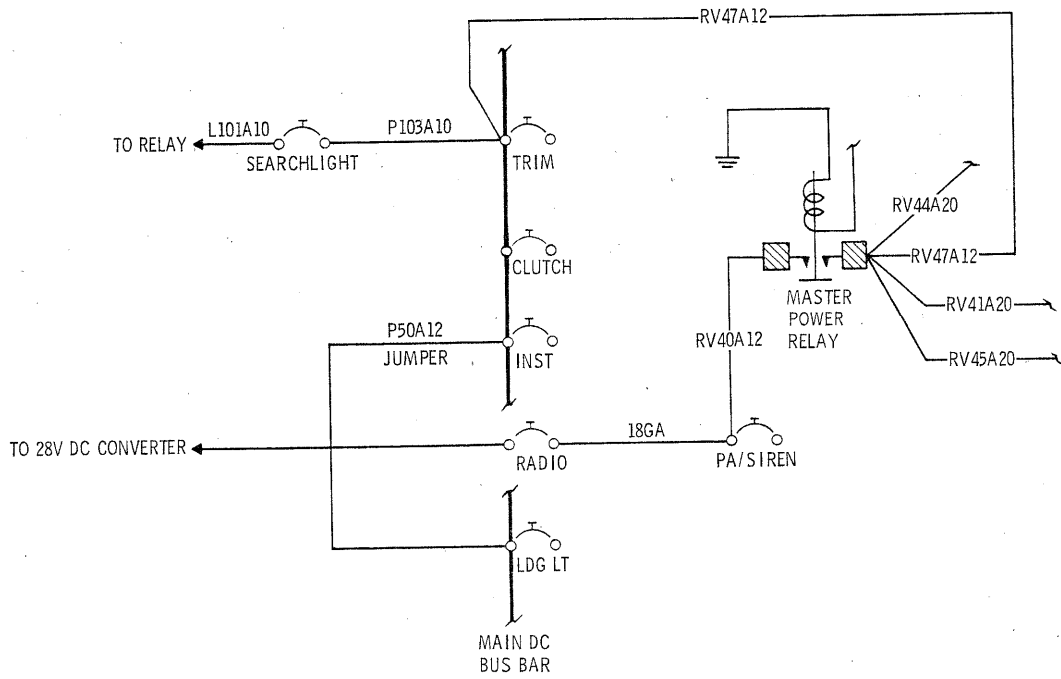
Figure 1. Wiring Modification - Integrated Dual Communications Console (ATI)

PREFACE: The information given in this Service Information Notice lists a procedure
for replacing and rerouting electrical wiring in the ATI console on the
above affected Model 269C helicopters. The purpose of the modification
is to preclude the possibility of an electrical overload, particularly if a
additional light unit and/or radio equipment are installed.

If 18GA wire is presently installed, replace with new 12GA wire (P50A12) as shown in Figure 1.

- d. Disconnect existing 12GA wire (RV47A12) from HEATER circuit breaker at main bus bar. Reconnect to TRIM circuit breaker at main bus bar as shown in Figure 1. Install new 12GA wire if length of existing wire No. RV47A12 is not sufficient.
- e. Check that existing 10GA wire (P103A10) from SEARCHLIGHT circuit breaker to main bus bar is connected to TRIM circuit breaker at main bus bar as shown. Install new 10GA wire if not installed as shown and length of existing wire No. P103A10 is not sufficient.
- f. Perform operational check of searchlight, landing light, and integrated communications systems.
- g. Reinstall panel fairing.
- h. Record compliance with this Service Information Notice in Compliance Record of helicopter Log Book.
