# SCHWEIZER SERVICE NOTICE

NOTICE NO. N-122  
DATE Dec. 4, 1974  
PAGE 1 OF 5

SUBJECT: INSPECTION-IMPELLER BOLT INSTALLATION

MODELS AFFECTED: 269A Helicopter Serial No. 0011 thru 0314  
269A (TH-55A) Helicopter Serial No. 0315 and subsequent  
269A-1 Helicopter Serial No. 0001 thru 0041  
269B Helicopter Serial No. 0001 and subsequent  
269C Helicopter Serial No. 0004 thru 0389

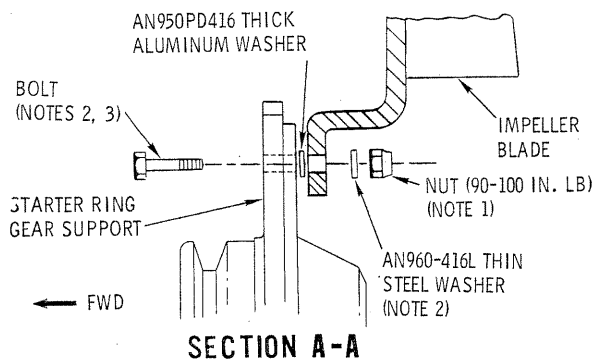
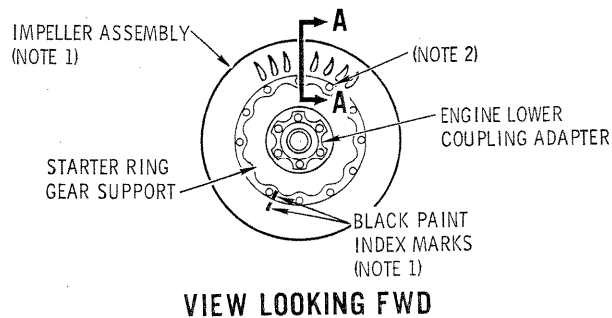
Figure 1. Impeller bolt installation

The information given in this Service Information Notice lists a procedure for a one-time inspection of the impeller to starter ring gear installation; an increase in bolt installation torque and a recheck of the nut torque at first 100-hours following the initial inspection and torque. The purpose of this Notice is to determine that proper clamp-up is obtained between the impeller and starter ring gear support assembly. Installation of non-approved hardware, particularly bolts having excessive grip length, can result in improper clamp-up, even though nut torque readings are correct.

d. Remove two close tolerance AN bolts (identified by triangle marking on bolt head), at hole with black index mark and at hole directly opposite (See Figure 1.)

e. Install two NAS 1304-12 bolts with thick AN960 PD416 aluminum washer between flywheel and impeller; and thin AN 960-416L steel washer under MS21042-4 nuts, at locations specified in step d.

g. Torque MS21042-4 nut (12 places) to 90-100 inch-pounds, plus nut running torque.

1. IF NOT PRESENT ON IMPELLER, ADD TO IMPELLER BEFORE DISASSEMBLY. INDEX MARKS MUST ALIGN AT REASSEMBLY.
2. BOLT, WASHERS AND NUT INSTALLATION, TYPICAL 12 PLACES. USE NAS1304-12 BOLT (12 PLACES) AND MS21042-4 NUT (12 PLACES) TO ENSURE PROPER CLAMP-UP OF IMPELLER.

3. MINIMUM OF TWO FULL THREADS MUST PROTRUDE THROUGH NUTS AFTER NUTS ARE TORQUED; IF NOT, REPLACE BOLT WITH NAS1304-13 BOLT.
