HUGHES SERVICE INFORMATION NOTICE

NOTICE NO. N-131

DATE 11 August 1975

SUBJECT: INSPECTION AND POSSIBLE REPLACEMENT THROTTLE GEAR
(PN 269A7223); PILOT'S AND COPILOT'S COLLECTIVE PITCH STICKS

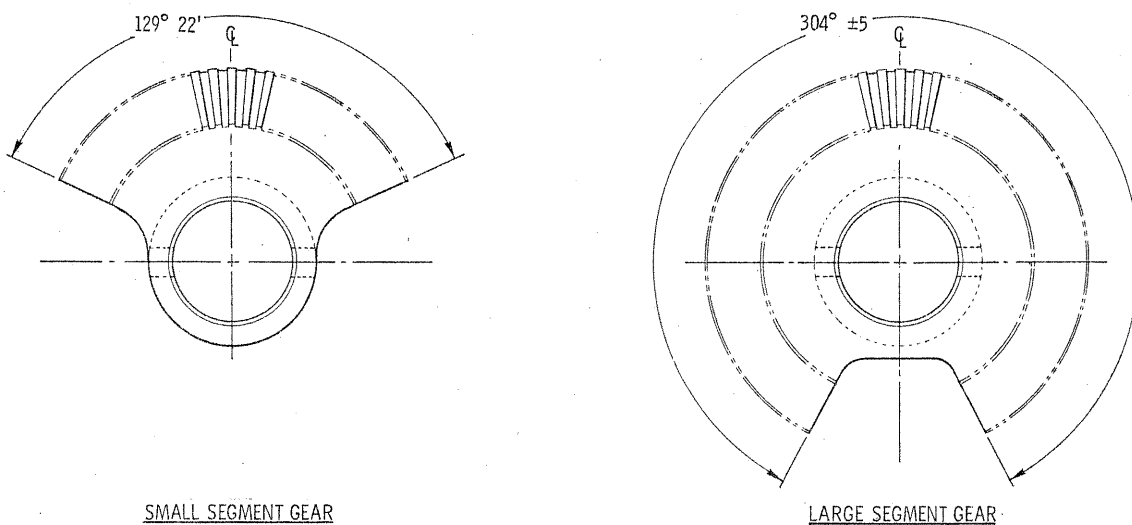
Figure 1. Throttle Gear Identification

PREFACE: Instances of cracking of the throttle gear have been noted in the field.
This notice provides information for a one time inspection of the gear,
and for replacement of the gear if required.

b. Determine whether throttle gear has small or large segment. (See Figure 1.)

1. SMALL SEGMENT GEARS MUST BE REPLACED.
2. ALL LARGE SEGMENT ALUMINUM GEARS MUST BE INSPECTED.

c. Replace all small segment gears with large segment steel gear and shaft assembly. (Refer to step e. and subsequent, and HMI for gear replacement procedure.)

d. Inspect all large segment aluminum gears for cracks, elongated hole in roll pin area, and other damage using magnifying glass. Inspect gear shaft assembly for corrosion. Determine if radial or axial play exists between the gear and shaft.

1. If cracks, radial or axial play, or damage is found, replace gear and shaft assembly.
