HUGHES SERVICE INFORMATION NOTICE

NOTICE NO. N-153.1*

DATE 28 October 1981

SUBJECT: INSPECTION AND REWORK OF LTS TAIL ROTOR HUB
PN 369A1725, 369A1725-5, and 369A1725-501

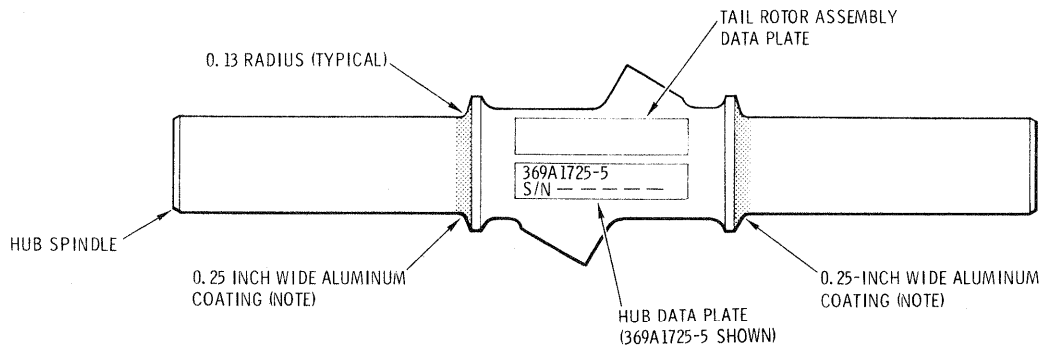
Figure 1. Rework of tail rotor hub assembly

PREFACE: Field reports indicate that corrosion pitting in the root radii of the PN 369A1725 series tail rotor hub has occurred in service. This Service Information Notice provides instructions for identification and inspection of the hubs affected and application of a corrosion resistant coating at the radius area between the spindles and center portion of the hub.

- a. As applicable, remove tail rotor assembly from helicopter and remove tail rotor blade assemblies, per Basic HMI. Disassemble hub and drive fork assembly, per Component Overhaul Manual (HMI Appendix C).
- b. Clean hub with trichloroethane.
- c. Using 10X glass, inspect hub for cracks, corrosion or other damage. Pay particular attention to area of 0.13 radii between the spindles and center portion of the hub. (See Figure 1.)

1. Shake contents of container thoroughly.
2. Brush a thin (0.002 to 0.005 inch) even coat onto cleaned surface of 0.13 radius areas on both sides of hub. (See Figure 1.) Limit width of aluminum coating to 0.25 inch to prevent contact with feathering bearings.
3. Allow a flash-off (drying) time of 8 to 10 minutes.
4. Bake hub for 1 hour at 375° to 425° F in oven or use heat lamps.
5. Air cool hub.

f. To denote rework of 369A1725-5 or 369A1725-501 hub, add letter "Z" following serial number on hub data plate; to denote rework of 369A1725 hub, add letter "Z" following part number on tail rotor assembly data plate. (See Figure 1.)

LIMIT WIDTH OF ALUMINUM COATING TO 0.25-INCH TO PREVENT CONTACT WITH FEATHERING BEARINGS.
