SCHWEIZER SERVICE NOTICE

NOTICE NO. N-195

DATE: 28 FEB 86

SUBJECT: INSPECTION OF MAIN TRANSMISSION ASSEMBLY, P/N 269A5175-11, -13, -15 and -17

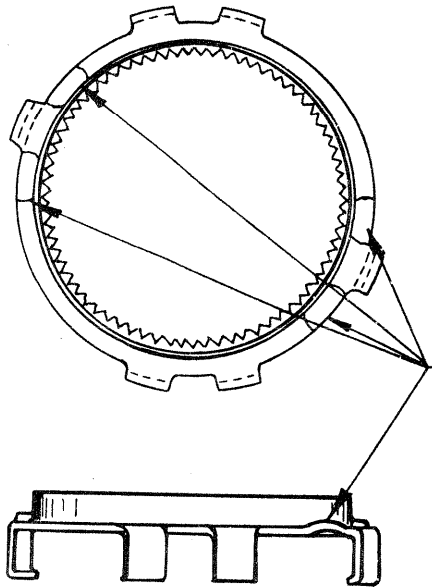
PREFACE: Reports indicate that a number of main transmission assemblies may have been assembled using a wrong lock-washer on the upper pulley nut which may lead to loss of torque on the aft pinion nut and possible premature wear of the input pinion shaft. The correct lockwasher is a SL60W9 however SL61W9 may have been installed. The SL61W9 has four retract dimples on the face which rides against the 269A5178 collar. These retract dimples will eventually deform causing loss of torque of the aft pinion nut. Also the collar stability is not as good as a completely seated collar.

**RETRACT DIMPLES
(TYP. 4 PLACES)**

A picture of both the SL61W9 and SL60W9 Lockwashers is shown above in Detail "A". Note that the incorrect SL61W9 Lockwasher has 4 retract dimples on the surface as compared with the SL60W9 Lockwasher which is smooth on the surface. The SL60W9 is the correct Lockwasher.

- c. If the transmission is found to have the wrong lockwasher, P/N SL61W9, then continue with the disassembly and inspection as follows.
- d. Remove incorrect lockwasher and discard. Replace with new SL60W9 lockwasher
