SCHWEIZER SERVICE NOTICE

NOTICE NO. N-210.1*

DATE: 30 May 1991

SUBJECT: IDENTIFICATION OF THROTTLE CABLE ASSEMBLIES; INSPECTION OF 269A4683 (BSC) OR -3 THROTTLE CABLE ASSEMBLIES HAVING THREADED END FITTINGS; REPLACEMENT OF 269A4683 (BSC) AND -3 THROTTLE CABLE ASSEMBLIES HAVING THREADED AND/OR ALUMINUM END FITTINGS.

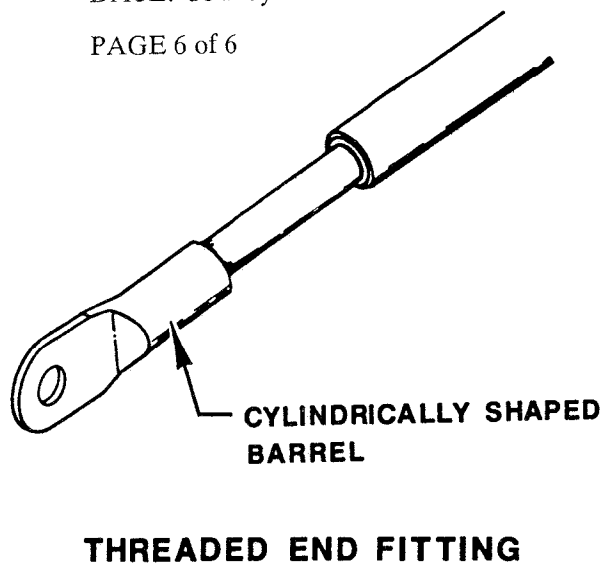
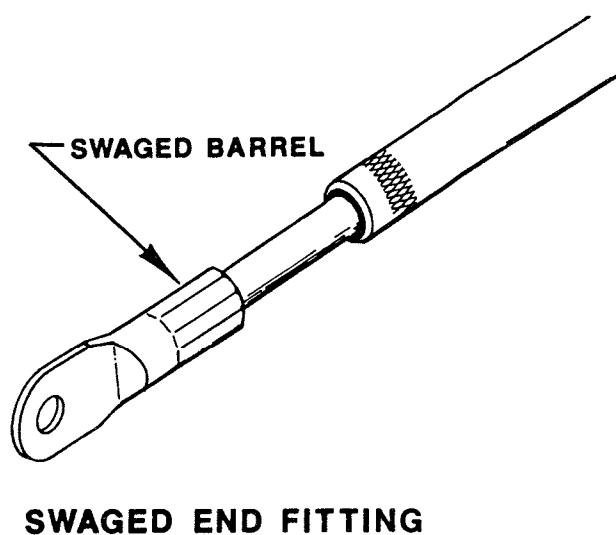
FIGURE 1. IDENTIFICATION OF THROTTLE CABLE ASSEMBLY

As shown in Figure 1, throttle cables which incorporates swaged end fittings may be identified by six evenly spaced flat spots around the barrel of the fitting. Threaded end fittings incorporate a cylindrical barrel (no flat spots).

- b. Visually check both ends of cable to determine whether cable incorporates swaged or threaded end fittings. (Refer to Figure 1.)
- c. If cable incorporates swaged end fittings, compliance with Parts II and III of this notice is not required. For these cable assemblies, record compliance in Helicopter Log Book as "CABLE WITH SWAGED END FITTINGS INSTALLED".
- d. If cable incorporates threaded end fittings, perform repetitive inspections in accordance with Part II of this notice until cable is replaced in accordance with Part III of this notice.
- e. Record compliance with Part I of this Service Information Notice in Compliance Record of Helicopter Log Book.

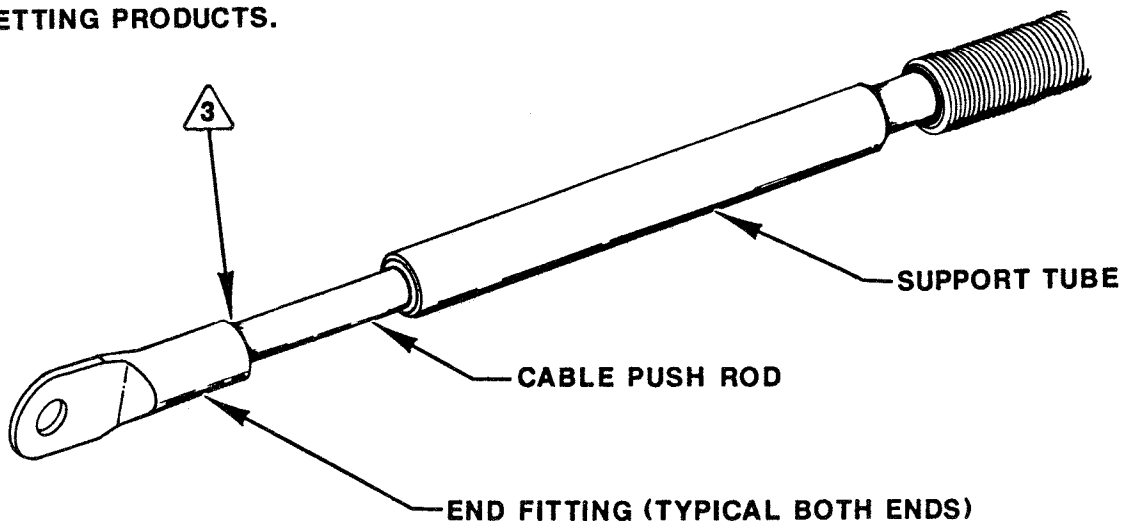
FIGURE 2. INSPECTION OF THROTTLE CABLE ASSEMBLY

PREFACE:Field reports indicate that the end fittings used on the subject throttle cable assemblies may become loose during service (possibly due to excessive vibration when coupled with improper maintenance practices). These fittings were originally secured to the cable with locking compound (loctite) and were not intended to be removed (or loosened) after initial installation. If the fitting becomes loose during service, the relative motion between the end fitting and its associated pushrod could cause the joining threads to wear. If allowed to continue in service, the threads could wear to a point that would allow the end fitting to disconnect from the cable assembly.

- a. Inspect cable end fittings (shown in Figure 2) for general condition and security of attachment. If any damage is noted, replace cable assembly in accordance with Part III of this notice.
- b. Using a flashlight, visually inspect cable push rod for exposed threads or black fretting products adjacent to end fitting (both ends of cable assembly). (Refer to Figure 2).
- c. If threads are visible or there is evidence of fretting, replace cable assembly in accordance with Part III of this notice.
- d. Record compliance with Part II of this Service Information Notice in Compliance Record of Helicopter Log Book.

1. PERFORM INSPECTIONS IN ACCORDANCE WITH PART II OF THIS NOTICE.
2. REPLACE CABLE IN ACCORDANCE WITH PART III OF THIS NOTICE.
3. INSPECT THIS AREA FOR EXPOSED THREADS OR BLACK FRETTING PRODUCTS.

DO NOT BEND THROTTLE CABLE SUPPORT TUBES (SHOWN IN FIGURE 2) MORE THAN 8 DEGREES FROM CENTERLINE OF CABLE. DOING SO COULD CAUSE DEFORMATION OF THE SUPPORT TUBES, PREMATURE FAILURE OF THE CABLE, AND LOSS OF THROTTLE CONTROL.

- b. Install 269A4683-7 or -9 throttle control cable assembly in accordance with Basic HMI, Paragraph 4-11.
- c. Rig throttle control in accordance with Basic HMI, paragraph 4-4 (and Configuration Supplement C, paragraph 4-3, as applicable).
- d. Check idle speed and idle mixture in accordance with Service Information Notice N-202. (Adjust as required.)
