**HUGHES
SERVICE INFORMATION
NOTICE**

NOTICE NO. N-92

SUBJECT: RELOCATION - WARNING INDICATOR LIGHT, SEARCHLIGHT CONTROL HANDLE

MODELS AFFECTED: All Model 269 Series Helicopters Equipped With P/N 269A4333 Manually Operated Searchlight Kit (Extendable Type)

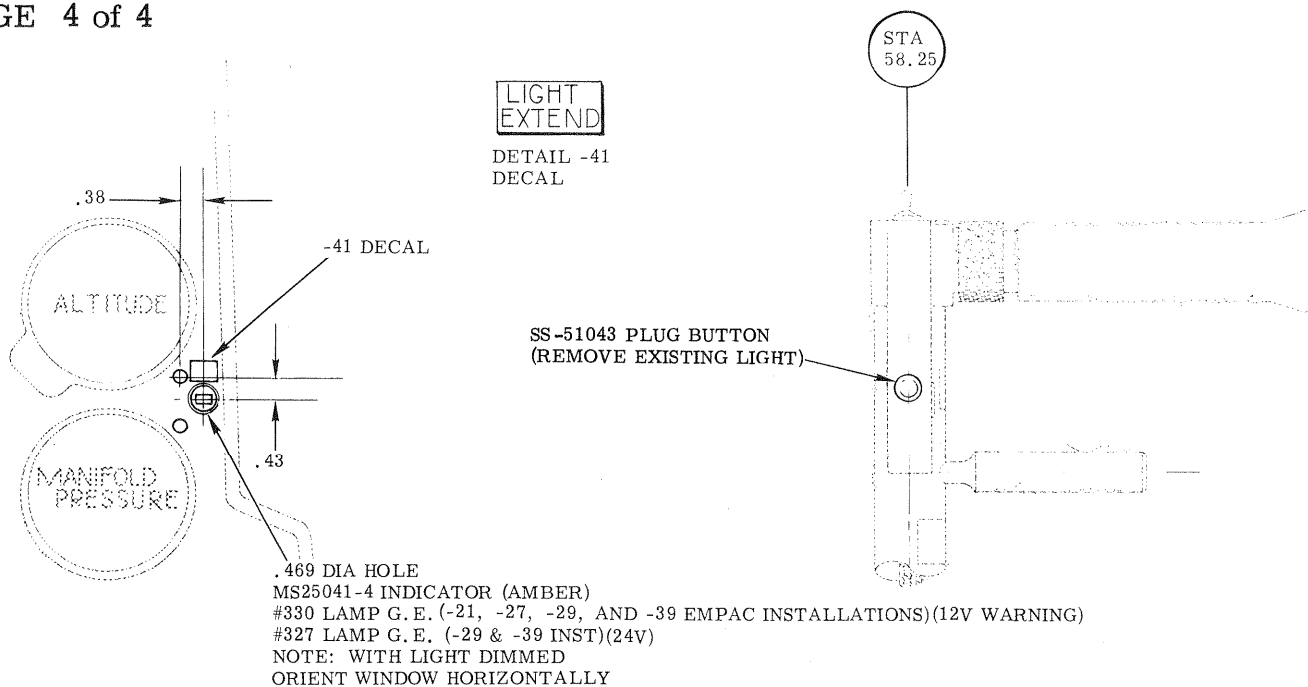
FIGURE 1. RELOCATION - WARNING INDICATOR LIGHT, SEARCHLIGHT CONTROL HANDLE.

PREFACE: The information given in this Service Information Notice lists a procedure for removing the existing warning indicator light on the searchlight control handle, and replacing it with a new type indicator light located on the instrument console. The new warning indicator and console location are designed to reduce reflection and glare.

- a. Check that all electrical power is OFF; disconnect battery.
- b. Remove instrument panel side fairing.
- c. Drill 0.469 in. diameter hole in instrument panel at dimensions shown in Figure 1.
- d. Install MS25041-4 amber indicator light (with applicable 12V or 24V lamp) in instrument panel.
- e. Revise electrical circuitry as follows (See Figure 1, wiring diagram):
 1. Disconnect existing wire no. WHITE 9-20 from magnetic relay switch.

- f. Install instrument panel side fairing; install new 269A4333-41 decal on instrument panel as shown.
- g. Connect battery.
- h. Perform functional flight test of searchlight assembly; check that warning indicator light on instrument console functions properly, when searchlight is in extended position.
