# SCHWEIZER SERVICE BULLETIN

B-292  
24 Oct 2008

**SUBJECT:** MODIFICATION OF CABIN DOOR HINGES

**MODELS AFFECTED:** • 269A, TH-55A, A-1, B & C Model Helicopters, 269C Model Helicopters  
Serial No 001 through 1917

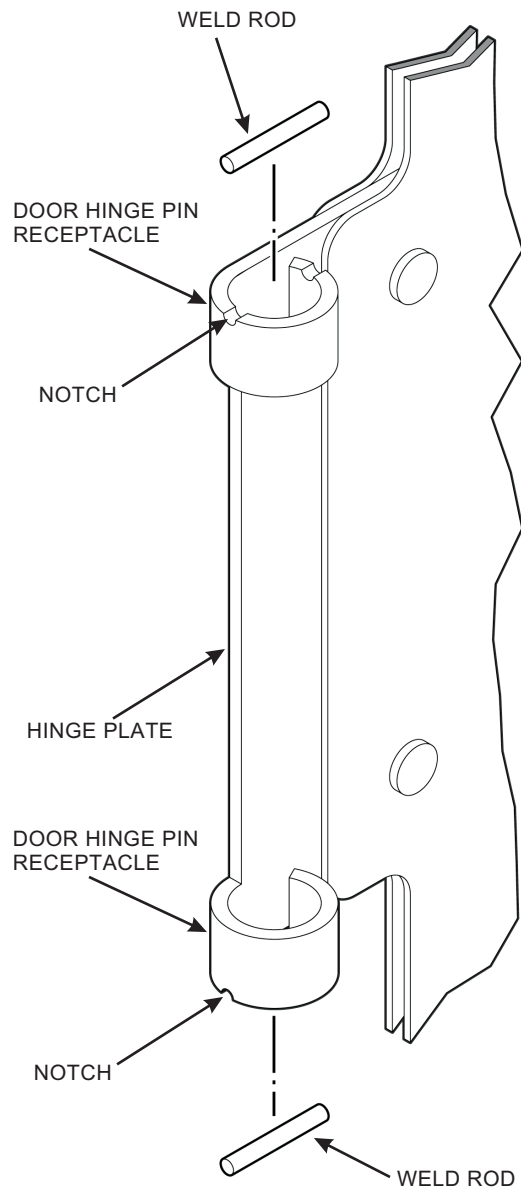
Figure B-292-1. Door Hinge Plate

**PREFACE:** • A report has been received that a cabin door separated from a helicopter in flight as a result of the door hinge pins disengaging from the hinge assembly. The hinge pins became free when a serrated release pin came out of the hinge pin. A modification of the door hinge plate has been developed that will prevent the hinge pins from disengaging if the release pins are lost.

- c. Remove paint from two pin receptacles of both door hinges. File small notches in outside edges of pin receptacle 180° apart and centered on holes as shown in Figure B-292-1. Do not exceed one half diameter of weld rod.
- d. Place weld rod in notches with 0.0625 inch overhang on each side. Using overhang as filter, TIG weld rod to edge of hinge receptacle in accordance with Advisory Circular AC 43.13-1B, Chapter 4, Section 5. File excess material flush with outside diameter of receptacle.
- e. Restore paint finish in accordance with HMI Appendix D.
- f. As required, install doors on helicopter.
