SCHWEIZER SERVICE BULLETIN

B-296
05 Jan 2011

SUBJECT: CLEVIS PIN CHAFFING BOTTOM OF FUEL TANK

MODELS AFFECTED: • All Model 269C Helicopters

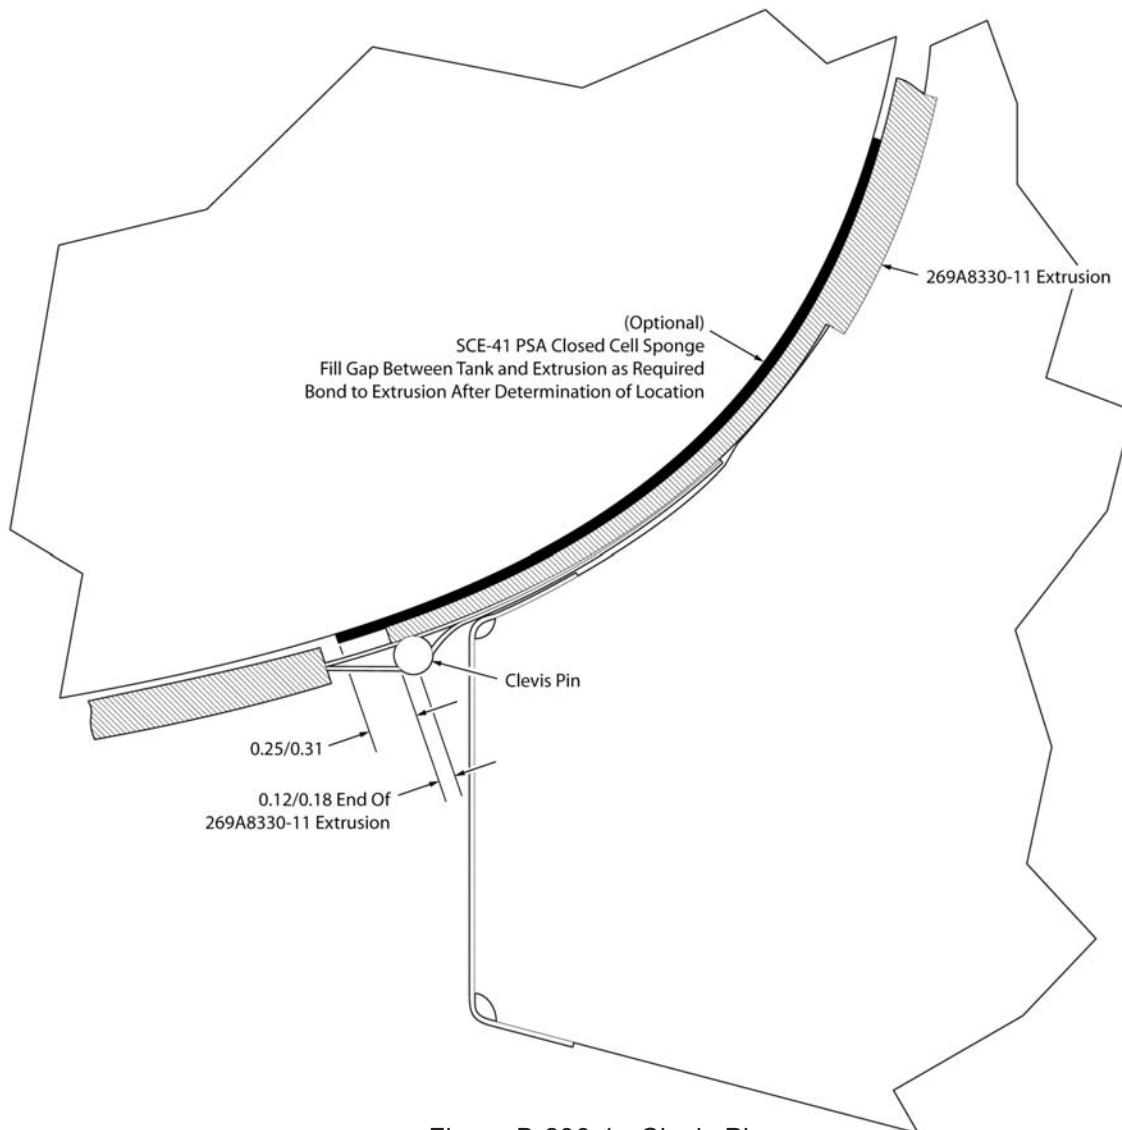
Figure B-296-1. Clevis Pin

PREFACE: • Schweizer Aircraft Corp. has received several reports that the heads of the clevis pins and washers, attaching the lower half of the fuel tank retention strap (band clamp) to the airframe, are chaffing the bottom of the tank. Investigation of the condition revealed that the rubber extrusion was not properly positioned between the fuel tank and strap attachment. The extrusion holds the strap away from the fuel tank and prevents the strap and pin assembly from contacting the tank. This Service Bulletin requires a one time inspection to assure the extrusion is properly positioned and chaffing has not occurred.

- a. Using a bright light and mirror, examine bottom of fuel tank and check that 269A8330-11 rubber extrusion is properly positioned between tank and retention strap clevis pin as shown in Figure B-296-1. Verify there is proper clearance between the clevis pin head, washers and fuel tank. Clearance needs to be verified after the fuel tank is fueled.

If rubber extrusion is installed as shown in Figure B-296-1, proper clearances have been established and there is no evidence of contact or chaffing, no further action is required. Record compliance with this Service Bulletin in the aircraft records.

- c. Remove installed 269A8330-11 extrusion from seat structure vertical beam. Using MEK, remove all residual adhesive.
- d. Trial fit a new length of 269A8330-11 extrusion on the seat beam and trim to .12 to .18 inch past the center line of the clevis pin position as shown in Figure B-296-1. Using waterproof cement, bond extrusion to vertical beam and portion of stainless steel strap attached to vertical beam.

- e. Reinstall fuel tank on helicopter in accordance with Basic HMI, Section 5.
- f. Check for proper clearance of clevis pin head. Verify clearance after fuel tank has been fueled. If there is not adequate clearance, repeat Step b. above and add additional layers of SCE-41 PSA Closed Cell Sponge, as required, as shown in Figure B-296-1.
