SCHWEIZER SERVICE BULLETIN

C1B-014
09 Aug 2002

SUBJECT: ONE-TIME INSPECTION OF 269A2172-5 AFT MAST SUPPORT TUBE FORWARD FITTING

MODELS AFFECTED: All Model 269C-1 Helicopters

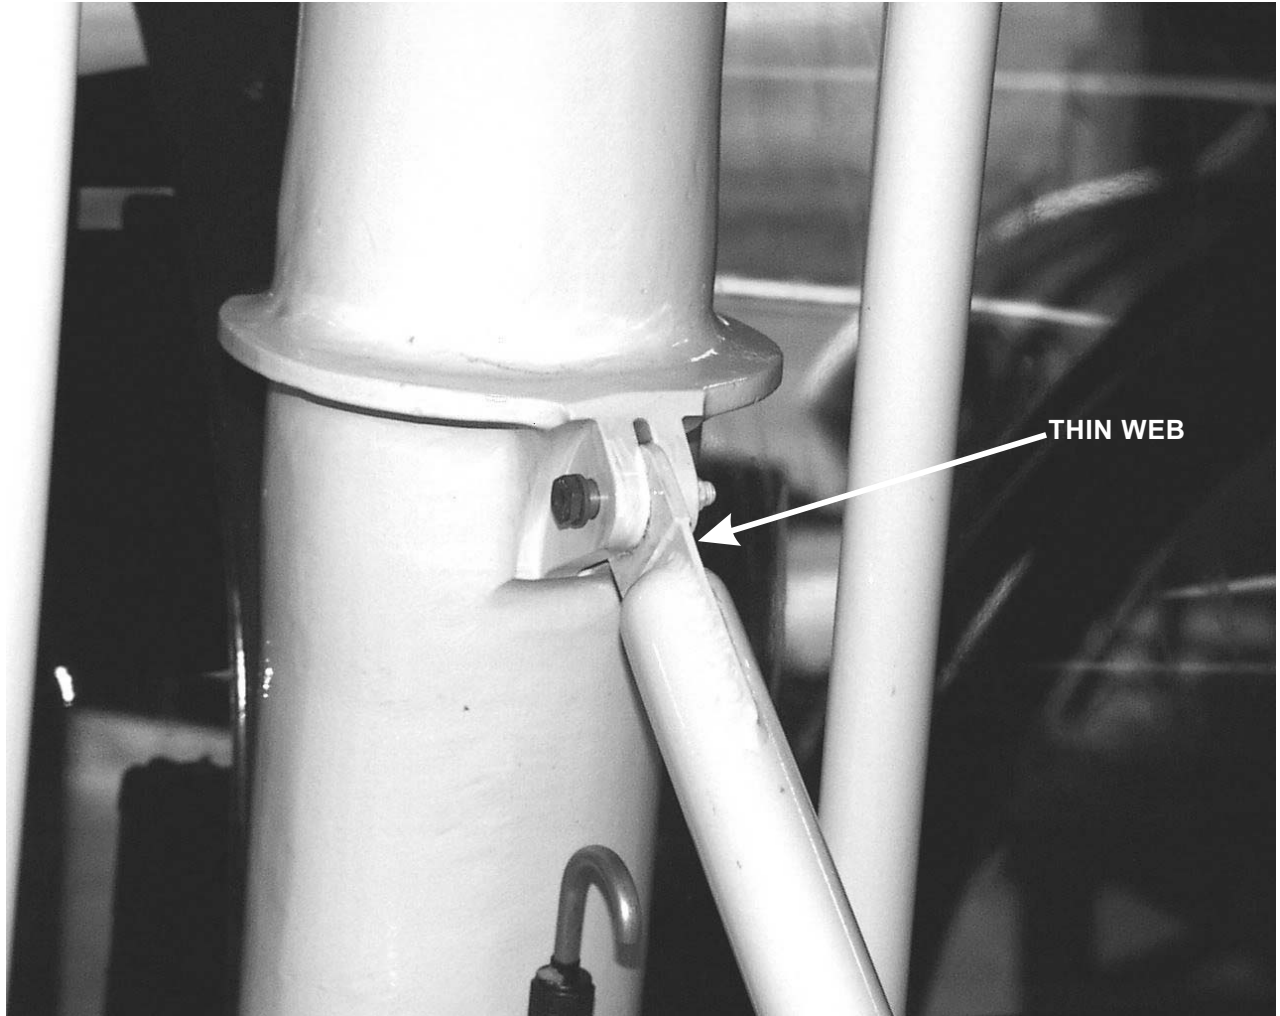
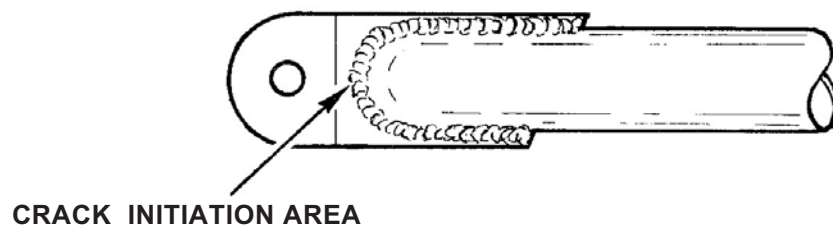
Figure C1B-014, Aft Mast Support Tube Forward Fitting

- PREFACE:
- Field reports indicate cracks can develop in the forward fitting of the subject tube and this can lead to a failure of the tube assembly. (See Figure C1B-014.) After completion of this one-time special inspection, the tube is to be inspected at the normal intervals found in HMI Appendix B.
 - Failure to comply with this Service Bulletin may lead to loss of control of the helicopter and subsequently cause property damage, injury or death.

- a. Using a ten power magnifying glass, thoroughly inspect the entire surface of both sides of the subject forward fitting for corrosion and cracks. Pay particular attention to the weld area where the fitting joins the tube. (See Figure C1B-014 for area to be inspected.) If corrosion is present or cracks are suspected but not confirmed, remove the support tube and magnetic particle inspect. Replace tube if cracks are found. Support tailboom and remove strut in accordance with HMI Sections 11 and 13. No weld repairs to strut are allowed.

- b. If corrosion is found on thin web, and crack is not found in magnetic particle inspection, glass bead clean. If corrosion pits are evident in thin web after glass bead clean, replace tube.
