SCHWEIZER SERVICE BULLETIN

C1B-023
28 Apr 2008

SUBJECT: REPRINT OF PRECISION AIRMOTIVE MANDATORY SERVICE BULLETIN

SUBJECT: HEX PLUG 383493 COMING LOOSE FROM REGULATOR COVER

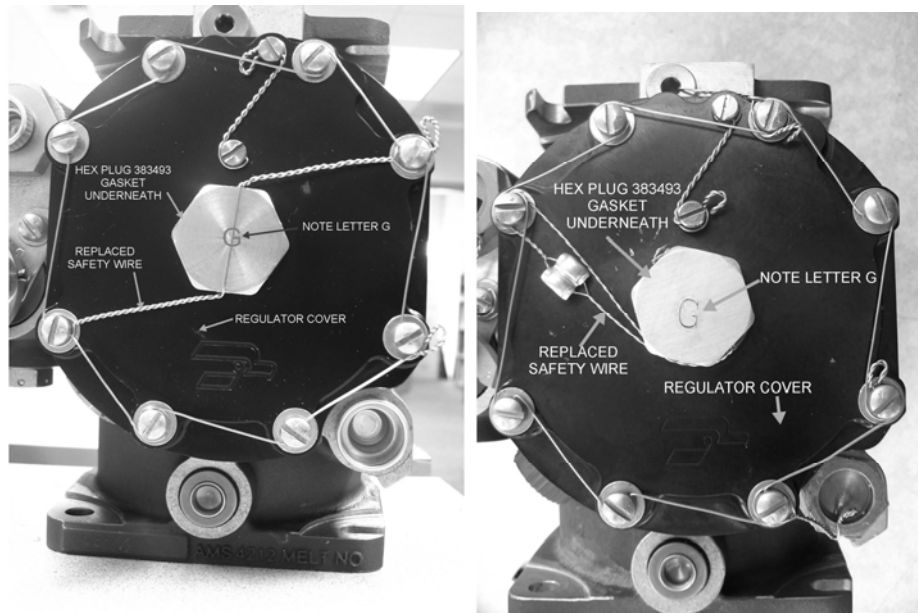
Note: The safety wire through the hex plug shown in the left hand photo is .025" wire wrapped around regulator screws under existing wire. It does not go through the holes in the screws. The safety wire through the hex plug shown in the right hand photo is .015" wire which passes through the regulator screw hole. This is the normal safety wire method used at the factory.

IMPORTANT: The letter "G" shown in the photos is to be stamped **ONLY** if the new gasket, part number 2577258 has been installed.

7. The hex plug must be safety wired with .015 thru .025 inch diameter wire to the regulator cover as shown in the photos on the next page. The wire shall pass thru the plug such that it pulls the plug in the tightened direction and does not rest on the corners of the hex on the plug (it is acceptable to wrap under the corners of the hex plug). These photos are just two examples of acceptable safety methods. Other safety wire methods such as those described in FAA AC 43-13-1B (or latest revision) are also acceptable.

6. Stamp or scribe the letter "G" onto the face of the hex plug as shown in the sample photos. This shall be done with the plug removed from the servo. **DO NOT** stamp the plug with it installed in the servo.
