# SCHWEIZER SERVICE BULLETIN

C1B-030  
24 Aug 2010

**SUBJECT:** CENTER CONTROL COVER CONTACTING LATERAL CYCLIC CONTROL ROD

**MODELS AFFECTED:** • 269C-1 Model Helicopters Serial Numbers 0001 - 0371

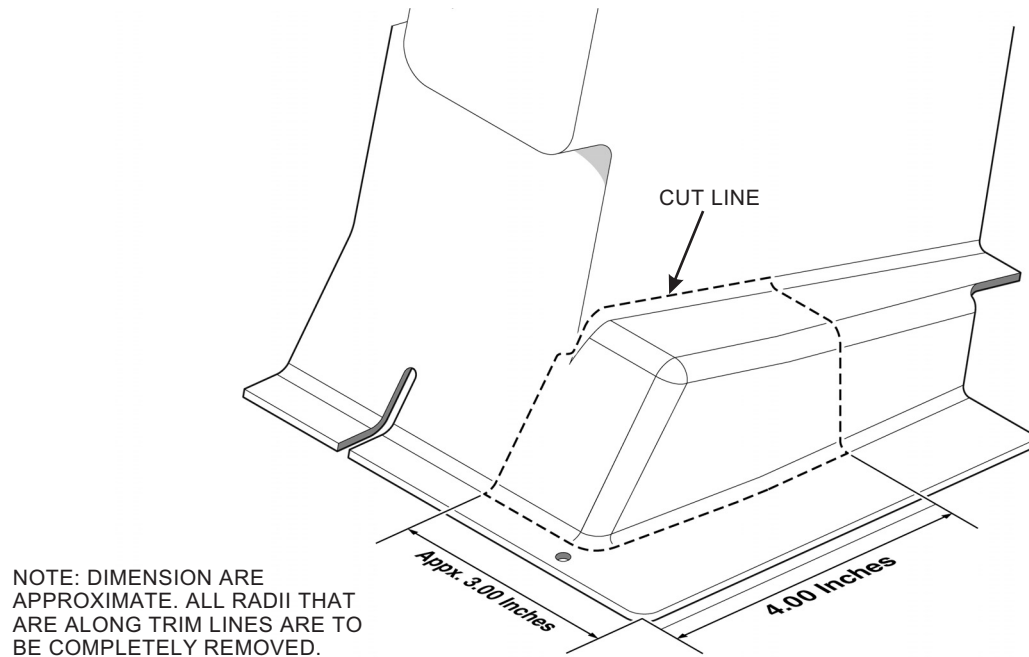
Figure C1B-030-1. Control Cover Modification

- PREFACE:**
- A condition exists where the left side bottom seat cushion contacts the center control cover and may displace the cover sufficiently to cause the cover to contact the lateral cyclic control rod. Over a period of time the cover chafes the control rod causing wear. If left uncorrected, the wear could exceed the wear limits published in the HMI and the control rod must be replaced. A cover modification has been developed that creates a recess in the cover to accommodate the seat cushion.
  - Failure to comply with this Service Bulletin may lead to chafing of the lateral control rod and subsequently require control rod replacement.

- b. Trim along CUT LINE as shown in Figure C1B-030-1 and remove section. Place patch over opening and against cover as shown in Figure C1B-030-2. Check for flat fit on all contact surfaces and trim as necessary for proper fit. While trimming, assure a minimum of .50 inch bend area overlap exists.
- c. Using 180 grit sand paper, rough all contact surfaces of patch and center cover in bond areas.
- d. Thoroughly clean bond area with Naptha or Alcohol and air dry for 15 minutes.
