SCHWEIZER SERVICE INFORMATION NOTICE

NOTICE NO. N-156

DATE 15 February 1979

SUBJECT: FIELD REPAIR OR REMOVAL - TRIM TAB, MAIN ROTOR BLADE,
PN 269A1160 Series, 269A1185 Series, 269A1190 Series,
269B1145 Series

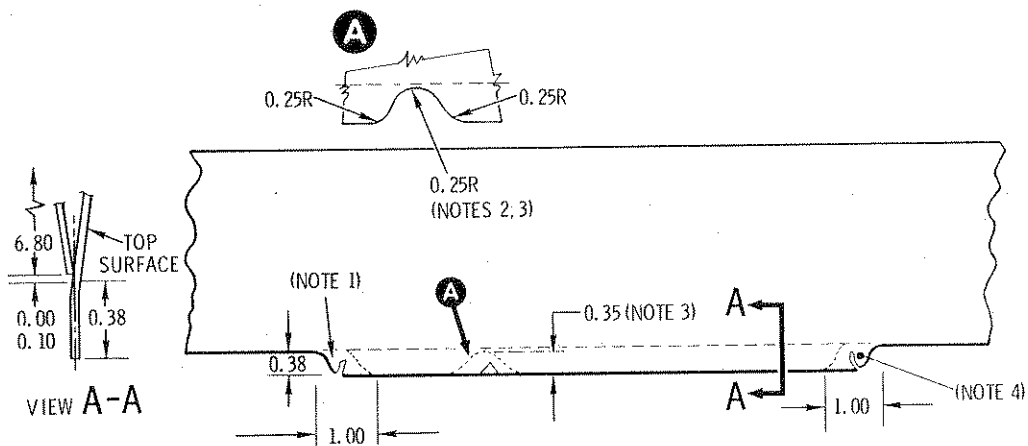
Figure 1. Repair and removal of trim tab, main rotor blade

It is to be noted that instructions in the Basic HMI specify that the blade must be rejected, if specified damage limitations for the tab area are exceeded. In the interest of safety and economy, the procedures given in this Notice provide a broader clean up of the damaged trim tab area, which distributes stresses over a larger area to preclude cracking and permit continued use of the blade.

- e. Remove damaged area of trim tab by making V-type cut with 45° sides joined by a 0.25-inch radius at the bottom of the V, as shown in Figure 1. Blend into trailing edge of the blade with a 0.25-inch radius as shown. Maximum V-cut depth is 0.35-inch; do not cut past trim tab area into main portion of blade.

- f. If damage occurs within 1-inch of either or both ends of trim tab, remove tab end(s) and restore contour as shown.
- g. If excessive damage requires full or partial removal of trim tab from blade, perform the following (no minimum length of trim tab is required):

2. Use metal cutting saw or equivalent to remove the 0.38-inch wide trim tab per dimensions shown in Figure 1, View A-A. Deburr edges in a SPANWISE direction only.

1. REMOVE DAMAGED END(S) IF THEY OCCUR WITHIN 1 INCH OF TAB ENDS.
2. 0.25 RADIUS CLEANUP. FINISH PER BASIC HMI.
3. MAXIMUM DEPTH OF REPAIR 0.35.
4. NO MINIMUM LENGTH OF TAB REQUIRED. IF DAMAGE OCCURS AT BOTH ENDS, IT IS PERMISSIBLE TO REMOVE AT BOTH ENDS.
5. ENTIRE TAB MAY BE REMOVED IF REQUIRED.
