# SCHWEIZER SERVICE NOTICE

NOTICE NO. N-163

DATE 26 November 1979

**SUBJECT:** PN269A6050 SERIES AND PN 369A1800-3 TAIL ROTOR PITCH CONTROL ASSEMBLY - SEATING OF BEARING INNER RACE; TORQUE INCREASE FOR PN 269A6258 LOCKNUT

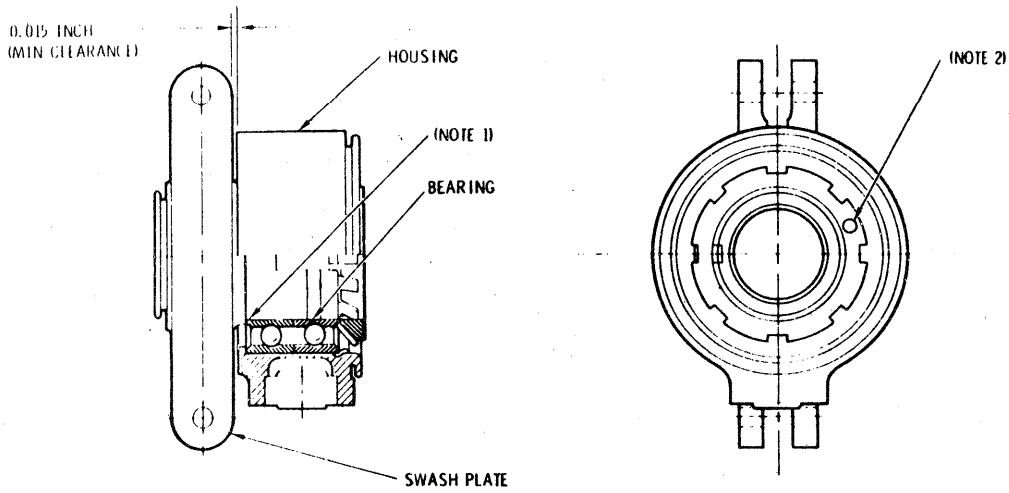
Figure 1. Tail rotor pitch control assembly - seating of bearing and increased torque for locknut

**PREFACE:** The information given in this Service Information Notice lists a procedure for seating the double row ball bearing of the tail rotor pitch control assembly, to ensure that the bearing inner race is firmly in contact with the shoulder of the swashplate. At reassembly of the pitch control assembly, the locknut is torqued to 400 to 450 inch-pounds. Reseating of the bearing inner race and increasing the torque for the locknut is designed to prevent loosening of the locknut and premature wear of the bearing during tail rotor operations.

- NOTES:  
1. INNER RACE FIRMLY SEATED AGAINST SHOULDER OF SWASH PLATE  
2. AFTER TORQUE, COLOR CODE WITH WHITE DOT (0.12 - 0.18 IN. DIA)

d. Place housing and swashplate assembly on arbor press bed with swashplate end down. Apply 2000 pounds of pressure to press inner race of bearing firmly in contact with shoulder of swashplate. Use suitable tube or sleeve to press INNER race of bearing only. Remove assembly from arbor press.

e. Install new 269A6051 or 369A1816 tang washer; reinstall locknut and torque locknut to 400 to 450 inch-pounds. Use wrench adapter and torque wrench, while assembly is held in holding block, to tighten locknut.

f. Check for sufficient clearance (0.015 inch minimum) between swashplate and housing ( see Figure 1).

i. Paint a 0.12 to 0.18 inch white dot on locknut, as shown in Figure 1, to denote reseating of bearing and locknut torqued to 400 to 450 inch-pounds.
