**HUGHES
SERVICE INFORMATION
NOTICE**

NOTICE NO. N-168
DATE 18 July 1980
PAGE 1 OF 4

SUBJECT: REWORK OF PILOT SEAT CUSHION ASSEMBLY, PN 269A4039

MODELS AFFECTED: Model 269C Helicopter Serial No. 0003 through 0959

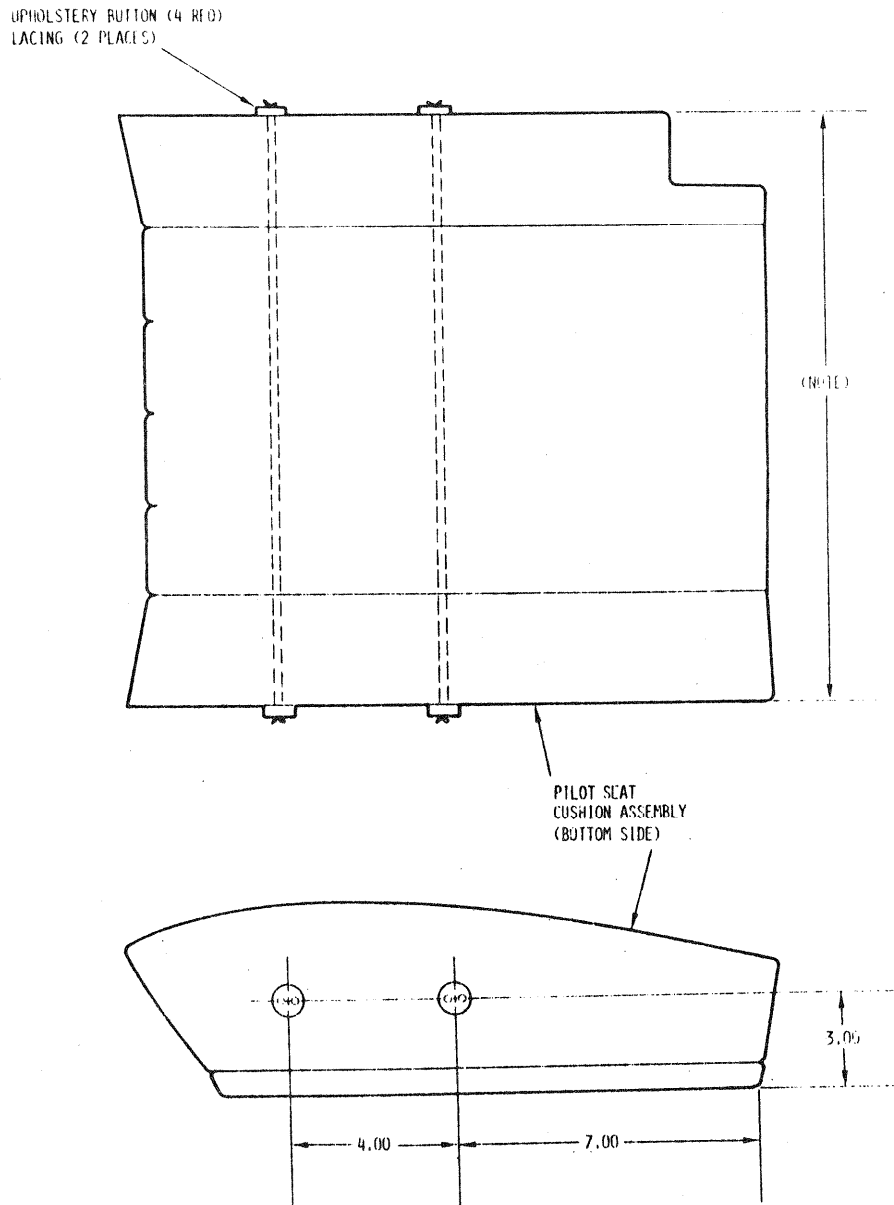
Figure 1. Rework of pilot seat cushion assembly

PREFACE: The information given in this Service Information Notice lists a procedure for field rework of the pilot's seat cushion assembly (bottom side) to preclude rubbing between the cover of the seat assembly and the pilot collective friction lock.

- a. Remove pilot seat cushion assembly.
- b. Install four upholstery buttons on bottom seat cushion at dimensions shown (see Figure 1):
 1. Use lacing tool (see Figure 2) to insert lacing through one button hole, through upholstery seat cushion and cover, and through hole in opposite button. Insert lacing in reverse direction through buttons and seat cushion and cover.
 2. Tighten and tie off lacing so that buttons are flush to 1/4-inch compressed into the cushion.
 3. Repeat steps 1 and 2 above for remaining two upholstery buttons
- c. Reinstall pilot seat cushion assembly.
- d. With pilot seat occupied, check that cushion bottom side cover does not contact the collective friction lever. Tighten lacing to further restrain cushion cover as required.
- e. Record compliance with this Service Information Notice in Compliance Record of helicopter Log Book.

NOTE:
TIGHTEN AND TIE OFF LACING SO THAT
BUTTONS ARE FLUSH TO 0.250 INCH
COMPRESSED INTO CUSHION.
