SCHWEIZER SERVICE NOTICE

NOTICE NO. N-200

DATE: 30 March 1987

SUBJECT: ONE-TIME INSPECTION OF BOLT HOLES AT TAIL ROTOR TRANSMISSION
ATTACHMENT AREA

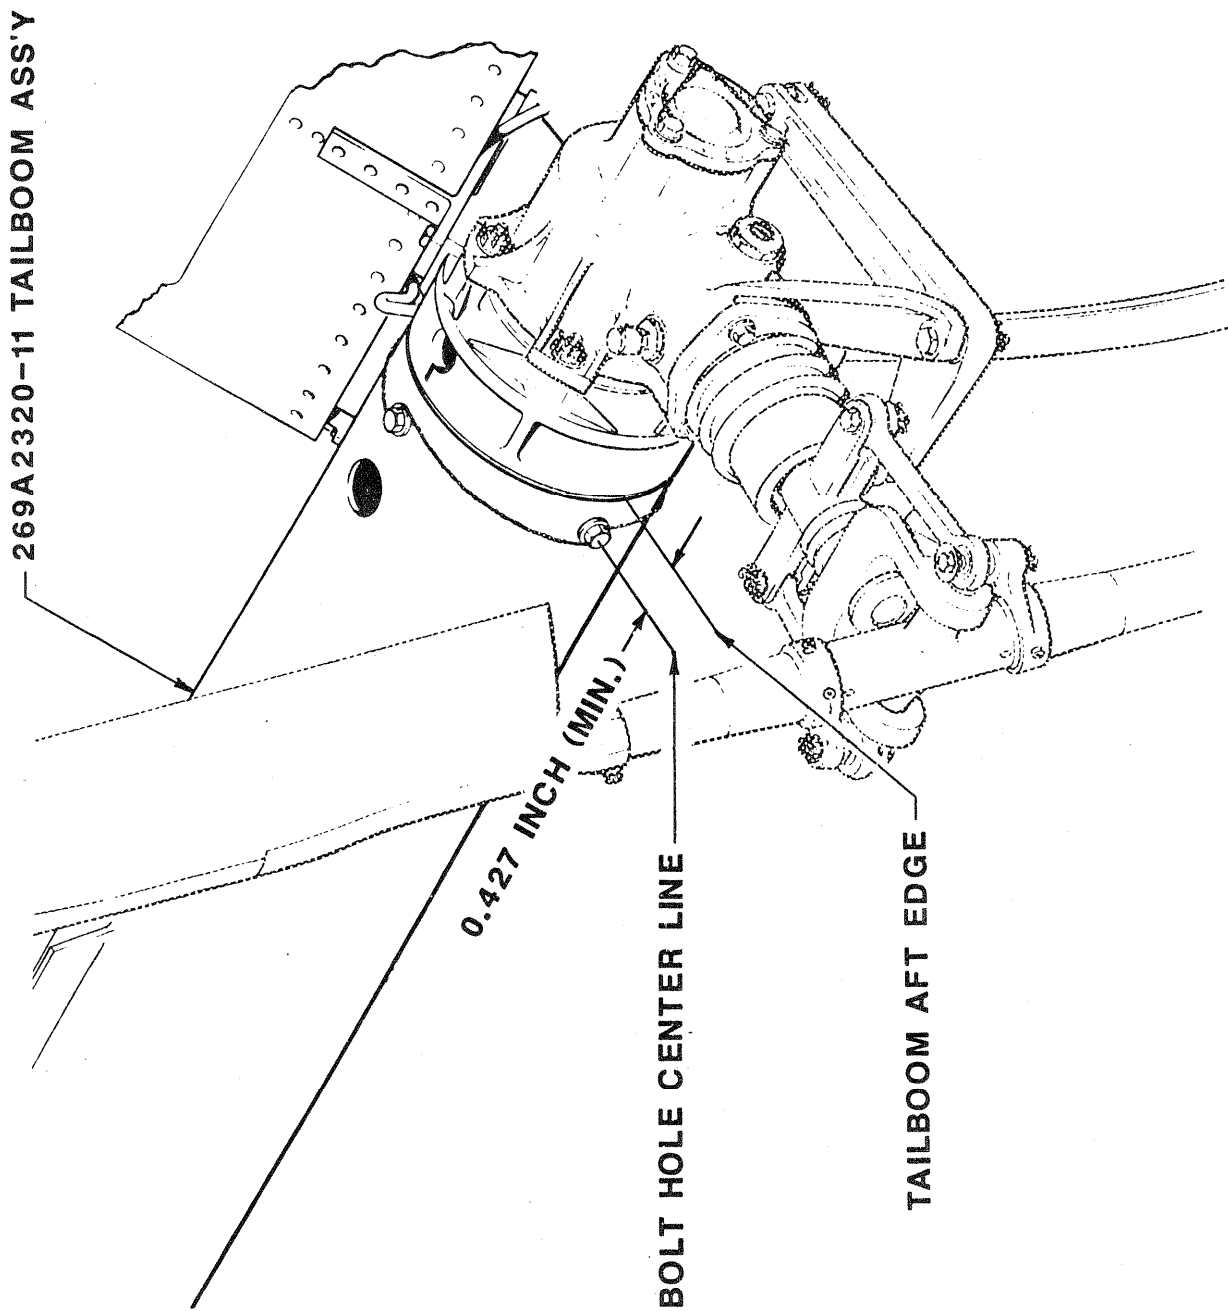
FIGURE 1

PREFACE: A reported incident of tail rotor drive shaft disengagement has re-
vealed the possibility of an error in the location of five tailboom
bolt holes at boom station 283.06. An error in the location of these
holes could result in a misalignment between the tail rotor drive
shaft and the driven spline. This misalignment could cause the drive
shaft to travel rearward during operation and allow the driven spline
to wear against the drive shaft internal bumper. This condition
could eventually cause the driven spline to wear through the internal
bumper, allowing the drive shaft to move further aft and slip off the
driven spline.

- a. Using a vernier caliper (or equivalent), verify that the dimension from
aft end of tailboom to centerline of each .249/.254 bolt hole is 0.437
 ± 0.010 inches. (See Figure 1.)
- b. If any dimension is not within the required limits, proceed as follows:
 - (1) Remove tail rotor drive shaft in accordance with Basic HMI,
paragraph 10-89.
 - (2) Repair tail boom in accordance with Basic HMI, paragraph 11-7,
Step f.
 - (3) Inspect tail rotor drive shaft aft spline for wear or damage.
 - (4) Replace shaft if wear can be felt as a step when a sharp scribe
type instrument is moved across face of spline teeth. (Contact your
SAC Customer Service Center for disposition.)

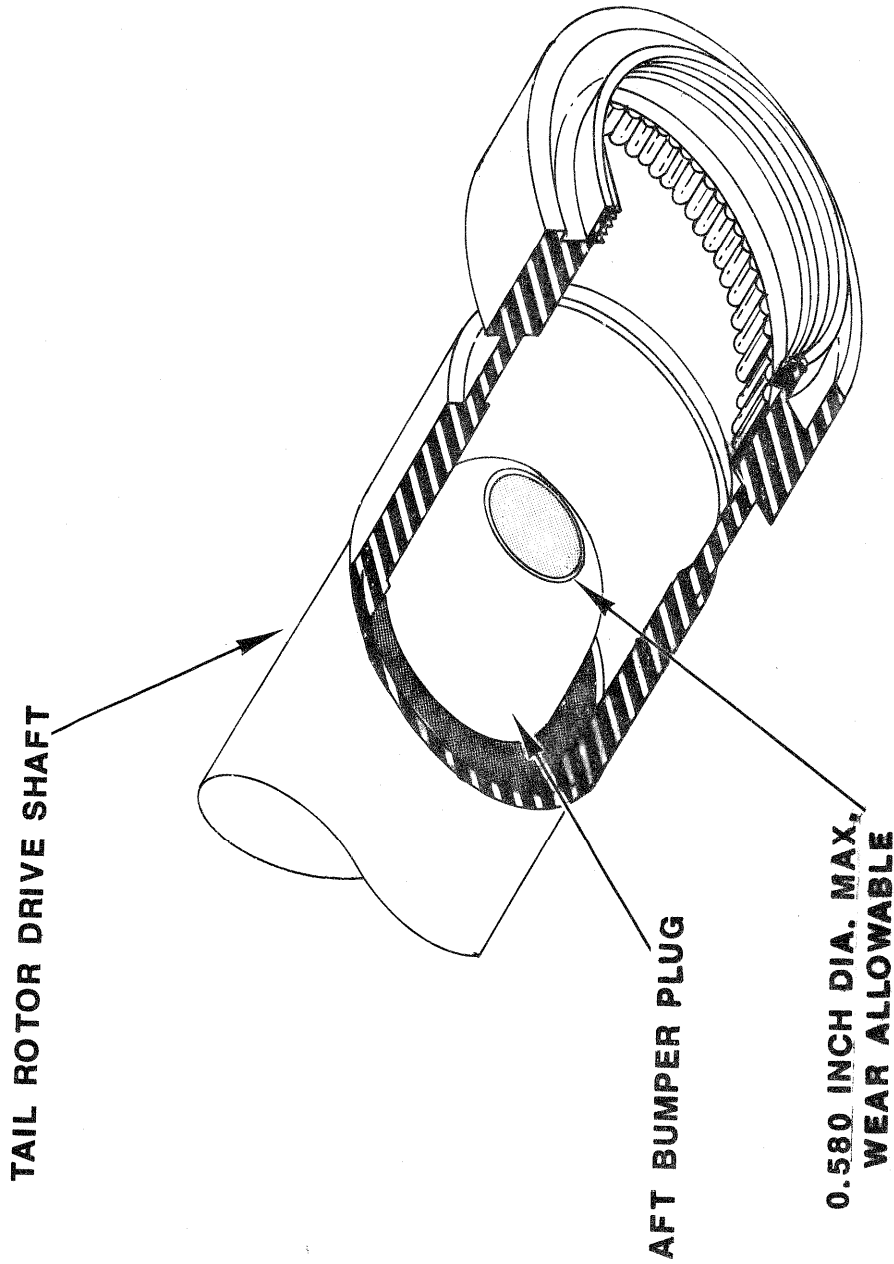
FIGURE 2. TAIL ROTOR DRIVE SHAFT AFT BUMPER PLUG

- (5) Inspect aft bumper plug in tail rotor drive shaft for wear or damage . (Refer to Figure 2.)
- (6) If wear or damaged area exceeds 0.580 inch diameter, replace drive shaft. (Contact your SAC Customer Service Center for disposition.)
- (7) Inspect tail rotor transmission driven spline and coupling nut in accordance with HMI Appendix C, Part III, Table 3-1; repair or replace as required.
- (8) Reinstall tail rotor drive shaft in accordance with Basic HMI, paragraph 10-93.
