SCHWEIZER SERVICE NOTICE

NOTICE NO. N-232
DATE: 06 Oct 1989
PAGE 1 OF 3

INSPECTION OF TAIL ROTOR DRIVE SHAFT DAMPER BLOCK ASSEMBLY
269A2330-3.

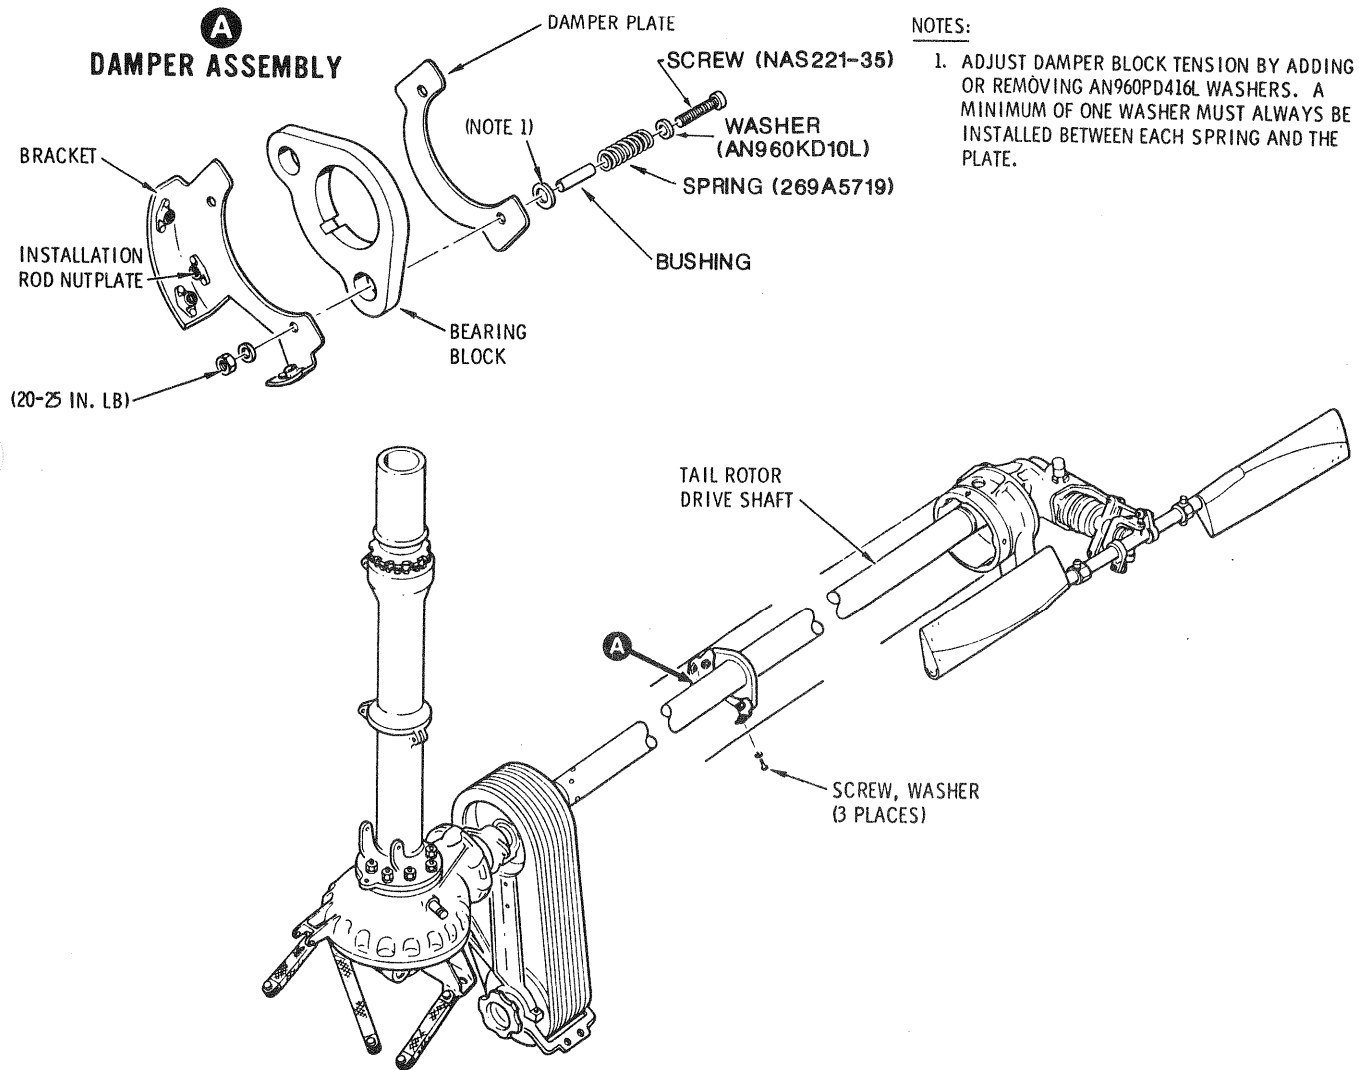
Figure 1. Tail rotor driveshaft and damper assembly

A possibility exists that washers (AN960KD10L) may not have been installed between the head of screws (NAS221-35) and tension springs (269A5719). In this event, the tension spring may slip over the screw head and cause a loss of friction on the damper block. This loss of friction may result in damper assembly damage and possible separation of the drive shaft. Failure to comply with the directives of this notice may lead to loss of aircraft control and subsequent injury or loss of life.

- a. Remove tail rotor drive shaft and damper assembly per Basic HMI, Section 10.
- b. Inspect damper assembly (Detail A, Figure 1) for installation of washers (AN960KD10L) between screw heads and springs. (If washers are installed, proceed to step e. If washers are missing, proceed to step c.)
- c. Disassemble damper assembly, as necessary to install missing washers, per Basic HMI, Section 10.
- d. Install washers, assemble damper assembly, and adjust per Basic HMI, Section 10.
- e. Install tail rotor drive shaft and damper assembly per Basic HMI, Section 10.
- f. Record compliance with this notice in compliance record of Helicopter Log Book.
