**HUGHES
SERVICE INFORMATION
NOTICE**

NOTICE NO. N-36

SUBJECT: INSPECTION-TAIL ROTOR DRIVE SHAFT, EXCESSIVE
END PLAY

MODELS AFFECTED: All 269 Series Helicopters

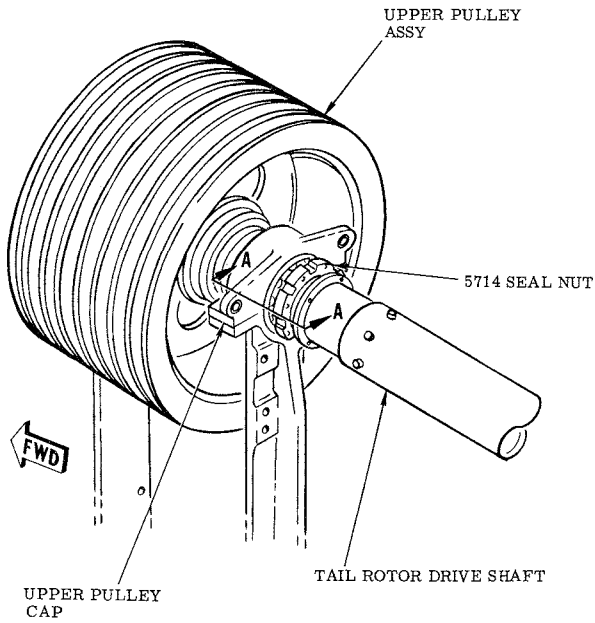
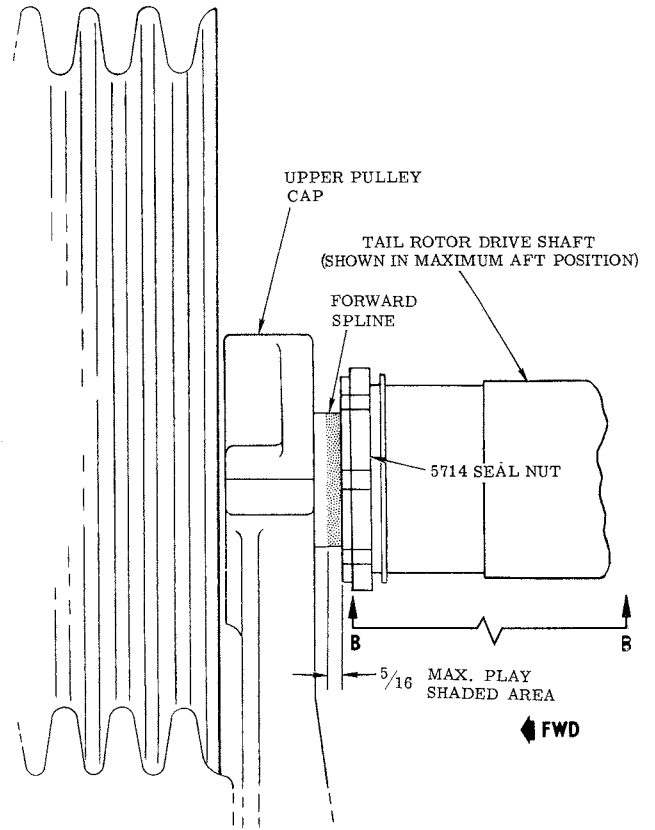
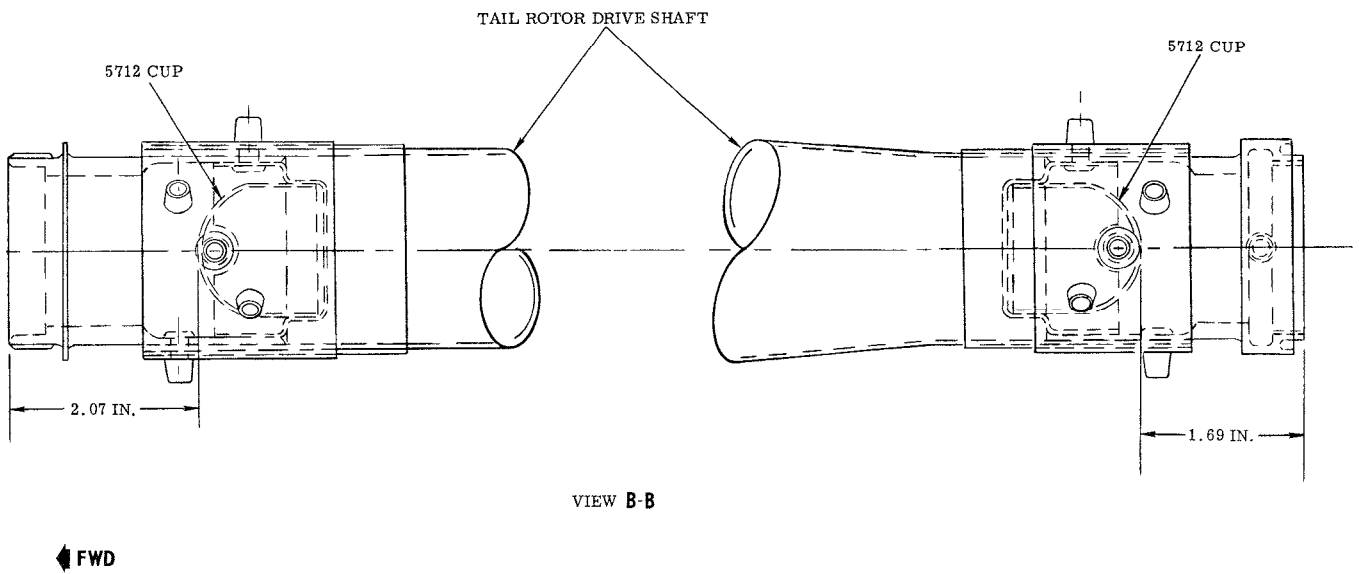
FIGURE 1. INSPECTION-TAIL ROTOR DRIVE SHAFT, EXCESSIVE END PLAY

The information given in this Service Information Notice lists a procedure to inspect for excessive fore and aft movement of tail rotor drive shaft, and assure proper installation of P/N 269A5712 cup at forward and aft ends of drive shaft assembly. Excessive play may result in marginal engagement of driving and driven splines.

- a. Grasp tail rotor drive shaft forward of boom and, using steady pressure, attempt to move shaft back and forth.
- b. Measure amount of end play. (See View A-A, Figure 1)
- c. If end play does not exceed 5/16 inch, no further action is required.

- d. If end play exceeds 5/16 inch, remove tail rotor drive shaft. (See reference)
- e. Measure distance of cups from forward and aft ends of drive shaft to determine if cups are in proper location. (See View B-B, Figure 1)

Cups must be installed and located properly at both ends of drive shaft. If cup is not installed at end of drive shaft or does not meet dimensional tolerance notify Service Department HTC-AD immediately.

- f. Inspect retainer nut and spline on tail rotor transmission input shaft for looseness, wear or damage.
- g. Inspect retainer nut and spline on upper pulley pinion shaft for looseness, wear or damage.
- h. Replace worn or damaged parts.
- i. Install tail rotor drive shaft, tail rotor transmission and tail rotor assembly.
- j. Inspect installation for discrepancies.
