HUGHES SERVICE INFORMATION NOTICE

NOTICE NO. N-37.2*

SUBJECT: RETIREMENT - BELLCRANK ASSEMBLY, LATERAL
PITCH MIXER IDLER (P/N269A7506)

MODELS AFFECTED: { 269A Helicopter Serial Nos. 0011 through 1033
269A-1 Helicopter Serial Nos. 0001 through 0041
269B Helicopter Serial Nos. 0001 through 0398

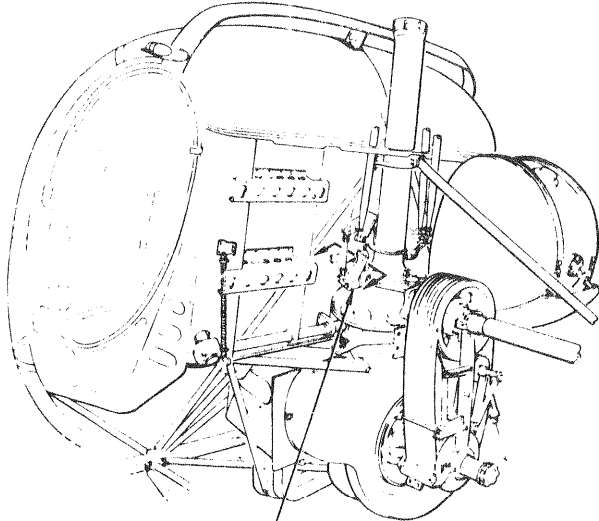
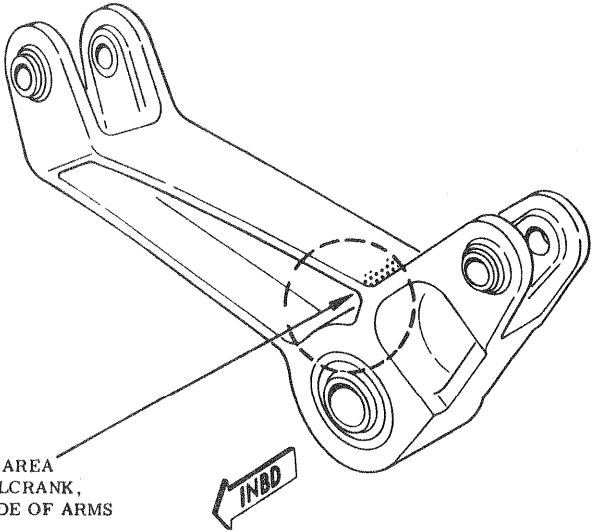
FIGURE 1. INSPECTION - 269A7506 LATERAL PITCH MIXER IDLER BELLCRANK ASSEMBLY

If inspection reveals damage, deformation or cracks, replace bellcrank assembly with new P/N269A7508 bellcrank assembly per Step I. Pay particular attention to junction of bellcrank arms, on inboard side of arms (See Figure 1).

APEX AREA
OF BELLCRANK,
INBOARD SIDE OF ARMS

1. Remove P/N269A7506 lateral control bellcrank assembly, per HMI, at scheduled 50-hour inspection period(s).
2. Visually and dye penetrant inspect bellcrank assembly; record compliance with inspection in helicopter Log Book.

Use good light source and 6X minimum power magnifying glass for visual inspection. Removal of paint from bellcrank not necessary for dye penetrant inspection.
