**HUGHES
SERVICE INFORMATION
NOTICE**

NOTICE NO. N-53
DATE June 24, 1968
PAGE 1 OF 3

SUBJECT: INSPECTION - TAIL BOOM CENTER ATTACHMENT
FITTING (P/N 269A2324)

MODELS AFFECTED: All 269 Series Helicopters

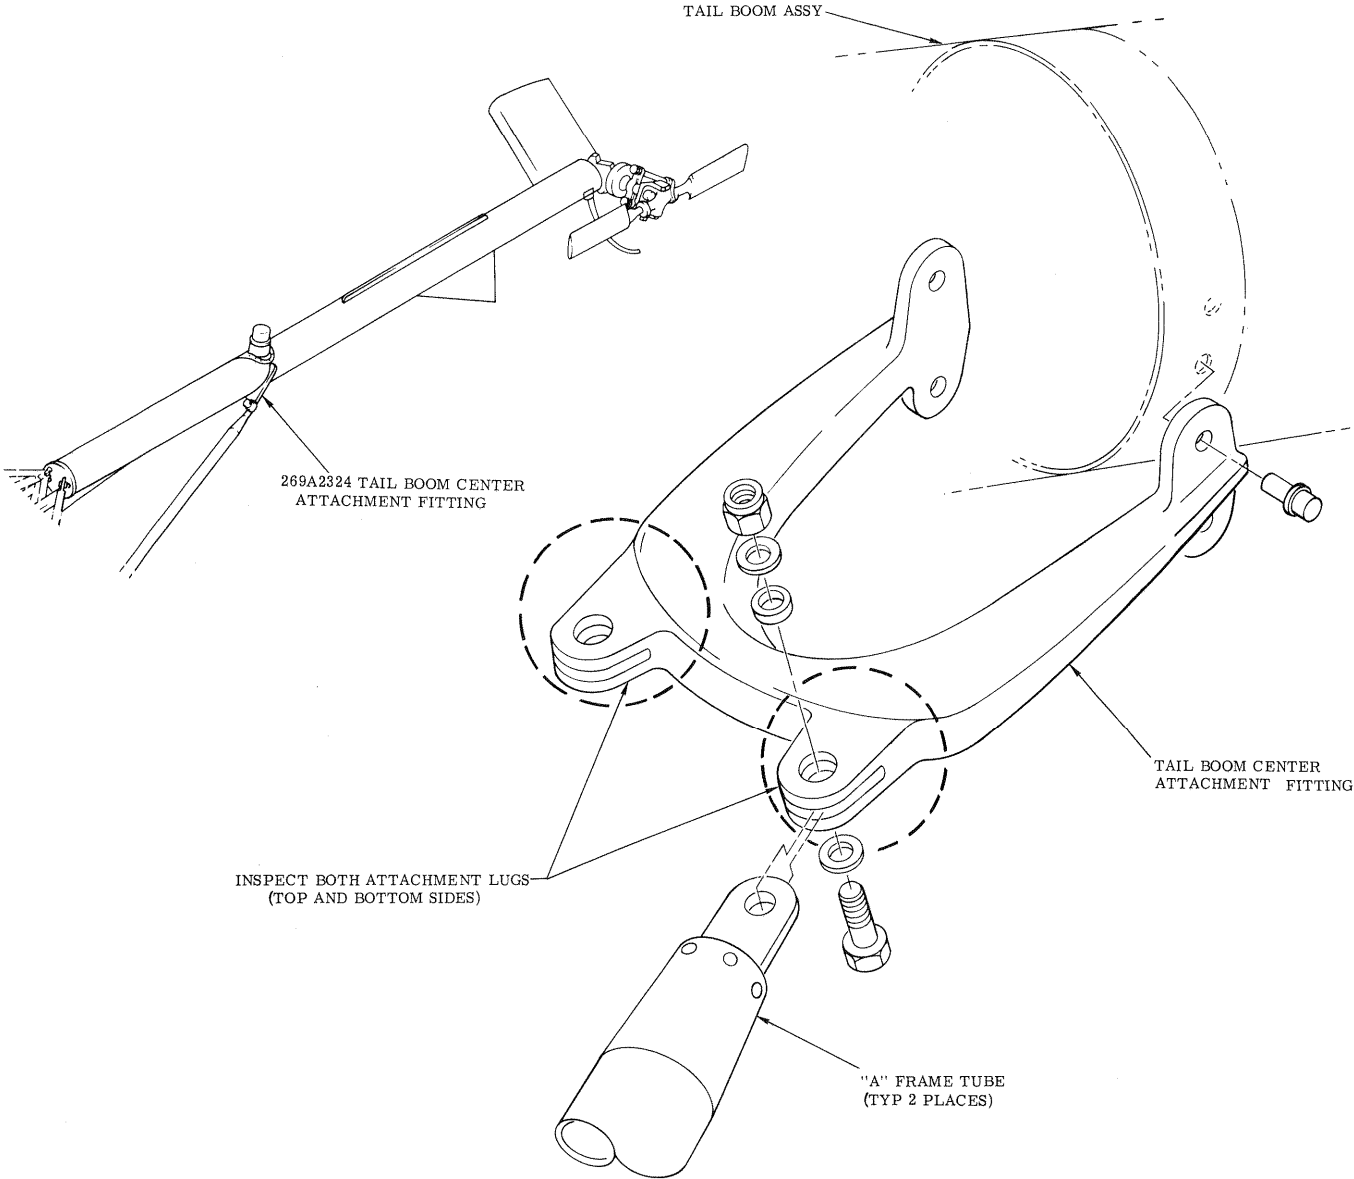
FIGURE 1. INSPECTION - TAIL BOOM CENTER ATTACHMENT FITTING

a. Visually inspect center attachment fitting for evidence of cracks, damage or deformation; pay particular attention to attachment lugs securing fitting to "A" frame tubes. (See Figure 1)

a. Dye penetrant inspect center attachment fitting for evidence of cracks; pay particular attention to attachment lugs securing fitting to "A" frame tubes. (Refer to Figure 1)

Existence of cracks shall be confirmed by performing STEP II - DYE PENETRANT INSPECTION, or equivalent method. If cracking, deformation or other damage is noted, remove and replace center attachment fitting, per Section IX of the HMI.

If cracking is noted, remove and replace center attachment fitting, per Section IX of the HMI.
