Sikorsky Aircraft Corporation

# 269C-1™ HELICOPTER

ASB C1B-046

**SUBJECT:** MAIN ROTOR AND CONTROL SYSTEM AND TAIL ROTOR AND CONTROL SYSTEM –  
Main Rotor and Tail Rotor Control Rods – One-time Inspection of Flight Control Pushrods  
with Adjustable Rod Ends

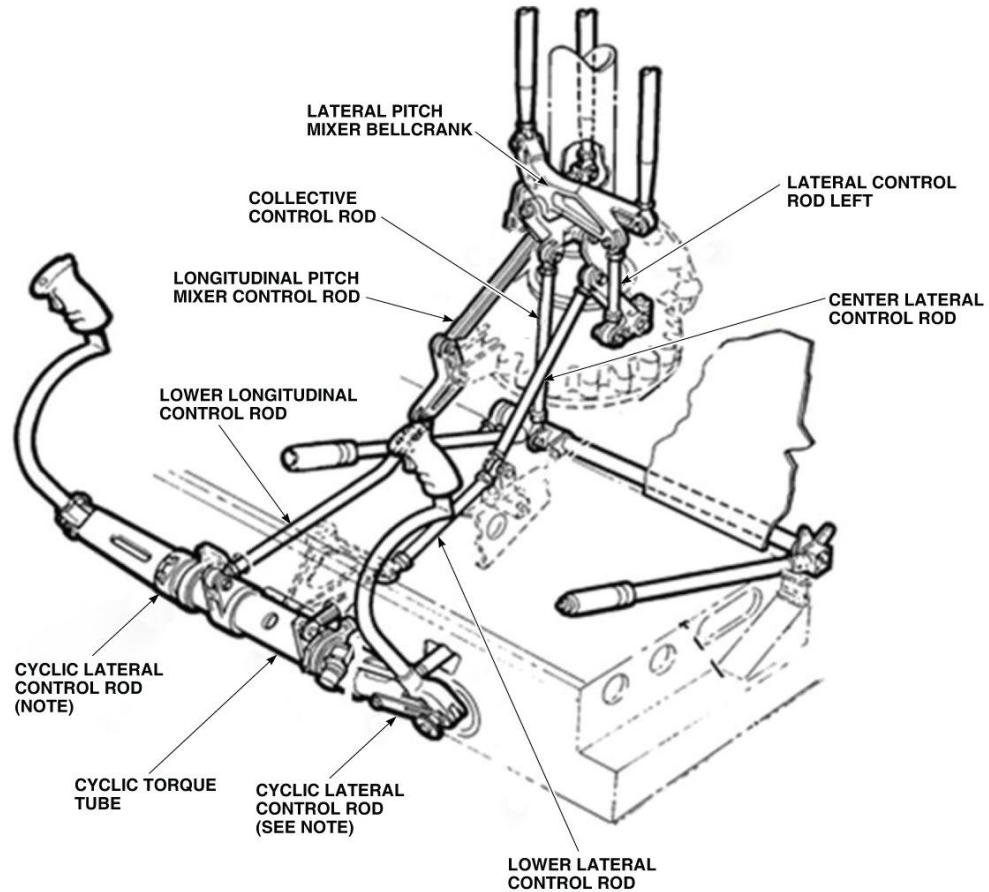
CYCLIC AND COLLECTIVE CONTROL PUSHRODS  
(LEFT SIDE PILOT IN COMMAND SHOWN)  
FIGURE 1

PILOTS AND CO-PILOTS CYCLIC LATERAL CONTROL RODS ARE INSIDE CYCLIC TORQUE TUBE (NOT VISIBLE IN THIS VIEW).
