SCHWEIZER SERVICE BULLETIN

B-234
16 Dec 1991

SUBJECT: INSPECTION AND MODIFICATION OF LONGITUDINAL TRIM MOUNTING PLATE AND TRIM ARM STOP

MODEL AFFECTED: ● All Model 269B Helicopters
● Model 269C Helicopters with Serial Numbers 0001 thru 1415, 1417 thru 1439, 1441 and 1443

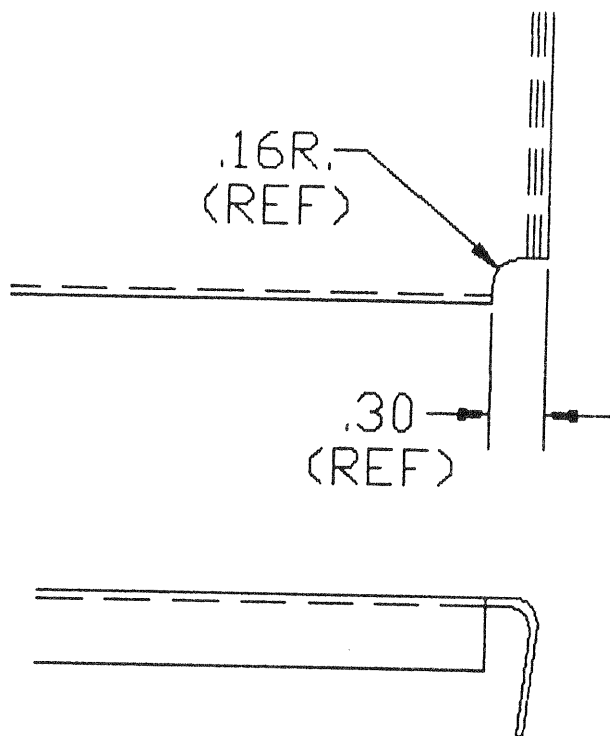
DETAIL A-1

PREFACE: Field reports indicate the possibility of the longitudinal trim spring cover lodging between the cyclic longitudinal trim mounting plate and the cyclic stick.

BEFORE MODIFYING

- a. Remove pilot seat assembly to gain access to longitudinal trim assembly.
- b. Carefully remove carpeting (as required).
- c. Remove longitudinal trim assembly in accordance with BHMI, Section 8 (BHMI8).
- d. Disassemble longitudinal trim assembly as required (BHMI8).
- e. Locate section of longitudinal trim mounting plate to be modified (Figure B-234-1, Detail A-1).
- f. Using extreme care, remove excess material from longitudinal trim mounting plate, with grinder and/or file (Figure B-234-1, Detail A-2).
- g. Remove all burrs and sharp edges, and apply zinc chromate primer to reworked area.

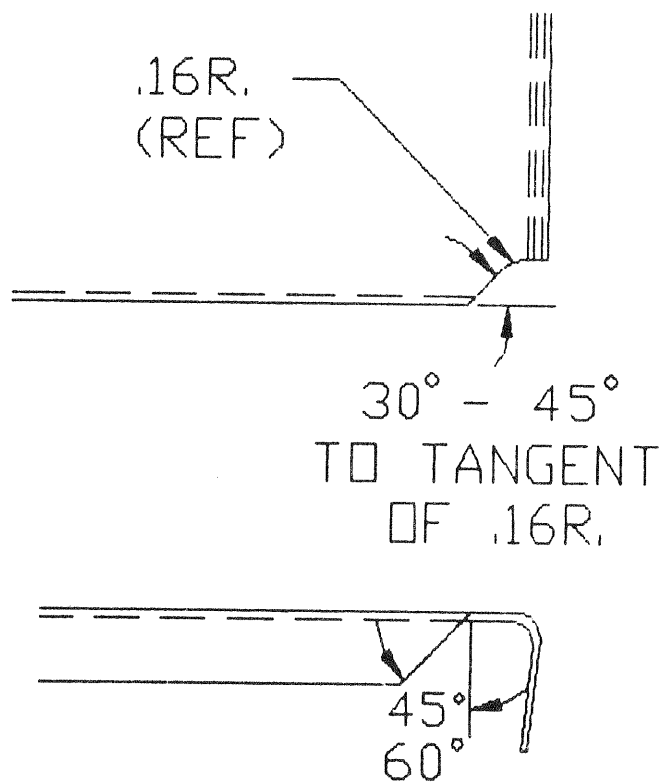
DETAIL A-2

AFTER MODIFYING

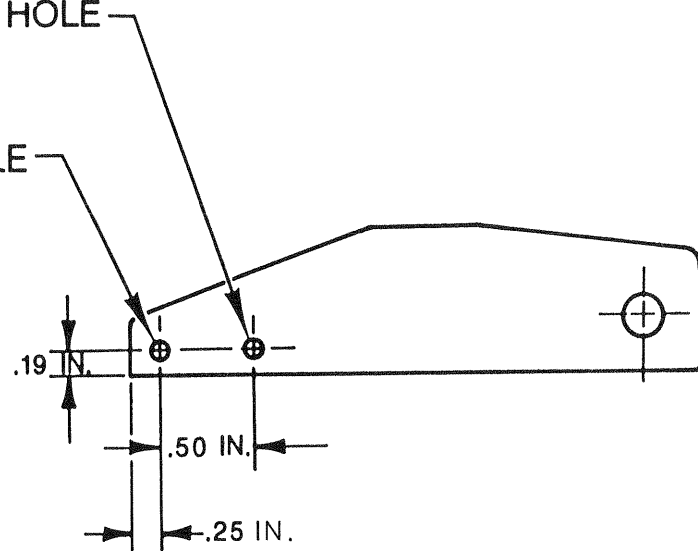
Figure B-234-2. Arm stop

1. Outboard attachment hole, (using the aircraft centerline as the point of reference) shall be used for 269C helicopter.
2. Either attachment hole may be used for the 269B helicopter.

- (3) Disassemble longitudinal trim assembly as required (BHMI8).
 - (4) Mark arm stop from center of existing attachment hole in accordance with Figure B-234-2 and drill .13 inch diameter hole.
