SCHWEIZER SERVICE BULLETIN

B-236
4 Sep 1991

SUBJECT: INSPECTION OF LOW TIP SPEED TAIL ROTOR SWASHPLATE BELLCRANK ASSEMBLY HOLE

MODELS AFFECTED: Model 269C Helicopters with Serial Numbers 1291 through 1432, inclusive, EXCEPT 1413 AND 1416

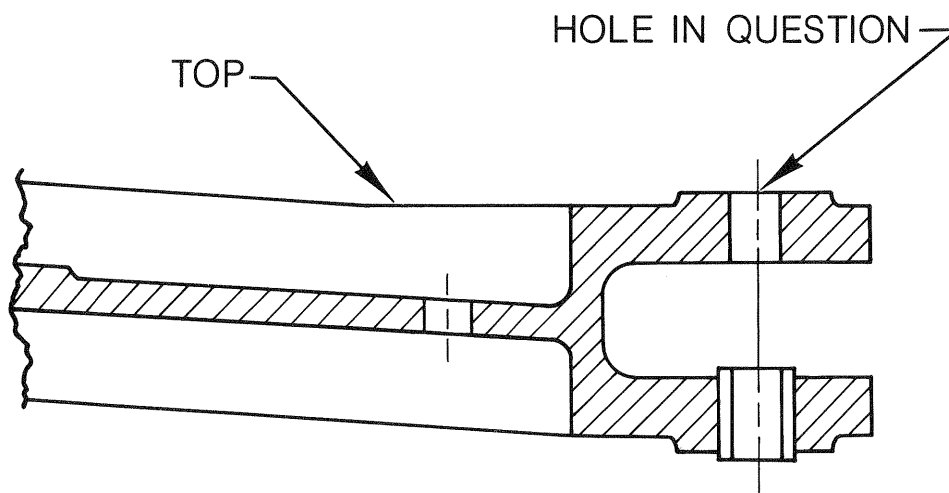
Figure B-236-1. 269A6042 Bellcrank Assembly Segment

PREFACE: 269A6042 bellcrank assemblies have been manufactured with either a 3/16 (.19) inch or a 1/4 (.25) inch hole through the upper surface on the end which attaches to the tail rotor control rod assembly. Those assemblies manufactured with the 1/4 (.25) inch hole should have an installed bushing which reduces the hole size to 3/16 (.19) inch.

- A possibility exists that some helicopters were manufactured WITHOUT the installed bushing.
- A one-time inspection is required to determine if this hole is:
 - 3/16 (.19) inch (**CORRECT**)
 - 1/4 (.25) inch with installed bushing, 3/16 (.19) inch I.D. (**CORRECT**)
 - or 1/4 (.25) inch WITHOUT installed bushing (**INCORRECT**).
- Failure to comply with the requirements of this Service Bulletin at the time interval specified under TIME OF COMPLIANCE could result in excessive wear of the bellcrank and excessive play in the flight control system.

- a. Remove bolt attaching bellcrank assembly to tail rotor control rod (BHMI, Section 9). Determine assembly upper hole size (Figure B-236-1).
- b. If hole is 3/16 (.19) inch or 1/4 (.25) inch with installed bushing (I.D. 3/16 (.19) inch), reinstall bolt (BHMI, Section 9), ensuring slotted bushing is in place in LOWER hole. Proceed to step d. below.

- c. If hole is 1/4 (.25) inch WITHOUT installed bushing:
- (1) Do NOT rework bellcrank assembly. Return assembly to SAC.
 - (2) Replace bellcrank assembly with serviceable spare and reassemble after inspecting condition of tail rotor control rod (BHMI, Section 9).
 - (3) Contact SAC Product Support Department.
- d. Record compliance with this Service Bulletin in the aircraft records.
