SCHWEIZER SERVICE BULLETIN

SUBJECT: TRIPLE-LATCH DOOR - LOWER LATCH BOLT AND COLLECTIVE FRICTION GUIDE ASSEMBLY INTERFERENCE

MODELS AFFECTED: All Model 269C Helicopters equipped with SA-269K-060 triple-latch door kit purchased prior to the issue date of this Service Bulletin or factory installed triple-latch doors prior to serial number 1583.

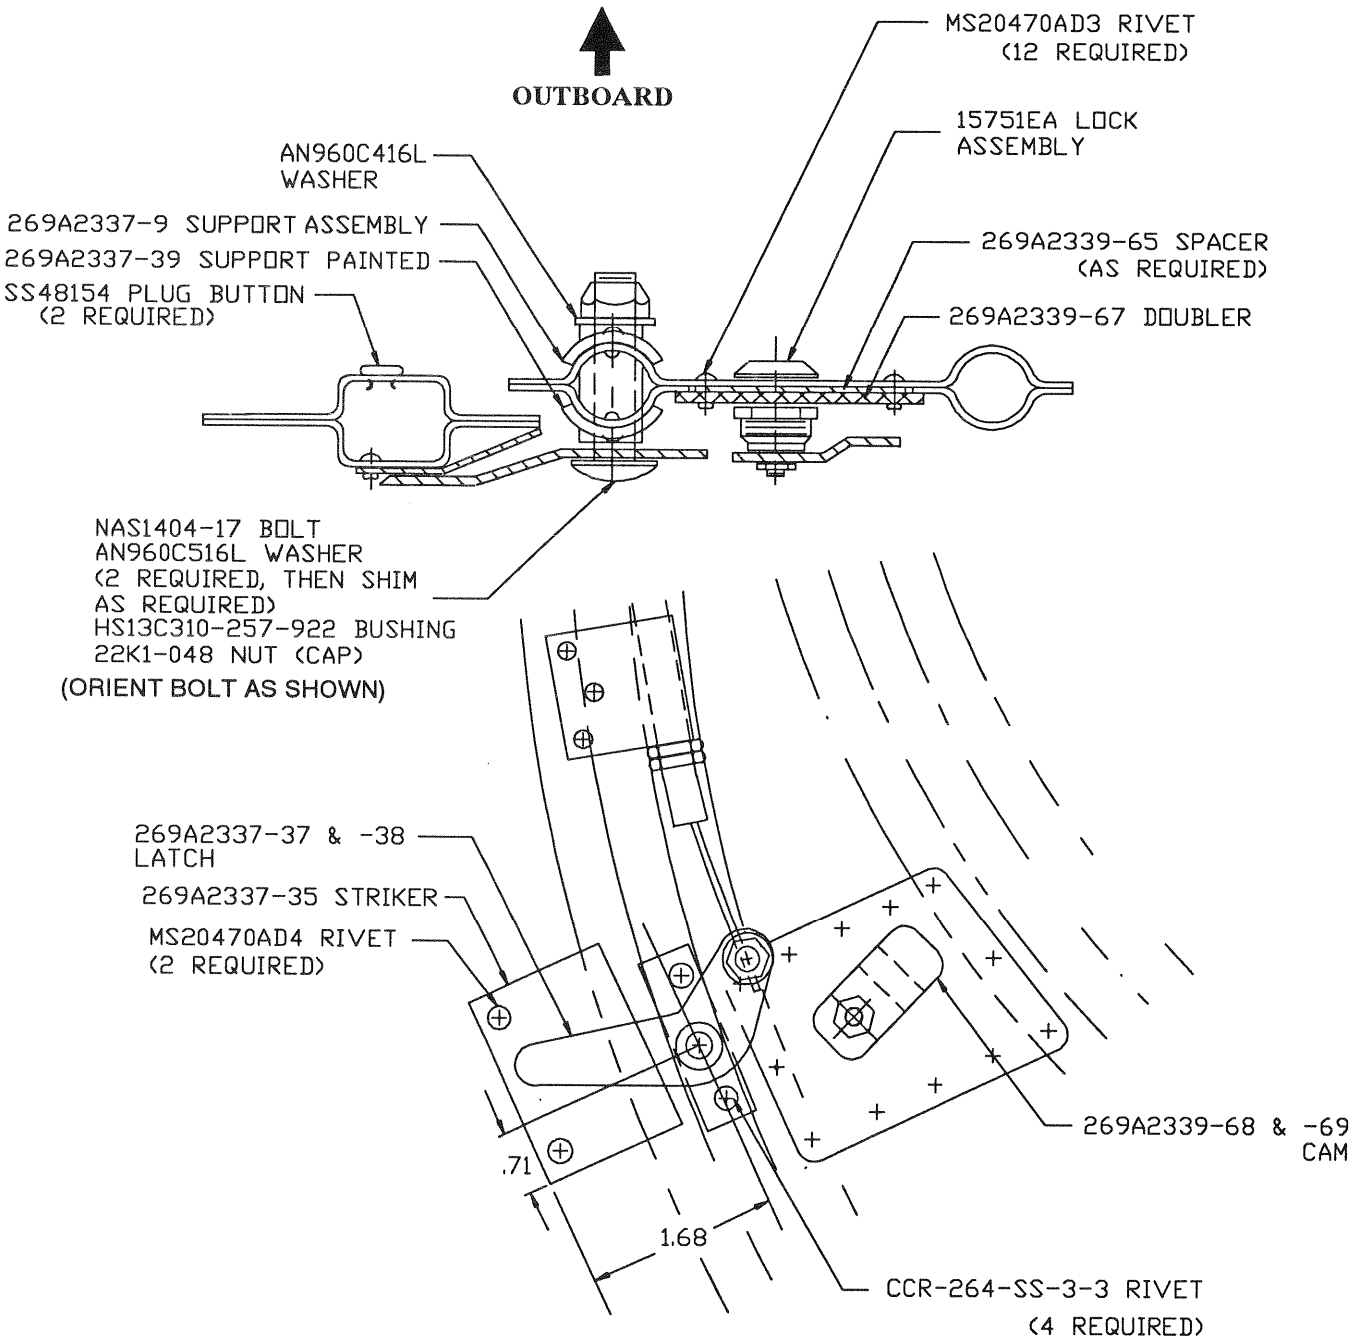
Figure B-250-1. Lower left latch bolt installation

PREFACE: Reports indicate that when the left side triple-latch door is installed the lower latch nut could interfere with the collective friction guide assembly, and restrict the movement of the collective stick.

Refer to Figure B-250-1 for steps a. through c.

- a. Remove the 22K1-048 cap nut and washer from left side door's lower latch assembly.
- b. While maintaining proper shim stack-up remove NAS1404-17 bolt and reverse its direction by installing bolt from the inside.
- c. Install washer and tighten cap nut (now located on outside of door assembly).
- d. Close and latch door. Move the collective stick through full range (up and down) to verify adequate clearance exists between collective friction guide assembly and lower latch nut/bolt.
- e. Record compliance with this Service Bulletin in the aircraft records.
