SCHWEIZER SERVICE BULLETIN

*B-251
20 Mar 1992

SUBJECT: INSPECTION OF CLUTCH CABLE ASSEMBLY AND TERMINAL END (P/N AN669L3RH OR MS21260L3RH)

MODELS AFFECTED: All 269A, 269A-1, 269B, TH-55A Helicopters and 269C Helicopters S/N 0001 through S/N 1349, as well as all clutch cable assemblies in spares stock purchased before 1 Jan 1990

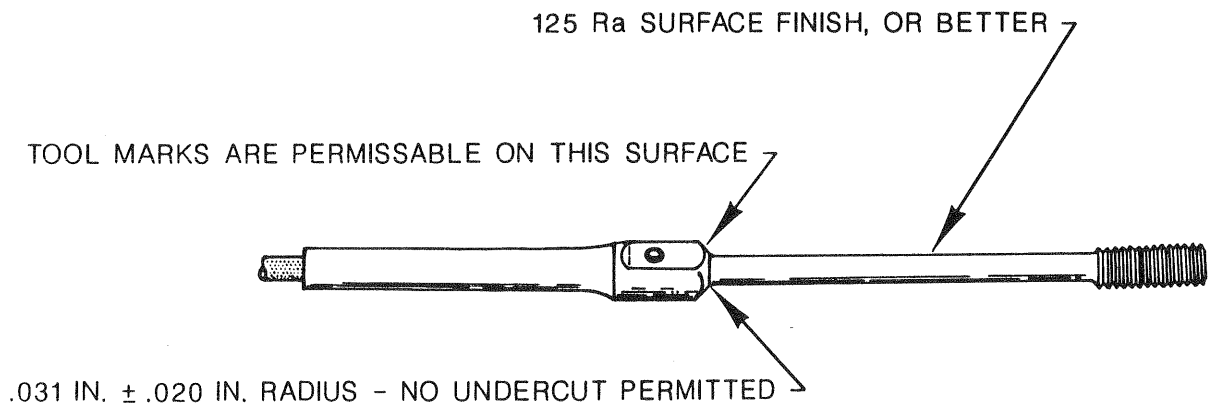
Figure B-251-1. Clutch Control Cable Terminal End

- a. Visually inspect the thread end half of the terminal end, and the radius where the shaft contacts the center shoulder (Figure B-251-1). Any score mark or undercut, or any surface roughness greater than 125 Ra is cause for rejection.
- b. Record compliance with Part I of this Service Bulletin in the aircraft records.
