SCHWEIZER SERVICE BULLETIN

B-255.1*
01 Feb 1993

SUBJECT: MAIN ROTOR DRIVE SHAFT INSPECTION

MODELS AFFECTED: All Model 269A, TH-55, 269A-1, 269B, and 269C Helicopters

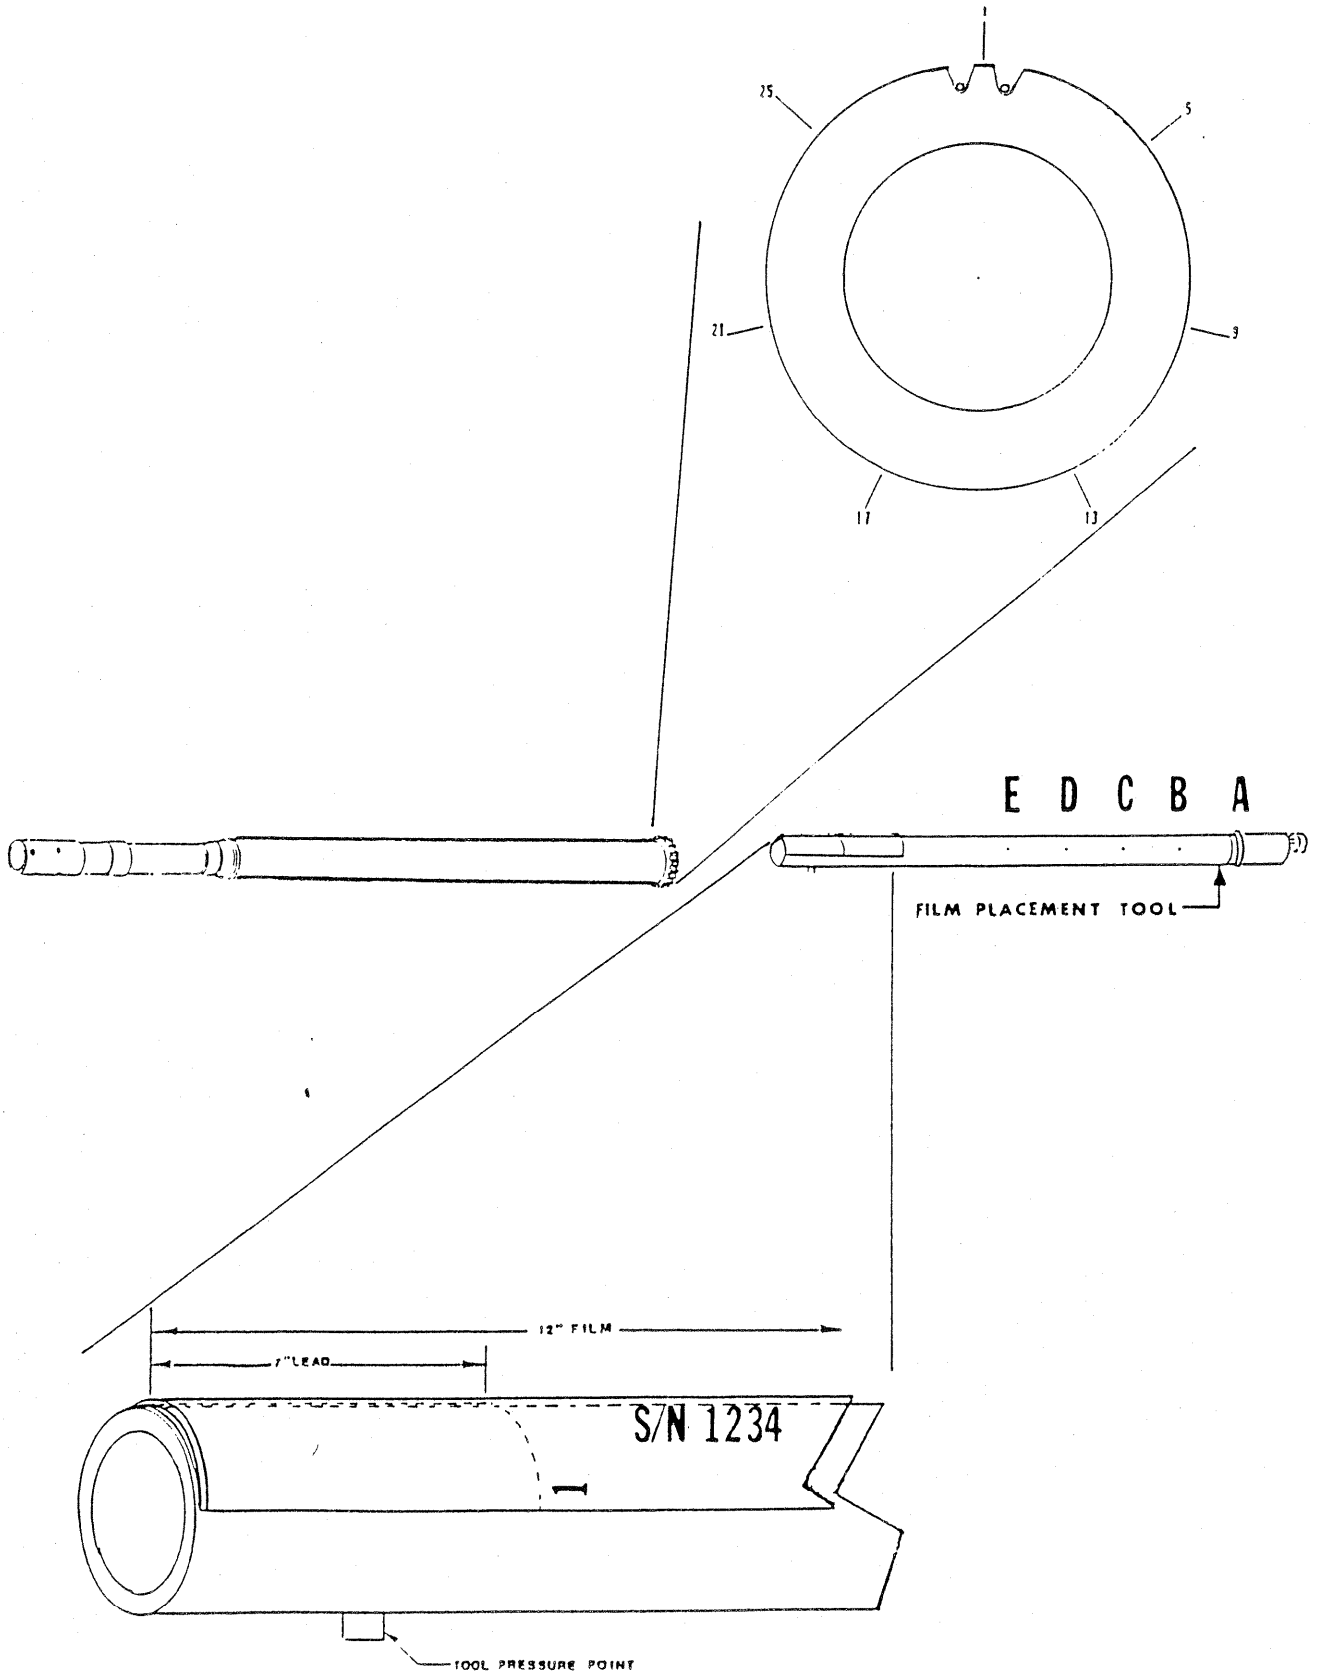
FIGURE 1

- 6.1.1. The relative positions of these views are as depicted in Figure 1 and are located by moving the positioning collar to an alphabet letter, such as A, B, C, etc.

- 6.1.1.1. This will allow the film to be located at different distances from the entrance end of the shaft.
 - 6.1.1.2. By placing the locating pins astraddle a given tooth, such as 1, 5, 9, etc., this will position the film in the required circumferential locations. Figure 1 depicts the location of the locating pins in relation to the tooth.

- 6.2.4. The view and serial number identification numbers shall be off of the lead patch and on the top surface of the film pack as depicted in Figure 1.

- 6.3. Film Placement
 - 6.3.1. Insert the film placement tool into the rotor shaft as depicted in Figure 1 after verifying that the tool pressure point is retracted below the surface of the tool.
