SCHWEIZER SERVICE BULLETIN

B-257.1*
21 May 1993

SUBJECT: ONE-TIME INSPECTION OF LOWER COUPLING DRIVE SHAFTS, AND NEW ENGINE/ROTOR TACHOMETER MARKINGS

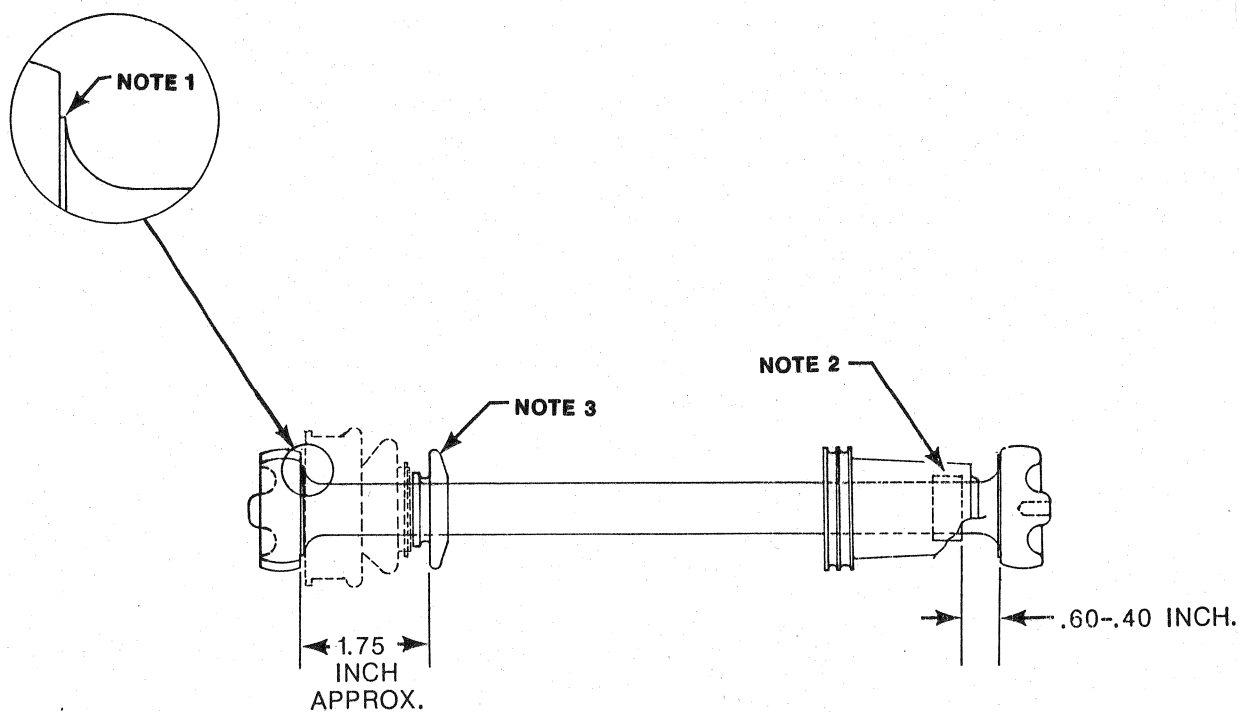
Figure B-257.1-1. Lower Coupling Drive Shaft

- (1) Move grease retainer to center of drive shaft to expose retainer ring (Figure B-257.1-1). Carefully break the bond to allow retainer ring to slide on shaft.
- (2) Cut safety wire from alignment ring and remove boot ring from boot to allow these parts to slide on shaft.
- (3) Thoroughly clean grease and bonding residue from drive shaft.
- (4) Visually inspect drive shaft between forward and aft splines, with particular attention to end radii, for cracks, machining steps, manufacturing tool marks, surface defects, and lack of clean up during the production grinding operation. (See Note below.) (Figure B-257.1-1)

The drive shaft is machined to a 125-250 finish, ground to a 32 finish, then shot peened and coated with manganese phosphate or black oxide. In the above inspection look for areas where the 125-250 machine finish has not been removed in the grinding operation. A rough or coarse manganese phosphate coating and/or the effects of shot peening (small indentations or compressions) may change the surface finish value, but are not cause for rejection.

Small indentations near the center of the drive shaft are the result of hardness testing, and are not cause for rejection.

- (5) If unable to adequately inspect driveshaft for lack of clean up during the grinding operation due to the phosphate coating, perform the following procedures:
 - (a) Clean and degrease shaft with either mineral spirits, alcohol, or stoddard solvent.
 - (b) Lightly abrade surface by hand with 3M scotch brite.
 - (c) Inspect drive shaft in accordance with PART I: b.(4).
- (6) If defects are found, the drive shaft must be retired from service or returned to SAC for further evaluation and disposition. Install serviceable drive shaft (PART I: c.).

- (1) If protective coating was removed from drive shaft, touch up affected area with BST-4 Presto Black in accordance with manufacturer's instructions. Locate and reassemble grease retainer, rings, and boot on drive shaft (Figure B-257.1-1).
- (2) Lubricate and install lower coupling drive shaft (Basic HMI, Section 10).

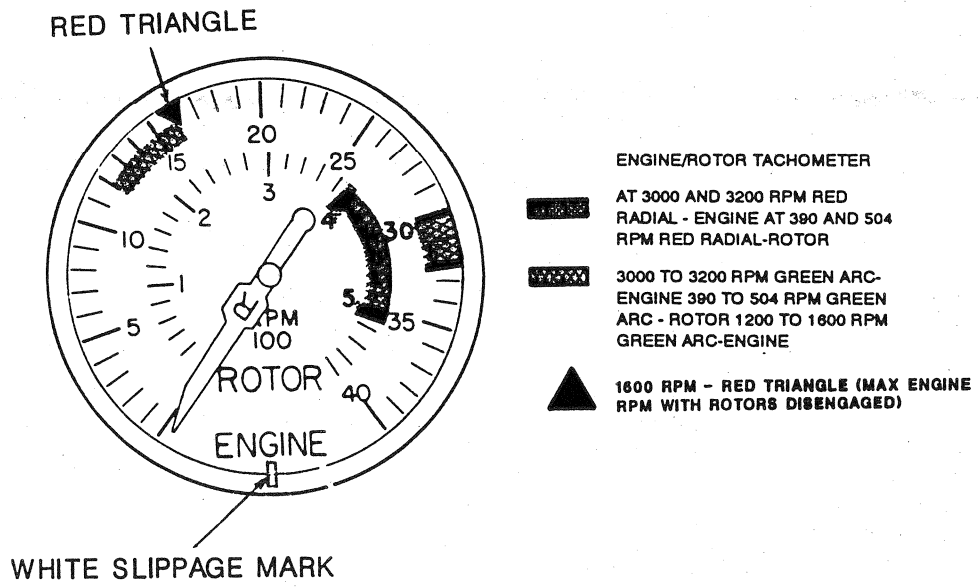
Figure B-257.1-2. Instrument Markings, ENGINE/ROTOR Tachometer

Engine operation in excess of 1600 rpm with the clutch disengaged is prohibited. To prevent lower coupling drive shaft damage due to overspeed in the event that the pilot inadvertently exceeds the 1600 RPM limit, SAC recommends installation of Engine Overspeed Control Kit, P/N 269A4997-1 or -3 as applicable on Model 269C Helicopters.

- (1) Using pressure sensitive vinyl decal material or paint, install a red triangle on lens of ENGINE/ROTOR tachometer at 1600 RPM.
- (2) Paint a white slippage mark at bottom of lens and across adjacent surface of lens frame.
- (3) Record compliance with PART II of this Service Bulletin in the aircraft records.

- (1) Remove ENGINE/ROTOR tachometer from instrument panel (Basic HMI, Section 14).
- (2) Have red triangle permanently marked on face of ENGINE/ROTOR tachometer at an FAA approved repair facility, in accordance with AC43.13-1A.
- (3) Install ENGINE/ROTOR tachometer in instrument panel (Basic HMI, Section 14).
