SCHWEIZER SERVICE BULLETIN

B-263
24 May 1995

SUBJECT: INSPECTION OF AFT CLUSTER FITTINGS

MODELS AFFECTED: All Model 269A, TH-55A, 269A-1, 269B and 269C Helicopters equipped with:

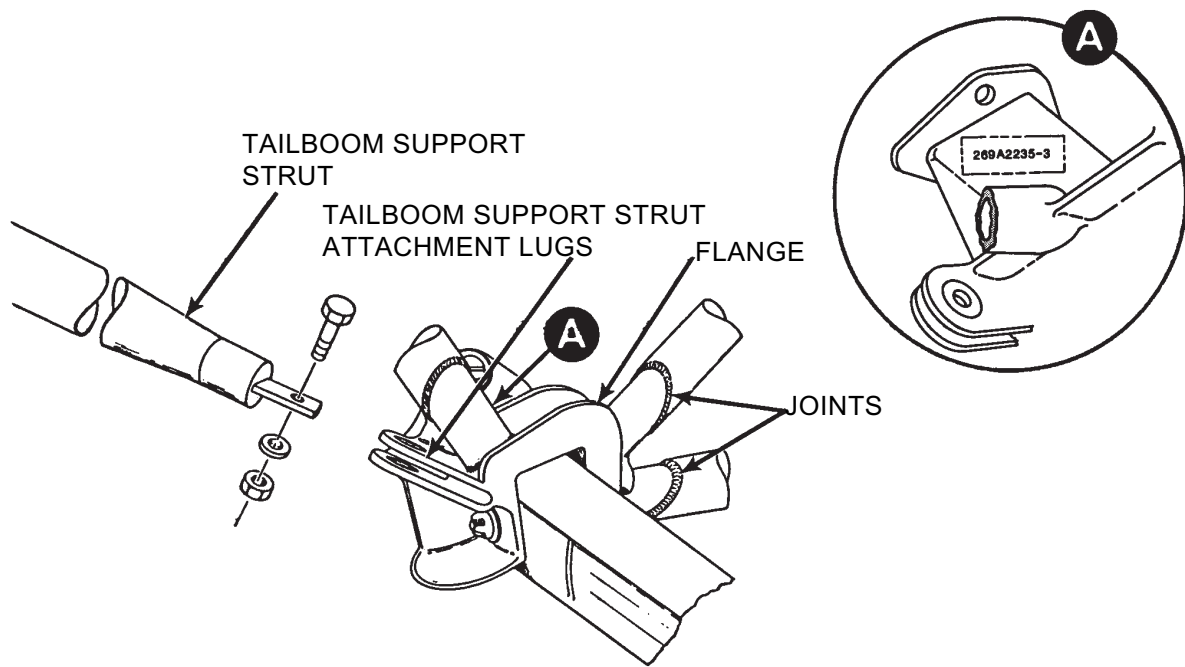
Figure B-263-1. Aft Cluster Fitting Inspection

- a. Using a 10X magnifying glass, visually inspect the left and right aft cluster fittings for cracks, corrosion or other damage. Pay particular attention to the tailboom support strut attachment lugs, cluster fitting flanges, and frame tube to fitting joints (Figure B-263-1).
- b. If cracked or distorted, replace cluster fitting prior to next flight.
- c. If corrosion is found on cluster fitting, remove corrosion and inspect in accordance with Basic HMI, Section 13.
- d. Record compliance with this Service Bulletin in the aircraft records.

RIGHT SIDE CLUSTER FITTING SHOWN
