SCHWEIZER SERVICE BULLETIN

B-266
15 Oct 1996

SUBJECT: TEXTRON LYCOMING SERVICE BULLETIN NO. 525

SUBJECT: Inspection of High Pressure Fuel Pump P/N LW-15473

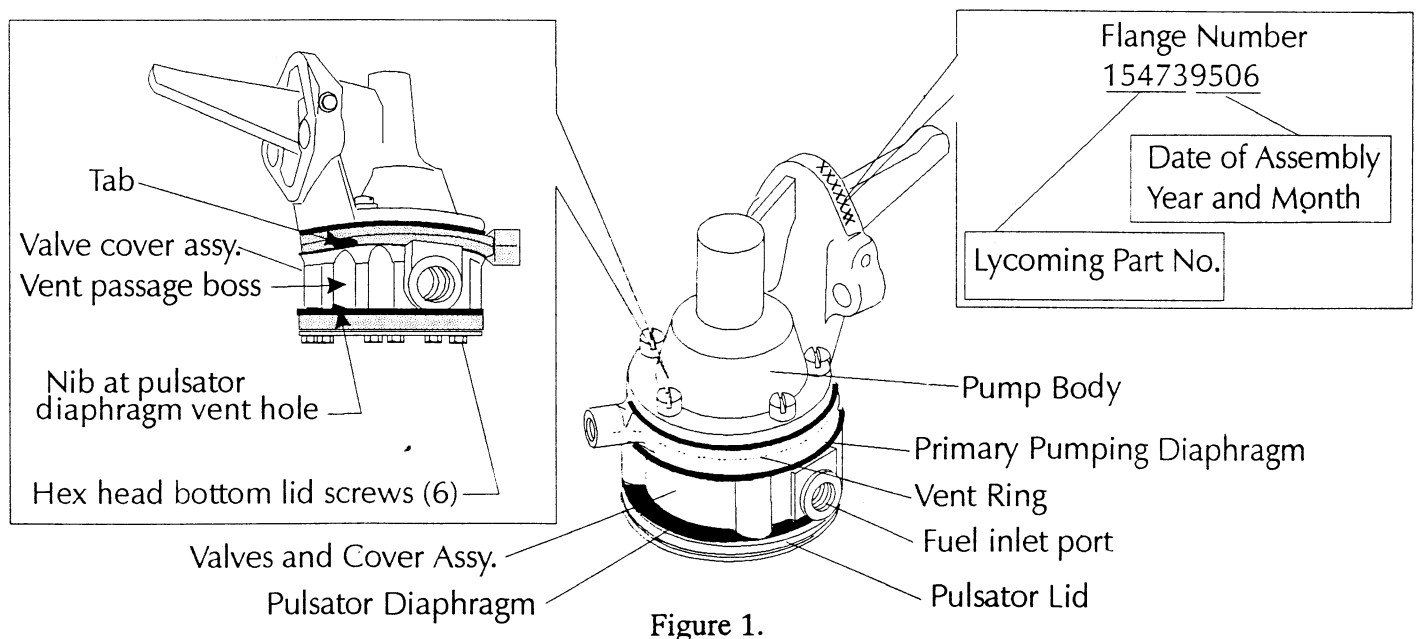
1. Remove the fuel pump from the engine.
2. With a felt tip marker, make a line down the side of the pump assembly at the vent passage boss (Refer to Figure 1) to aid in part alignment for subsequent reassembly.

3. Completely loosen but do not remove the six hex head bottom lid screws and remove the entire bottom section of the pump as a unit assembly including the lid screws and valve cover assembly. (Refer to Figure 1.) Set this unit assembly aside for later examination (step 7).

11. To identify that this examination was accomplished on the pump assembly, mark an “A” by metal stamp or scribe on the pump mounting flange immediately before the flange number (Refer to Figure 1.) If necessary due to space constraints, the “A” may be located just above the rocker shaft pin. An entry in the engine and/or aircraft log book should also be made.
 12. If the pump was removed for examination, reinstall it per standard practice according to the appropriate Overhaul Manual. Examine the port fitting “o” ring seals and the mounting flange gasket, replace if necessary.
- Once the pump is reinstalled on the engine, run the engine on the ground and inspect the pump and fuel lines for fuel leaks.

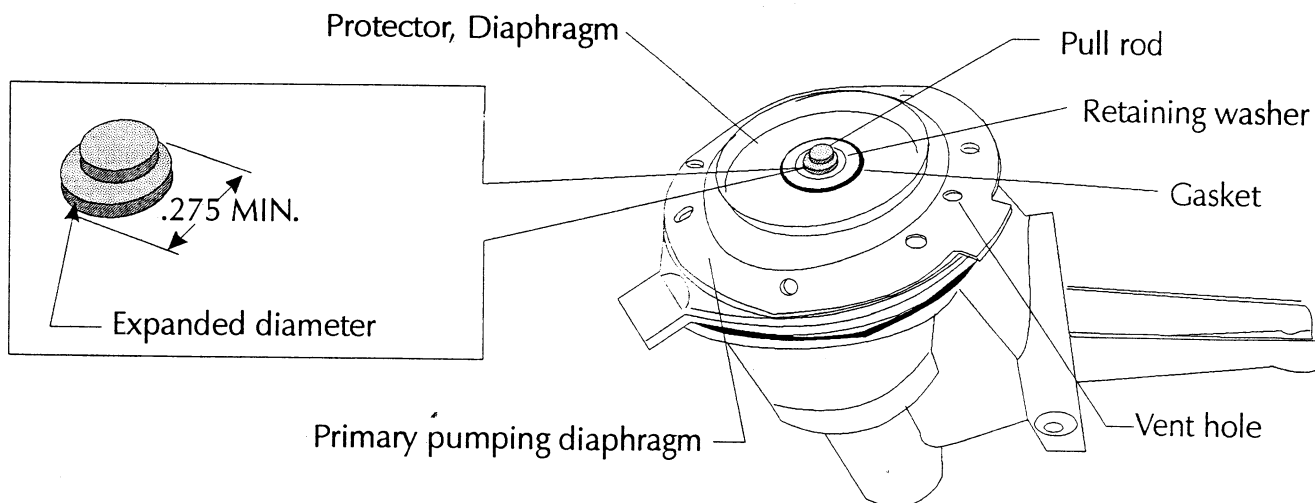
Figure 2.

4. Visually inspect for proper location and retention of the gasket in the pull rod/diaphragm assembly. (Refer to Figure 2.) If the gasket is not found to be between the retaining washer and diaphragm protector or it protrudes more than 1/16 inch beyond the retaining washer at any point, the pump is unserviceable and must be replaced.

5. Using vernier or dial calipers, measure the expanded diameter of the pull rod section immediately next to the retaining washer (larger copper plated diameter). If this diameter measures less than .275 inches, the pump assembly is unserviceable and must be replaced.

6. Visually inspect the primary pumping diaphragm for cracks or tears. If the diaphragm is cracked or torn, the pump is unserviceable and must be replaced.
