SCHWEIZER SERVICE BULLETIN

B-294
24 Aug 2010

SUBJECT: INCORRECT BUSHING USED IN 269C FLIGHT CONTROLS

MODELS AFFECTED: • 269C Model Helicopters Serial No. S1166 & Subs.

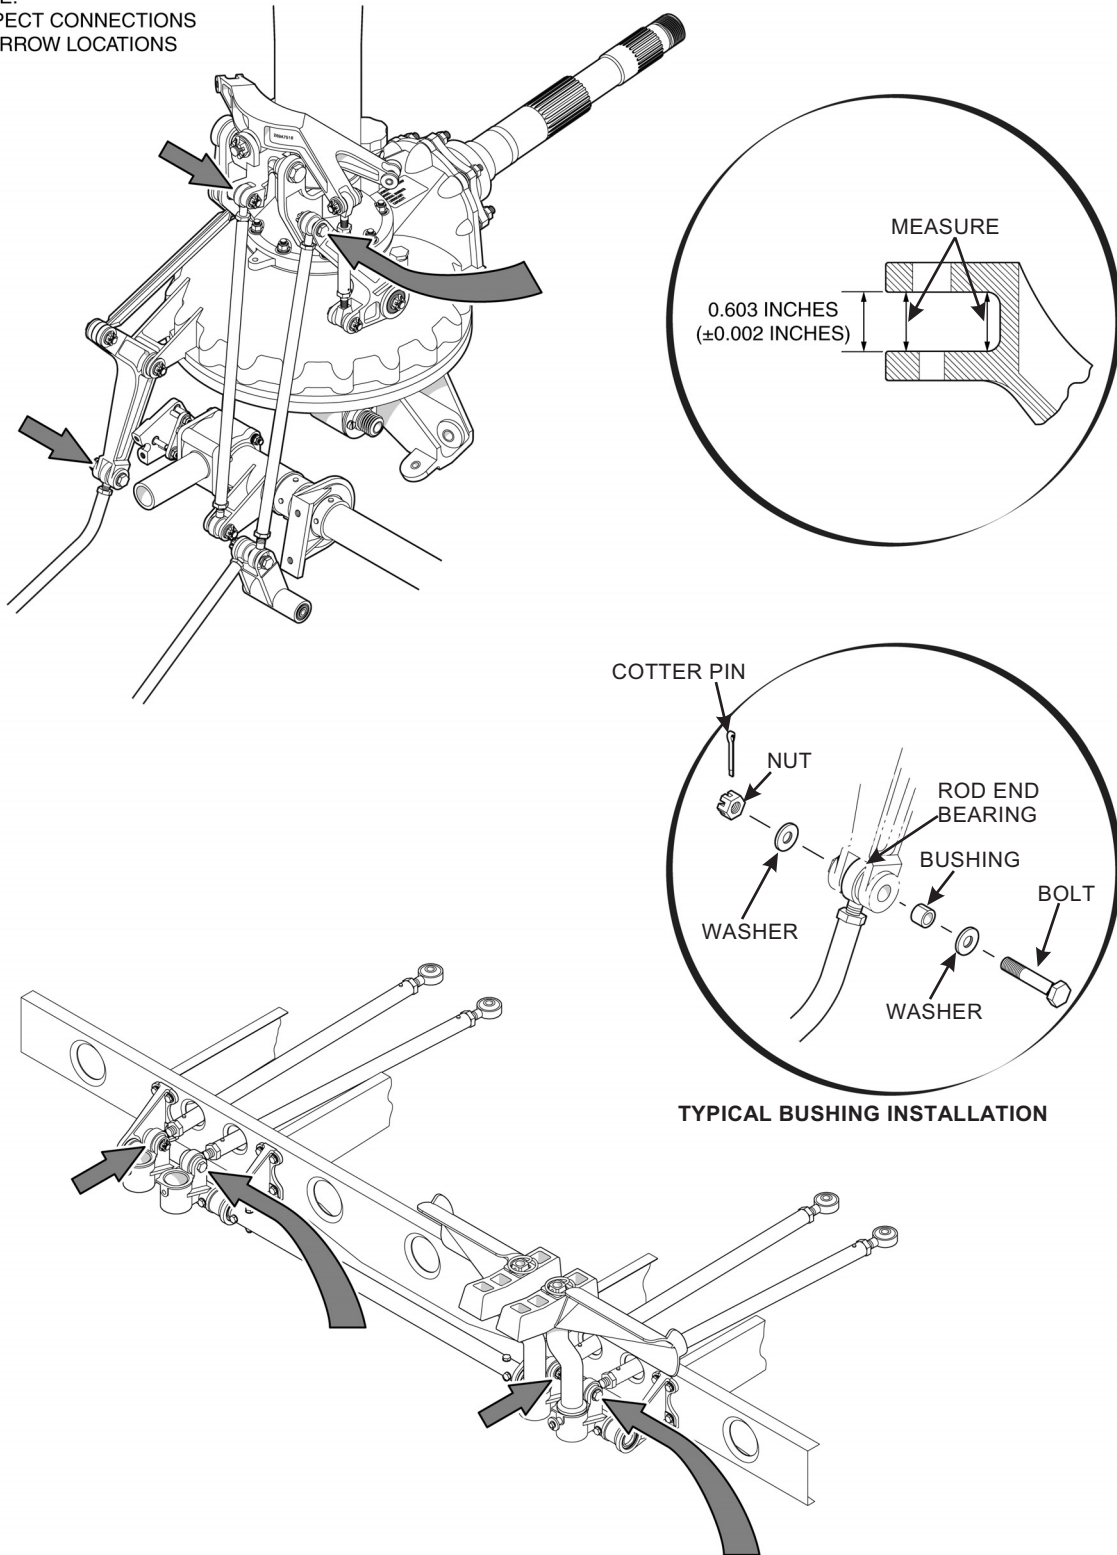
Figure B-294-1. Flight Control Inspection Points

- a. Review Figure B-294-1 and note locations of all SHS626-4-313 bushing installations.

At installation, the SHS626-4-313 bushings are designed to be longer than the thickness of the bellcrank lug. When torqued, the bushing should contact the bearing rod end and extend above the bellcrank outside surface, keeping the washer from touching the bellcrank. If the washers on both sides of the fork are in contact with the fork, the incorrect bushing is installed.

If the incorrect bushing has been installed when the hardware is torqued, the legs of the forks will be drawn to the inner race of the rod end bearing. This can cause permanent distortion of the fork legs that can lead to cracks at the root end of the legs.

NOTE:
INSPECT CONNECTIONS
AT ARROW LOCATIONS

- c. If incorrect bushing is installed, remove bellcrank. Using Vernier calipers, check that the inside surfaces of the fork legs in two locations measure $.603 \pm .002$ (Figure B-294-1) and are parallel to each other. If surfaces are parallel, perform a dye penetrant inspection in accordance with Basic HMI Section 2. Remove from service and destroy any bellcrank found to have distorted or cracked legs.

- d. If a dye penetrant inspection has been performed and the bellcrank is found to be acceptable within the design specifications specified in drawing number 269A7508, restore paint finish in accordance with HMI Appendix D, Corrosion Control Manual.
