# 269C™ HELICOPTER

ASB B-308A

Revision A • August 4/15

**SUBJECT:** MAIN ROTOR AND CONTROL SYSTEM – Pilot's Collective Pitch Control Stick - One-Time Inspection of Collective Pitch Control Torque Tube

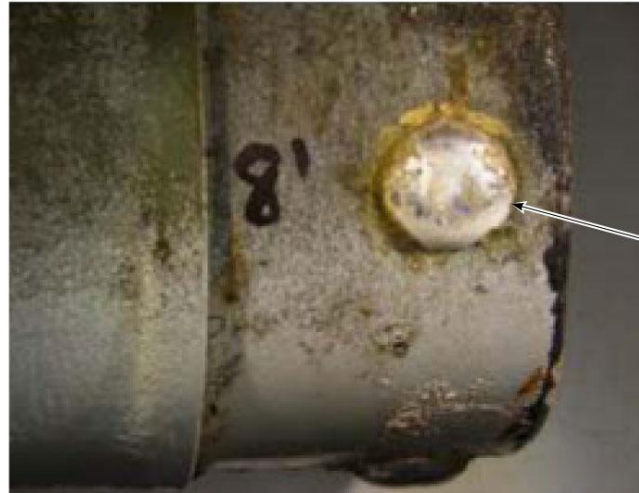
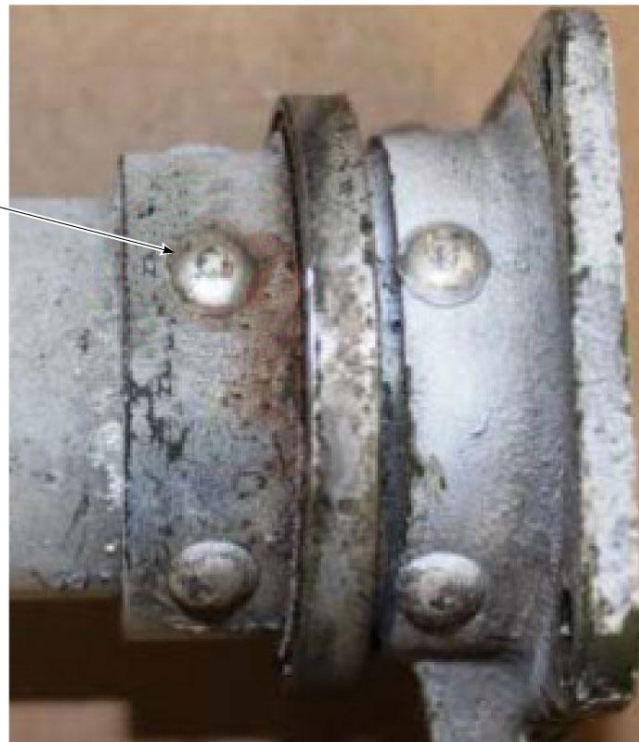
FIGURE 1

Incorrect "plain", "A" type rivets were found installed on collective pitch control torque tube, which could lead to reduced functionality of the collective pitch torque tube.

INCORRECT  
PLAIN "A" TYPE  
RIVET

CORRECT "B" TYPE  
RIVET WITH  
RAISED CROSS

INCORRECT PLAIN "A" TYPE RIVET HEAD (TOP) AND CORRECT "B" TYPE RIVET WITH RAISED CROSS (BOTTOM)

- (b) If paint has not been removed, proceed to Step B.(8).
- (4) If “plain”, “A” type, or damaged rivets are found:
  - (a) Record all “plain”, “A” type, or damaged rivets on the Collective Pitch Control Torque Tube Inspection Data Sheet (Refer to step D).
  - (b) All “plain”, “A” type, or damaged rivets are removed and replaced with rivets (MS20470B5, CR3213-5, or NAS1738B5-5). If tube (269A9937-3) or fitting (269A7205) are damaged, remove from service and replace. (Refer to Temporary Revision No. 269I-A-4, Torque Tube Installation, and Temporary Revision No. 269I-A-5, Torque Tube Installation, or Temporary Revision No. 269I-C-10, Torque Tube - Collective Pitch Control, and Temporary Revision No. 269I-C-11, Torque Tube - Collective Pitch Control.)
- (5) Treat bare surfaces of collective pitch control torque tube with alodine (1132 Touch-N-Prep or equivalent) as follows:

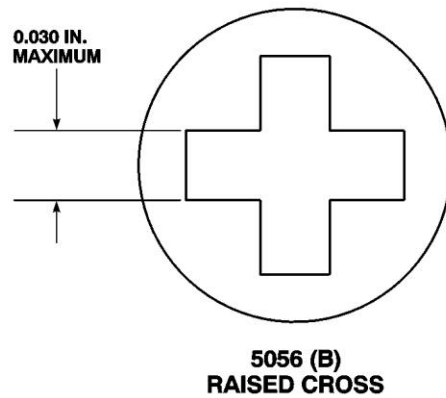
"B" TYPE RIVET MATERIAL IDENTIFICATION MARK  
FIGURE 2

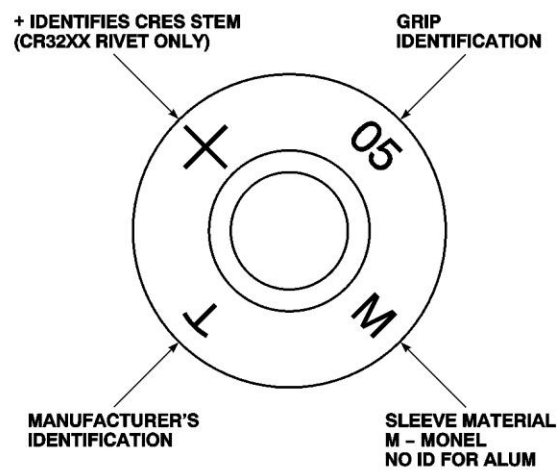
CHERRYMAX® RIVET MATERIAL IDENTIFICATION MARK  
FIGURE 3

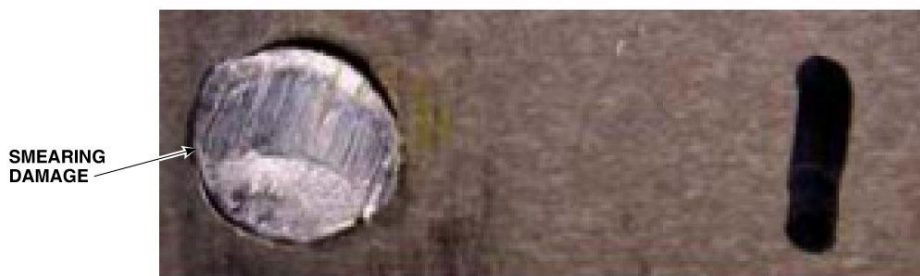
FAILED RIVET SHOWING SMEARING  
FIGURE 4

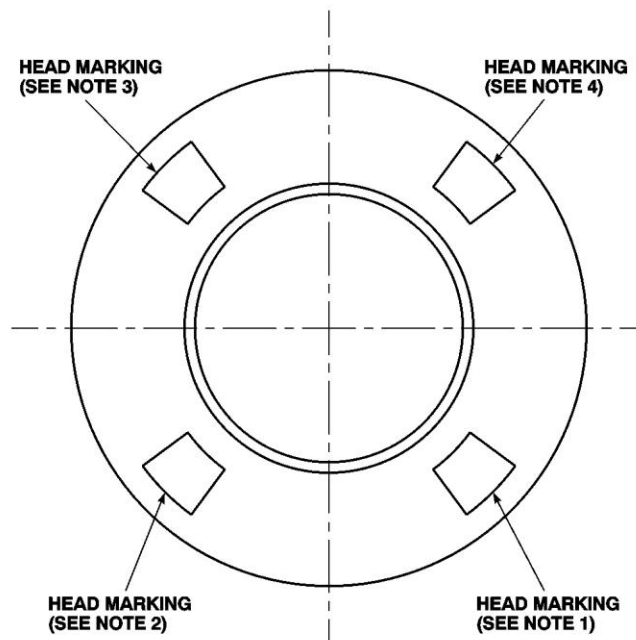
NAS1738 PROPER RIVET MATERIAL IDENTIFICATION MARK  
FIGURE 5

- (2) Inspect at least three of the most accessible rivet heads in row for presence of grip identification on rivets (if NAS1738B5-5). (Refer to Figures 1, 5, 6 (Row 4), Temporary Revision No. 269I-A-4, Torque Tube Installation, and Temporary Revision No. 269I-A-5, Torque Tube Installation, or Temporary Revision No. 269I-C-10, Torque Tube - Collective Pitch Control, and Temporary Revision No. 269I-C-11, Torque Tube - Collective Pitch Control.)

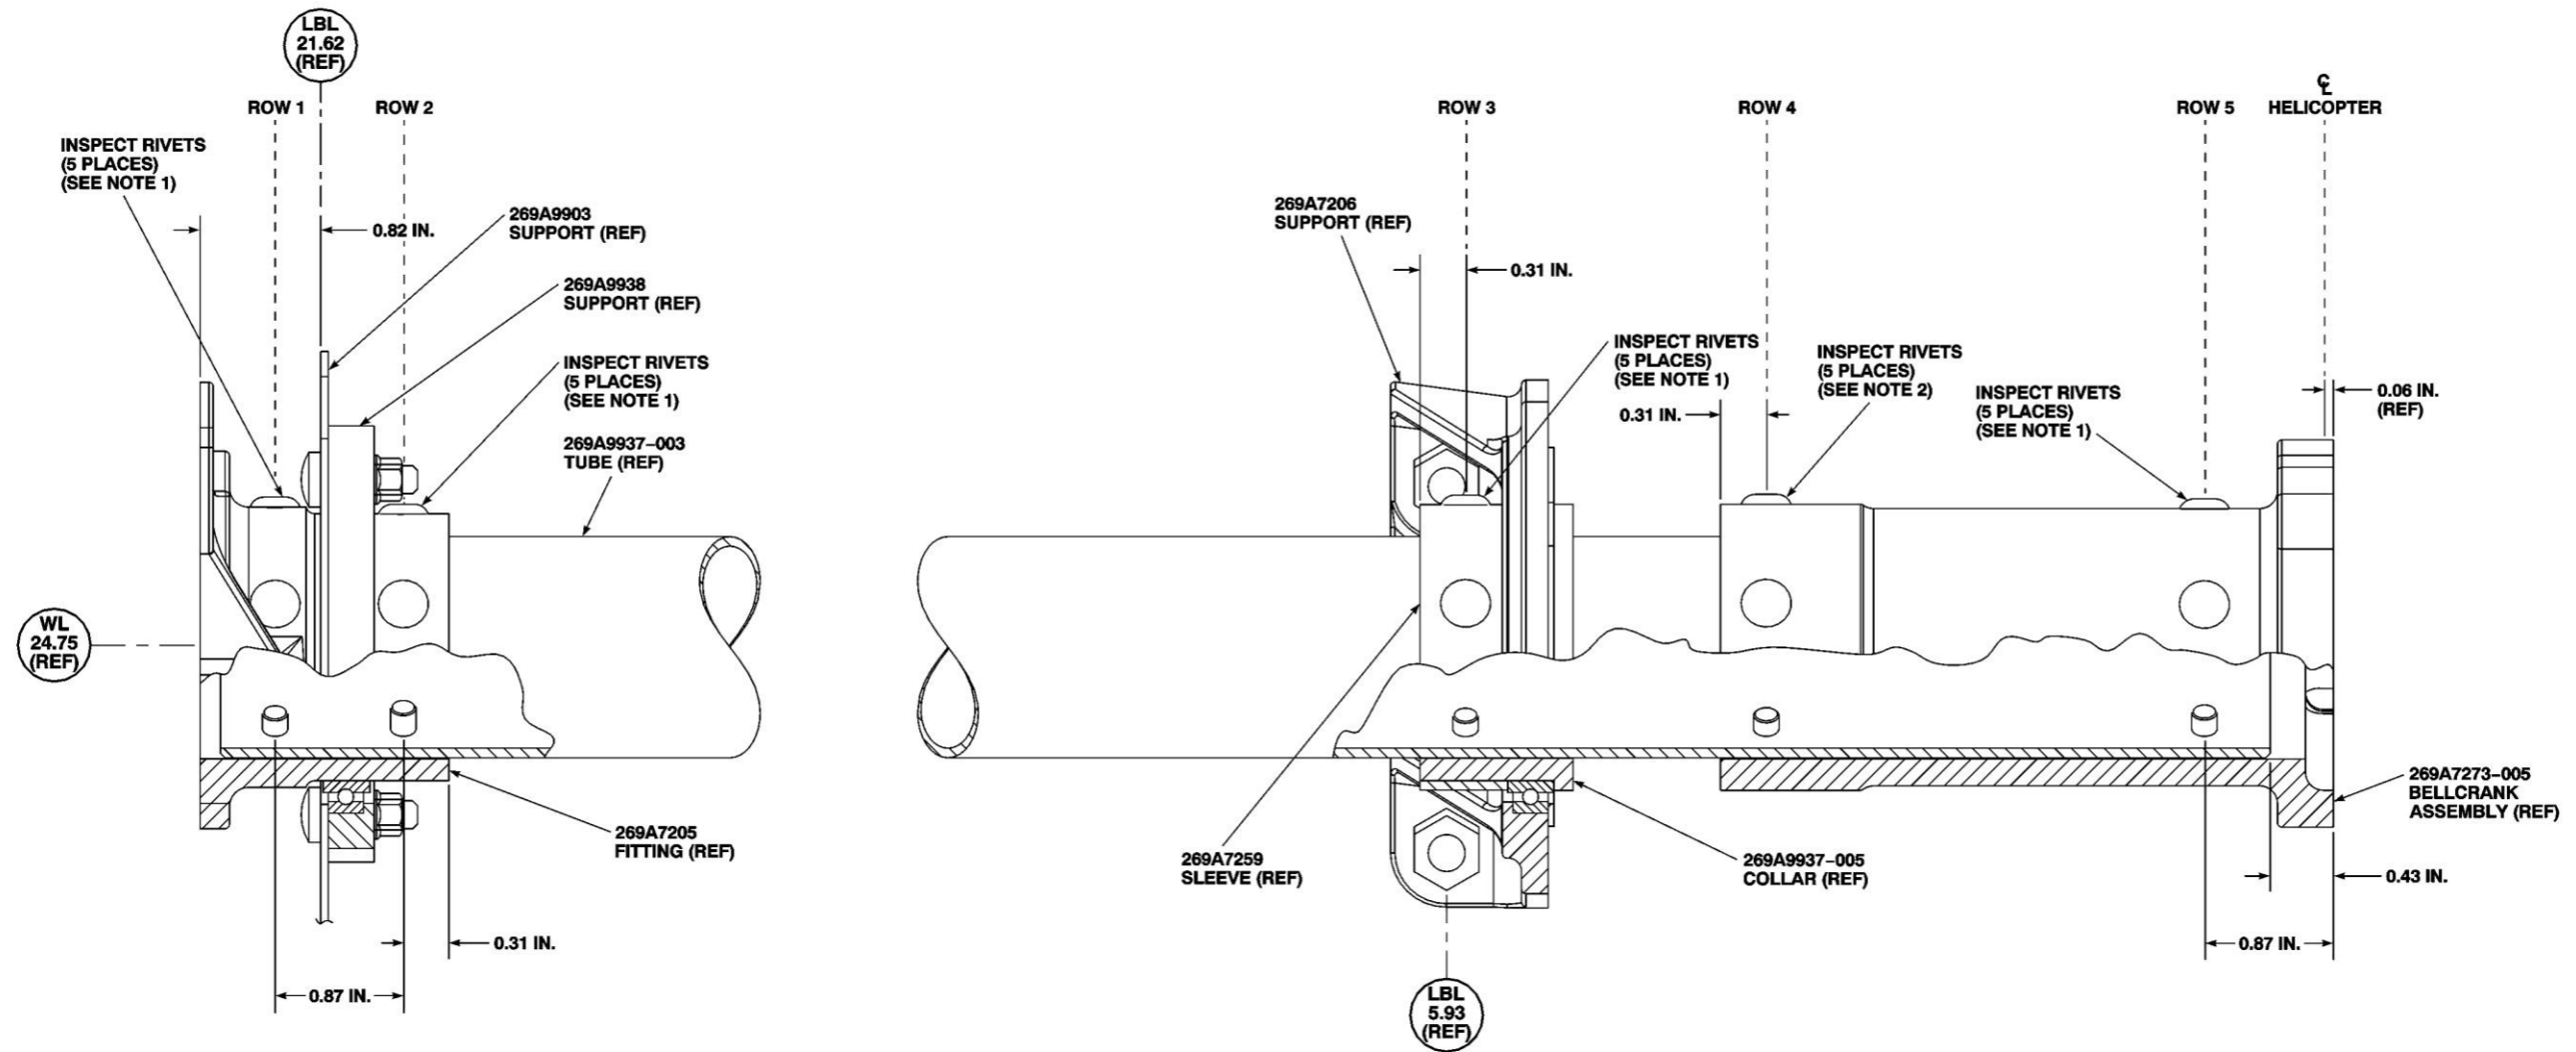
1. INSPECT RIVETS PER FIGURES 2 AND 3.
2. INSPECT RIVETS PER FIGURE 5.

RIVET INSPECTION LOCATIONS  
FIGURE 6

- (1) Inspect at least three of the most accessible rivet heads per row for presence of raised cross on rivets (if MS20470B5), or presence of grip identification on rivets (if CR3212-5). (Refer to Figures 1, 2, 3, 6 (Rows 1, 2, 3, and 5), Temporary Revision No. 269I-A-4, Torque Tube Installation, and Temporary Revision No. 269I-A-5, Torque Tube Installation, or Temporary Revision No. 269I-C-10, Torque Tube - Collective Pitch Control, and Temporary Revision No. 269I-C-11, Torque Tube - Collective Pitch Control.)
