SCHWEIZER SERVICE BULLETIN

C1B-020
29 Nov 2006

SUBJECT: SLICK SERVICE BULLETIN SB1-06A

SLICK SB1-06A

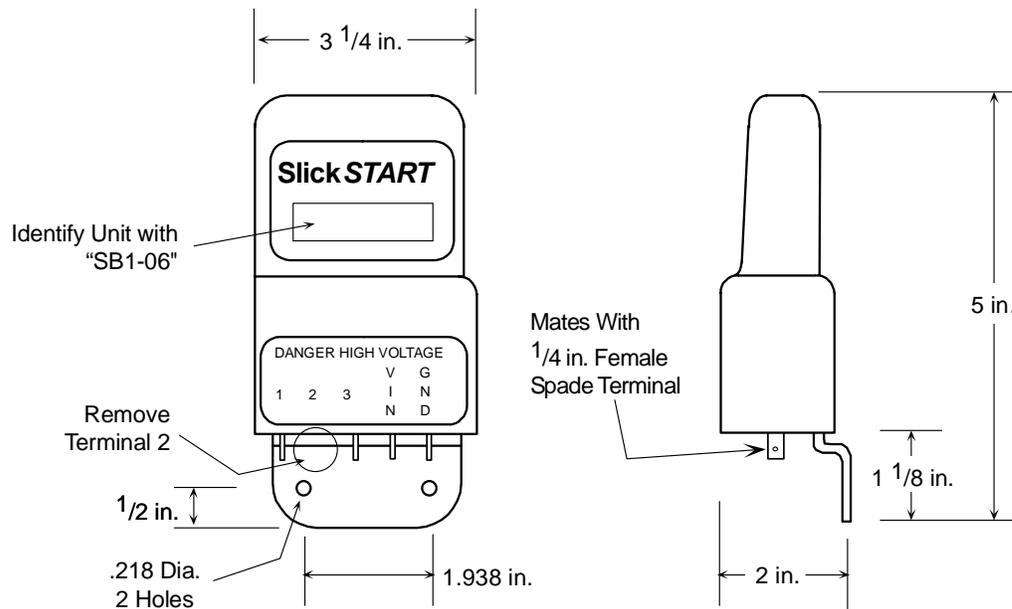
Figure 1

Previous installation instructions for the SS1001 allowed connection of the SlickSTART™ to both left and right magnetos. Unison Industries now recommends the removal of this connection method because it potentially compromises the redundancy of the ignition system. Therefore, this unit must be disconnected from the right hand magneto and pin #2 must be removed from the SlickSTART™ unit, thus allowing the right magneto to operate independently.

In most applications, this pin will not be connected, but the pin should still be physically removed to prevent any connection in the future.

- If the SlickSTART™ unit is accessible, cut of the #2 pin as short as possible to prevent future use of this pin. See Figure 1. If necessary, remove the SS1001 from the firewall to complete this operation then re-install it.

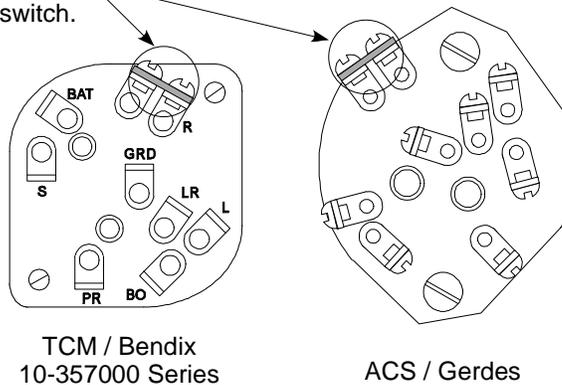
Figure 2

CAUTION: ON ENGINES WITH ONE RETARD BREAKER MAGNETO OR ONE IMPULSE COUPLING MAGNETO INSTALLED, FAILURE TO GROUND THE RIGHT MAGNETO DURING START WILL RESULT IN ENGINE KICKBACK AND POSSIBLE DAMAGE TO THE STARTER AND ASSOCIATED ACCESSORY GEAR TRAIN.

- A. In most applications, the right magneto can be grounded during start by the ignition switch. If the wiring connections on the back of the ignition switch are similar to those shown in Figure 2, a jumper can be added to the two terminals shown to provide a ground path during start.

Verify that this jumper is installed if your aircraft is equipped with this type of switch.
