# SCHWEIZER SERVICE BULLETIN

C1B-024.1\*  
24 Nov 2008

**SUBJECT:** THROTTLE CONTROL RESTRICTION

**MODELS AFFECTED:** 269C-1 helicopters serial numbers 0001 through 0345.

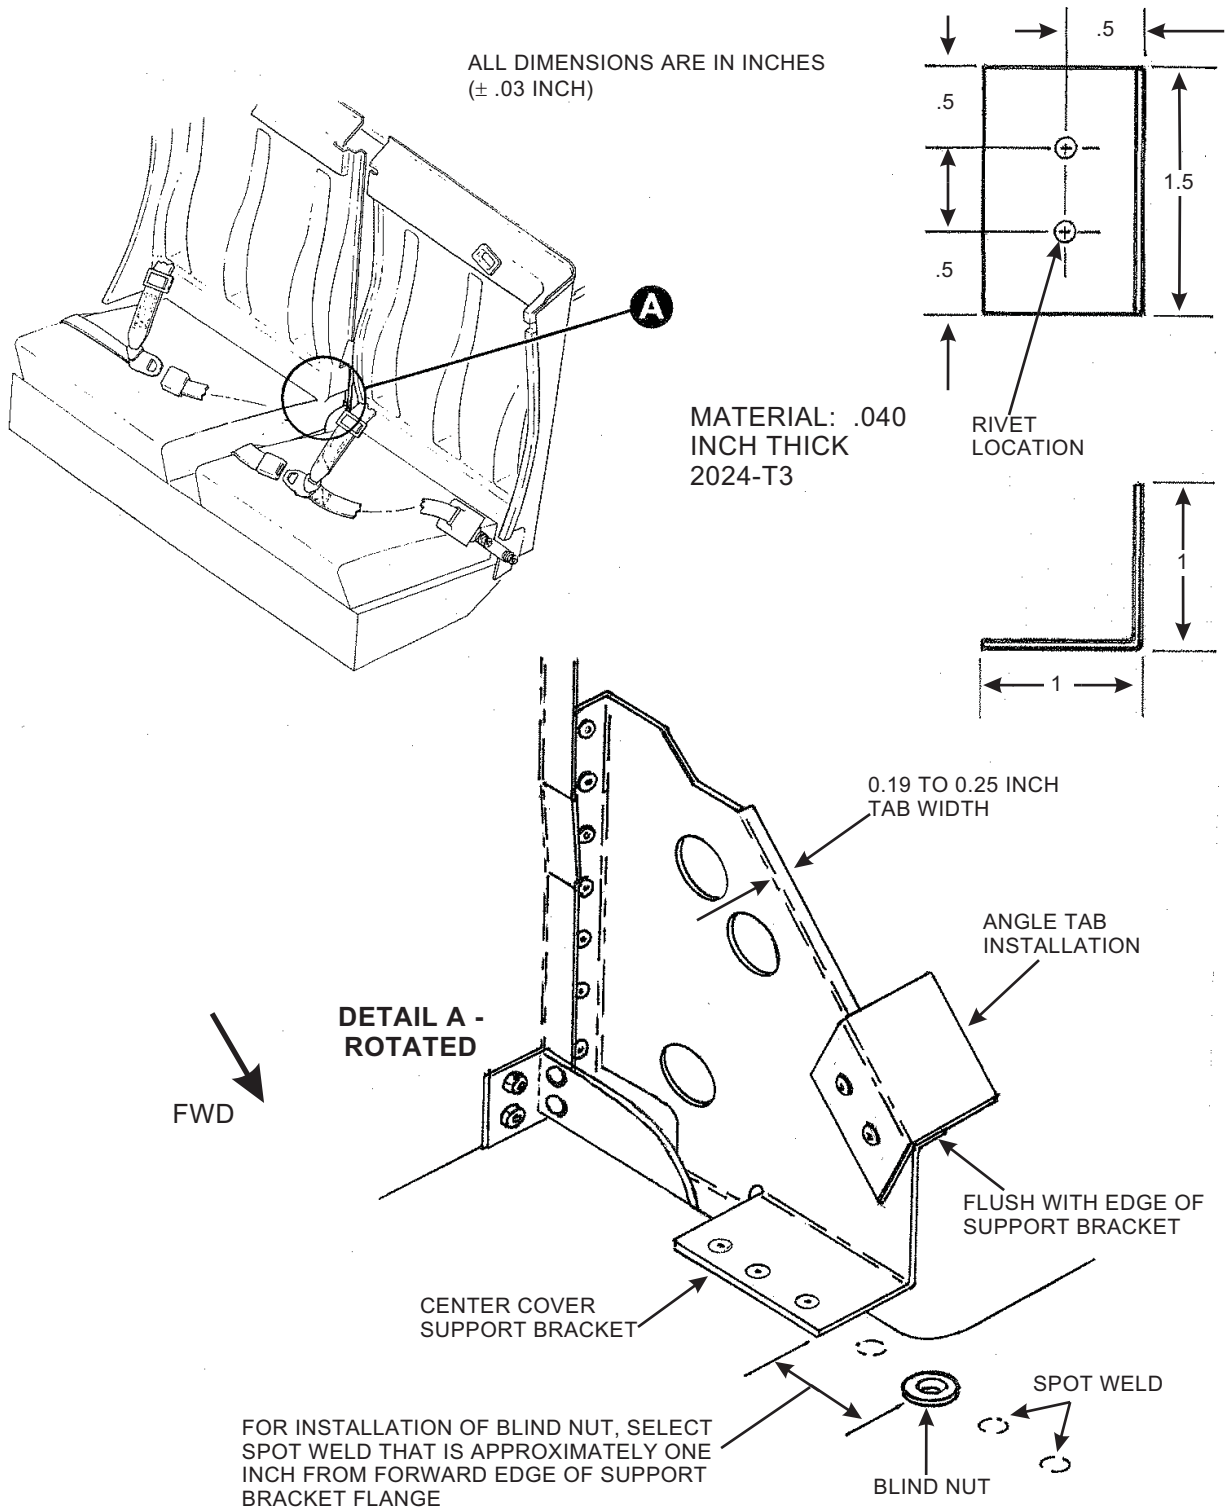
Figure C1B-024-1. Angle Tab Installation

In the following step, helicopter serial numbers 0144 through 0310 were equipped with center cover support brackets with a top flange of 0.19 to 0.25 inch wide. Helicopters in this serial number group or any that have flanges modified to a dimension less than 0.60 inch, require installation of a 90° angle tab.

- b. Measure flange on top edge of center cover support bracket as shown in Figure C1B-024-1. If flange is less than 0.60 inch wide, Fabricate a 90° angle tab to dimensions shown in figure. Place angle tab in position with flange flush against lower edge of support bracket. Using number 27 drill, drill two rivet holes in locations shown in figure and secure angle bracket to support bracket using CR2249-4 rivets.

- c. Select a spot weld that is approximately 1 inch forward of forward edge of bottom flange of support bracket (Fig. C1B-024-1). Drill a .250 to .256 inch hole in center of selected spot weld and make a key slot in edge of hole to accommodate key of blind nut. Install S10K80 blind nut in hole.
- d. Install and secure center flight control cover in position. Using a hole finder centered on blind nut, drill a .190 to .195 inch hole in flange of cover. Secure cover flange to seat bench with AN525-10-7 Screw and AN960KD10L Washer.
- e. Check throttle for freedom of movement and no interference.
- f. Reinstall all removed panels and seat cushions.
- g. Record compliance with this Service Bulletin in the aircraft records.

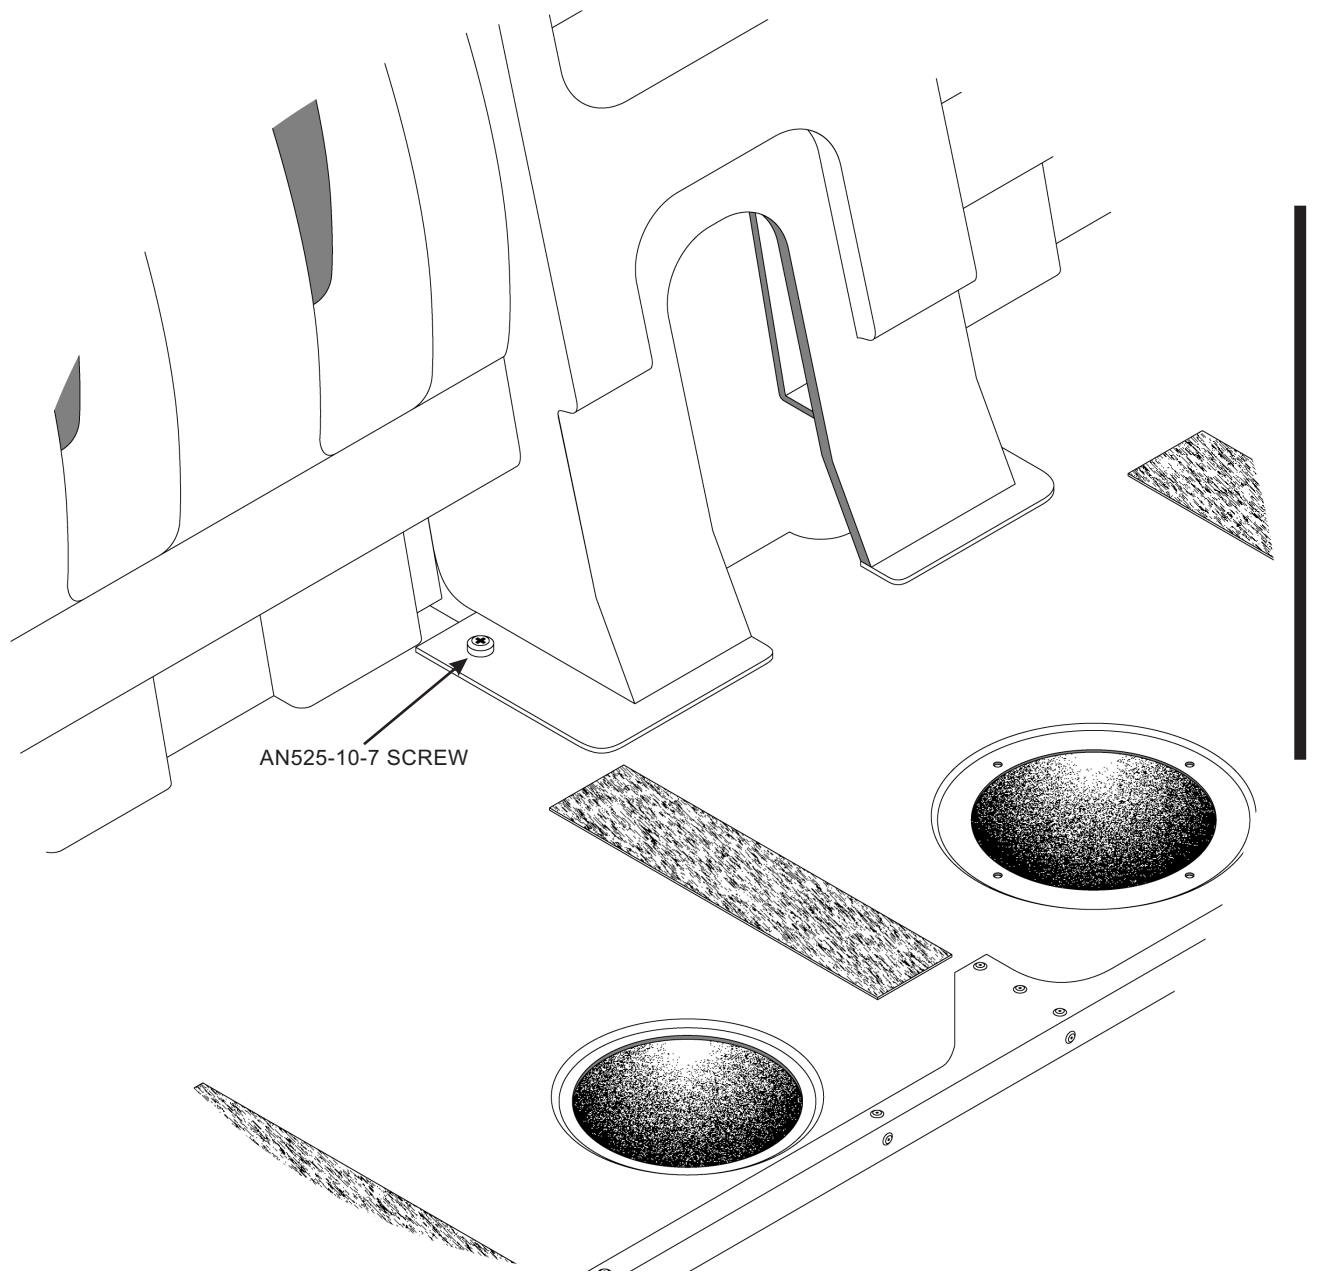
Figure C1B-024-2. Throttle Control Restriction

**PREFACE:** • During routine maintenance, a throttle control restriction can occur if the flight control cover in the center of the seat back is reinstalled incorrectly. Installation of a 90° angle tab on the center cover support bracket will prevent the edge of the flight control cover from being placed between the support bracket and the throttle bellcrank during cover installation. Helicopter serial numbers 0311 and subsequent have the tab installed. Also, installation of a blind nut and screw in all the affected serial numbers above will assure the cover is installed and secured in the proper position.

**FAILURE TO COMPLY WITH THIS SERVICE BULLETIN MAY LEAD TO A THROTTLE RESTRICTION THAT MAY SUBSEQUENTLY LEAD TO AN ENGINE AND ROTOR OVERSPEED. A ROTOR OVERSPEED THAT IS UNCONTROLLED BY THE PILOT MAY ULTIMATELY LEAD TO STRUCTURAL FAILURE OF THE ROTOR AND SUBSEQUENT SERIOUS INJURY, DEATH, AND/OR PROPERTY DAMAGE.**
