# SCHWEIZER SERVICE BULLETIN

C1B-033  
05 Jan 2011

**SUBJECT: CLEVIS PIN CHAFFING BOTTOM OF FUEL TANK**

**MODELS AFFECTED:** • All Model 269C-1 Helicopters

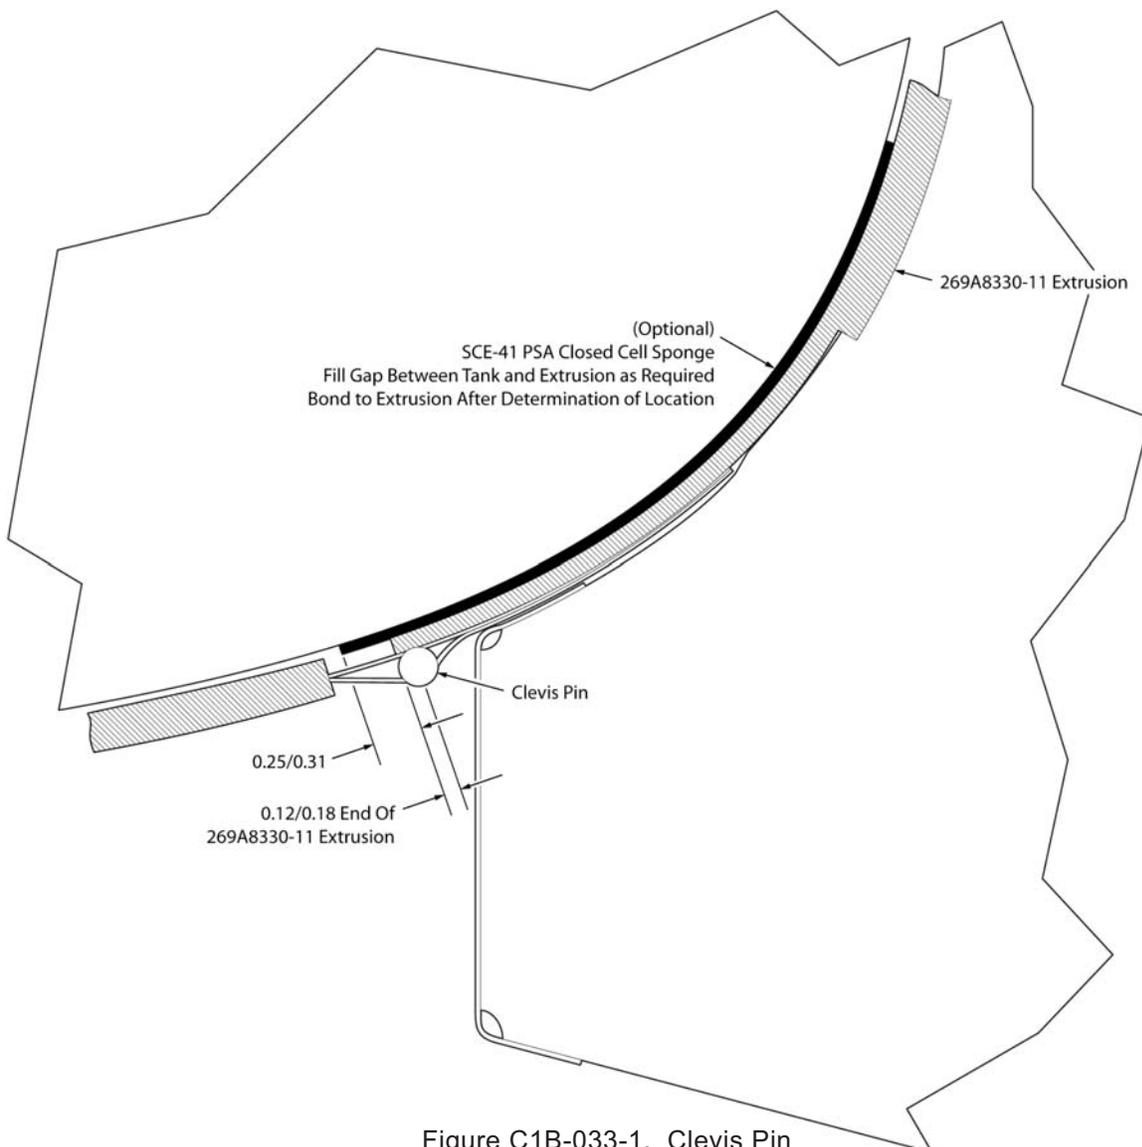
Figure C1B-033-1. Clevis Pin

**PREFACE:** • Schweizer Aircraft Corp. has received several reports that the heads of the clevis pins and washers, attaching the lower half of the fuel tank retention strap (band clamp) to the airframe, are chaffing the bottom of the tank. Investigation of the condition revealed that the rubber extrusion was not properly positioned between the fuel tank and strap attachment. The extrusion holds the strap away from the fuel tank and prevents the strap and pin assembly from contacting the tank. This Service Bulletin requires a one-time inspection to assure the extrusion is properly positioned and chaffing has not occurred.

- a. Using a bright light and mirror, examine bottom of fuel cell and check that 269A8330-11 rubber extrusion is properly positioned between tank and retention strap clevis pin as shown in C1B-033-1. Verify there is proper clearance between the clevis pin head, washers and fuel tank. Clearance needs to be verified again after the fuel tank is fueled.

If rubber extrusion is installed as shown in Figure C1B-033-1, proper clearances have been established and there is no evidence of contact or chaffing then no further action is required. Record compliance with this Service Bulletin in the aircraft records.

- c. Remove installed 269A8330-11 extrusion from seat structure vertical beam and using MEK, remove all residual adhesive.
- d. Trial fit a new length of 269A8330-11 extrusion on the seat beam and trim to .12 to .18 inch past the center line of the clevis pin position as shown in Figure C1B-033-1. Using waterproof cement, bond extrusion to vertical beam and portion of stainless steel strap attached to vertical beam.

- e. Reinstall fuel tank on helicopter in accordance with Basic HMI, Section 5.
- f. Check for proper clearance of clevis pin head. Verify clearance after fuel tank has been fueled. If there is not adequate clearance, repeat Step b. above and add additional layers of SCE-41 PSA closed Cell Sponge, as required, as shown in Figure C1B-033-1.
