SCHWEIZER SERVICE BULLETIN

DB-015.1*
19 Apr 2006

SUBJECT: MODIFICATION OF CEF 8618M33 LINEAR ACTUATOR

MODELS AFFECTED: 269D and 269D Config. "A" Model helicopters serial numbers 0001 through 0056.

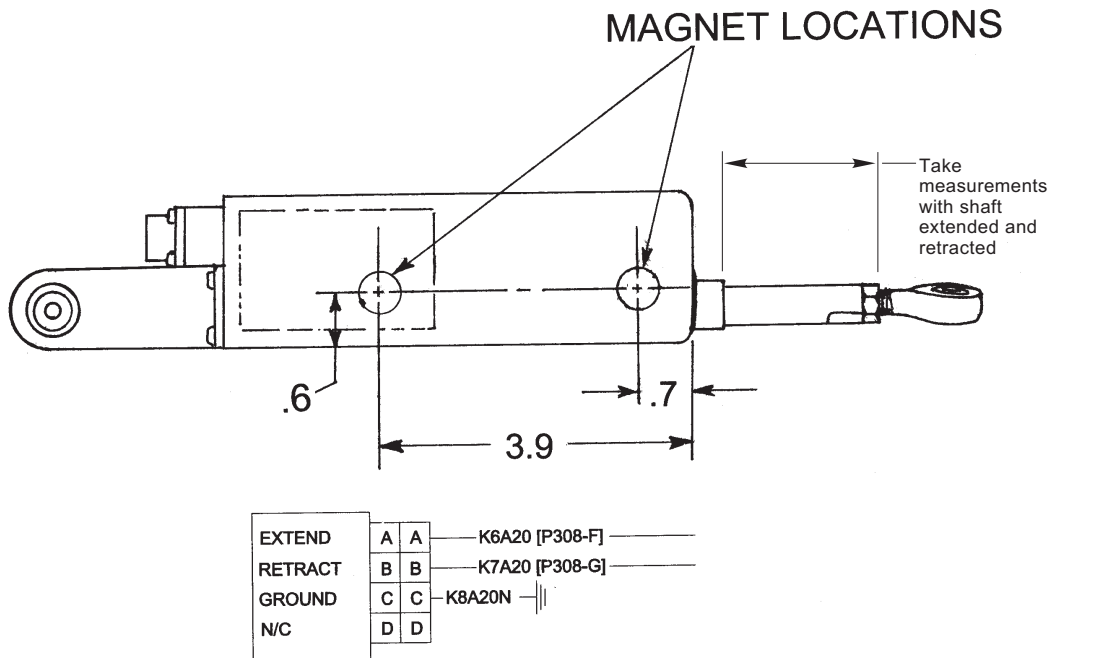
- A report has been received of an internal separation in a power turbine trim actuator that resulted in loss of control of the engine N₂ speed. Due to this, all trim actuators identified with CEF Industries part number 8618M33 are to be removed from service and replaced by part number 8618M33A. Due to the limited availability of actuators configured to the new part number, 8618M33 actuators may remain in service for the next 500 hours (or 1 year, whichever occurs first) until a replacement is available. In this case, periodic inspections are required until the actuator is replaced. All used actuators can be returned to Schweizer Aircraft Corp. for modification to the current drawing revision. Consult Service Letter DL-010 for information on the actuator exchange program.

- (3) Place permanent magnet at fixed end in area shown in Figure DB-015-1 on the data plate side and retract actuator shaft until sound from electric motor shows it has stalled.
- (4) Measure length of shaft protruding from actuator and record measurement.
- (5) Place magnet at the opposite end (Fig. DB-015-1) and extend actuator shaft until motor stalls. Measure and record length of shaft protruding from actuator.
- (6) Subtract fully retracted measurement from fully extended measurement. A measurement less than 1.128 inches indicates an unserviceable actuator that must be removed from service before further flight.
- (7) Retract a serviceable actuator to mid range and reinstall trim actuator in accordance with Basic HMI Section 4.
- (8) Record compliance with this periodic inspection in the aircraft records.
