SCHWEIZER SERVICE BULLETIN

DB-018.3*
13 Dec 2007

SUBJECT: INSPECTION FOR FATIGUE CRACKING IN 269D3300-1 AFT FUSELAGE ASSEMBLIES AND INSTALLATION OF STABILIZER MOUNT DOUBLERS

MODELS AFFECTED: All Model 269D and 269D configuration "A" Helicopters Serial Numbers 0001 through 0062A that are equipped with 269D3300-1 Aft Fuselage Assemblies.

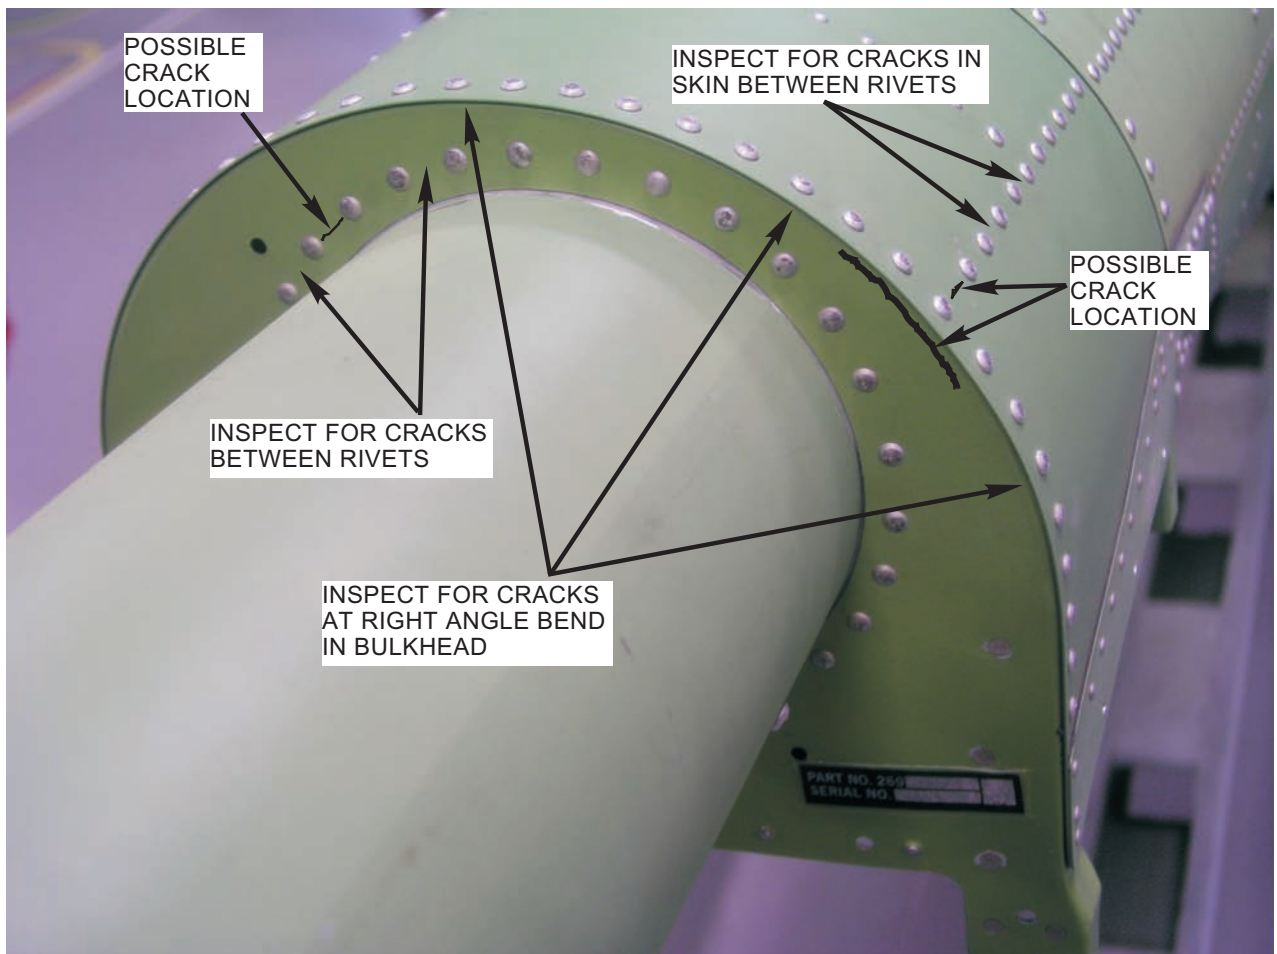
Figure DB-018-1

- a. Visually check aft bulkhead and adjacent skin for cracks and cracks in paint film in the areas indicated in Figure DB-018-1. If cracks in metal structure or in paint film alone are found, or new cracks extend from under repair patches, perform an interior inspection in accordance with Part II of this Service Bulletin before next flight.

NOTE: VISUALLY INSPECT SKIN AND BULKHEAD, WITH PARTICULAR EMPHASIS ON AREAS INDICATED BY ARROWS.

- e. Aft fuselage assemblies with a cracked clip, cracks in aft bulkhead and/or adjacent skins (Fig. DB-018-1), can be repaired locally in accordance with Basic HMI Section 11. 269D3300-1 assemblies that have been repaired, require a periodic inspection of the interior structure at each 200 hours of operation after repair.
