269D® HELICOPTER ALERT SERVICE BULLETIN

ASB DB-050 BASIC ISSUE • May 2/13

SUBJECT: One-Time Tail Rotor (T/R) Blade Borescope Inspection for Excess Primer

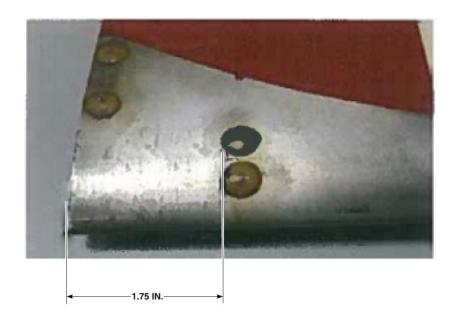
Figure 1: Reference Mark

- (2) Remove T/R blades from the T/R hub assembly in accordance with the HMI (Section 9).
 - (3) Measure 1.75 inches from the tip of the blade and mark the location with a non-permanent marker. (Refer to Figure 1). Use this line shown in Figure 1 as a reference measurement. As the primer coating inside the spar is allowed to extend from the root end of the blade to a location no closer than 1.75 inches from the blade tip.

- (a) If any primer coating extends to within 1.75 inches from the tip of the T/R blade, remove the blade from service and contact Customer Service Engineering at 1-800-WINGED-S for further blade disposition.
- (b) If the break line of the primer is not within 1.75 inches from the tip of the T/R blade, the blade inspection is complete and the blade may continue in service. (Refer to Figure 3).
- (7) Reassemble T/R with serviceable blades to T/R hub and complete T/R assembly in accordance with HMI (Section 9)
- C. Return helicopter to service.

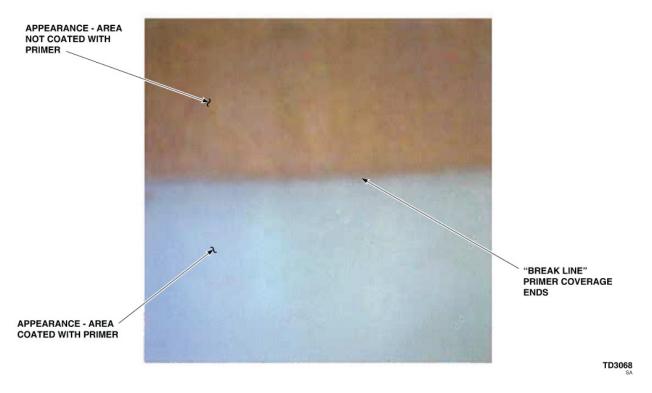
Figure 2: Typical Borescope View – End of Primer Coating

- (5) Slowly push the borescope cable into the blade until the end of the primer coating is visible on the borescope monitor. Figure 2 shows how the end of the primer coating typically appears. When the borescope reaches the "break line" of the end of the primer, hold the borescope cable steady and apply a wrap of tape to the borescope cable coming out of the root end of the blade so that the depth measurement ("break line" location) can be determined.
