269D™ HELICOPTER

ASB DB-062

SUBJECT: MAIN ROTOR AND CONTROL SYSTEM AND TAIL ROTOR AND CONTROL SYSTEM – Main Rotor and Tail Rotor Control Rods – One-time Inspection of Flight Control Pushrods with Adjustable Rod Ends

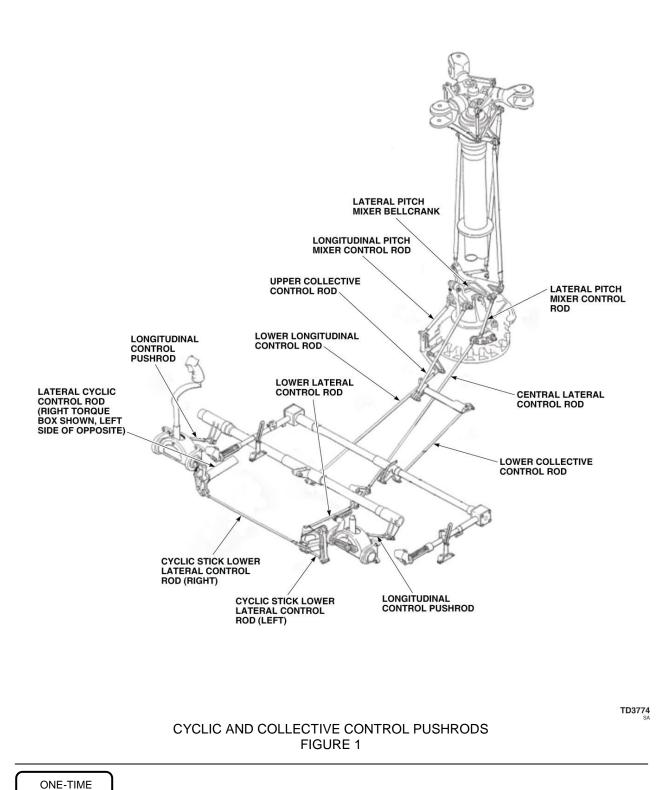
- (1) Turn off all helicopter electrical power.
- (2) Gain access to flight control pushrods below the lateral pitch mixer bellcrank that contain P/N AN316-6R and AN3165-5R, or equivalent, shear type jam-nuts by removing seat, access panels, and fairings as required.
- B. Inspect all flight control pushrods located in the fuselage, tailboom, and below the lateral pitch mixer bellcrank (Refer to Figures 1 and 2):
