SCHWEIZER SERVICE LETTER

SUBJECT: STRUCTURAL ENHANCEMENT OF TAIL ROTOR PEDAL MOUNT

MODELS AFFECTED: All 269D Model Helicopters.

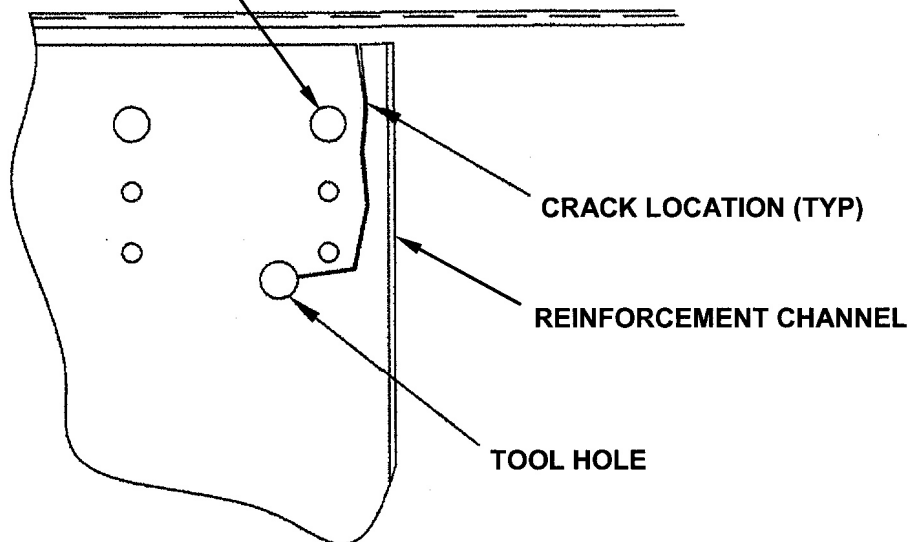
**TOP PEDAL SUPPORT
ATTACHMENT BOLT HOLE**

Service Bulletin DB-022 was issued requiring inspection of the tail rotor pedal attachment structure and installation of the SA-269DK-40 reinforcement kit. Additional cracks have been reported in some aircraft on the left side of the helicopter. The cracks are located near the flange radius of the reinforcement channels of the pedal support structure. The cracks start at the top right side and propagate down along the edge of the top nut plate to an empty tool hole (see figure below). During the 100 hour inspection of the pedal support structure, if these cracks are noted, they can be repaired by installing an SA-269DK-44 Repair Kit. Due to the amount of floor structure that must be removed to gain access to the damaged areas, it is recommended that the SA-269DK-44 kit be installed at the same time the SA-269DK-40 kit is installed.
