SCHWEIZER SERVICE LETTER

L-160
14 Oct 1996

SUBJECT: STRUT AND BRACKET ASSEMBLY - BELT DRIVE INSTALLATION

MODEL AFFECTED: 269C Helicopters; S/N S-004 through S-1732

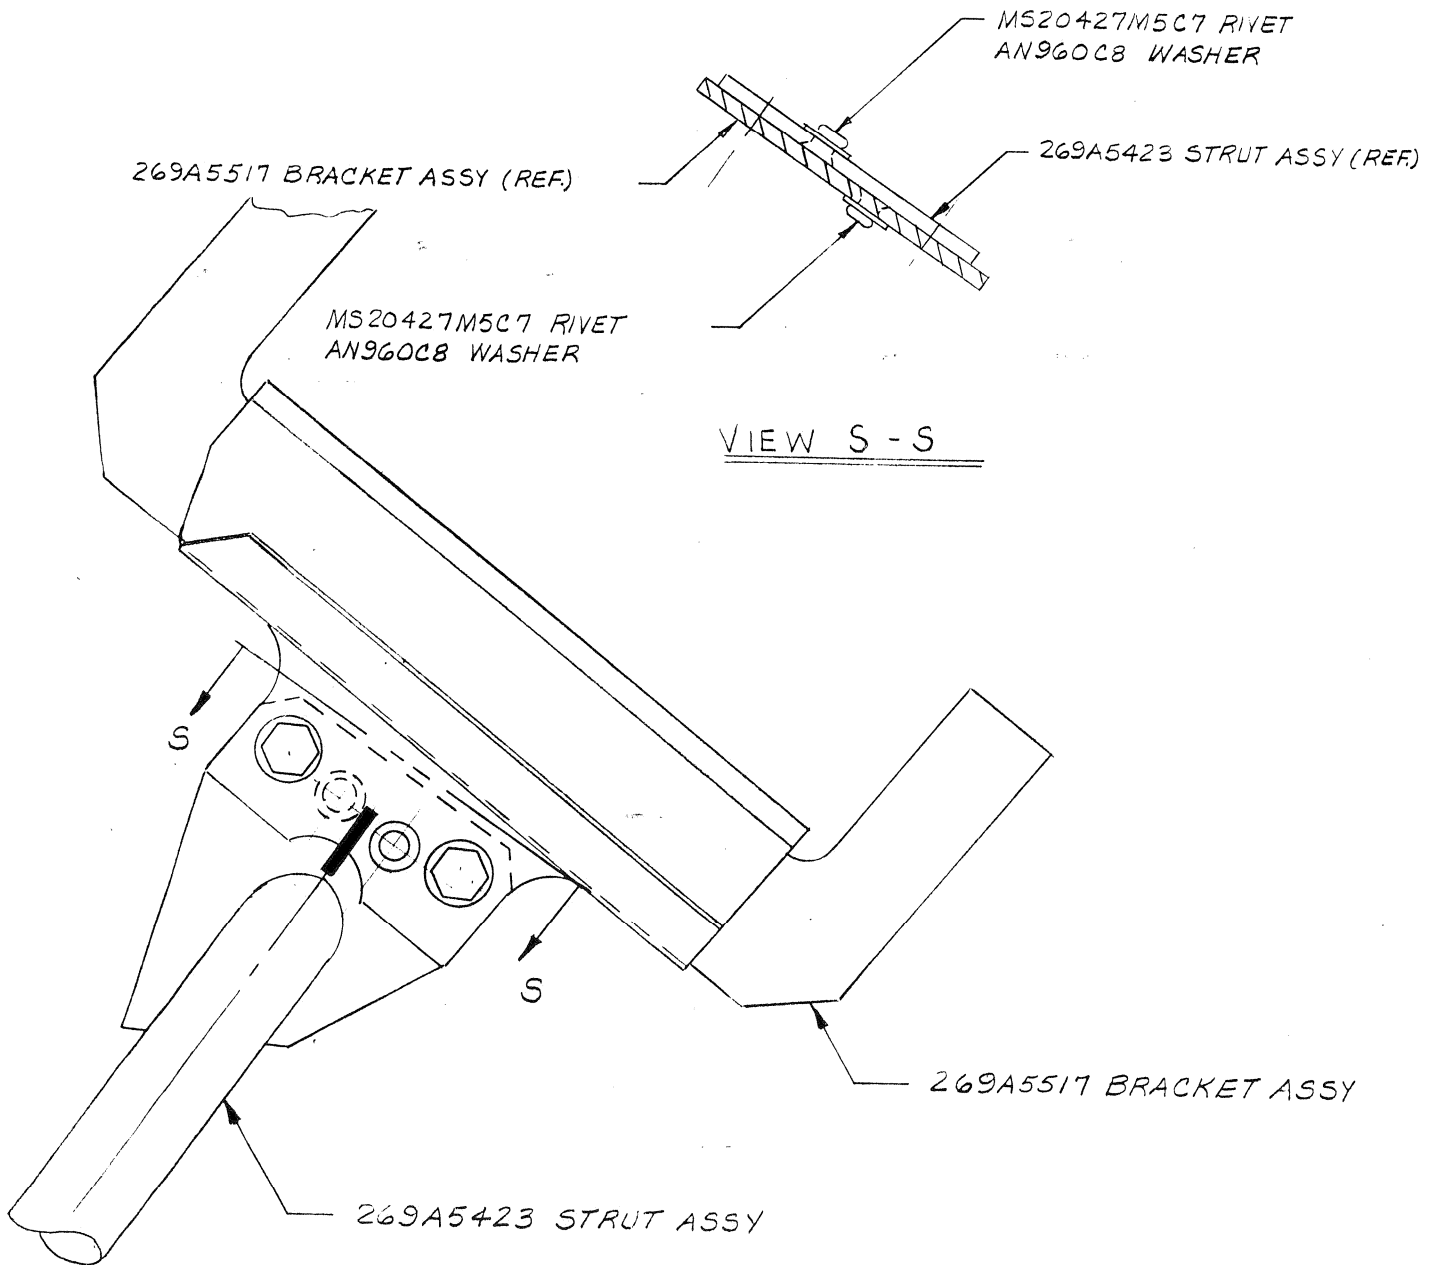
Figure L-160-1. Bracket and Strut Orientation

The 269A5423 strut assembly could be inadvertently reassembled incorrectly, in relation to the 269A5517 bracket assembly, after maintenance of belt drive system. The correct orientation of the strut, and attachment to bracket, is illustrated in Figure L-160-1 (Page 2 of 2).

- a. The strut is installed on top of the bracket.
- b. The strut is installed upside down (narrow side of attachment flange forward).
- c. The strut is installed upside down and on top of the bracket.

On helicopter S/N S-1733 and subsequent (and current spares) both bracket and strut have an arrangement to prevent disorientation of mating parts. As an option, the rivet and washer arrangement shown on Figure L-160-1 can be installed in the field.

If in doubt that the bracket and strut are assembled correctly, orientation should be checked for the conditions specified above. If assembled wrong, it is recommended that these parts be disassembled, inspected for cracks, and reassembled correctly.
